STRUCTURAL HEALTH MONITORING OF THE FIRST GEOSYNTHETIC REINFORCED  
SOIL – INTEGRATED BRIDGE SYSTEM IN HAWAII

A THESIS SUBMITTED TO THE GRADUATE DIVISION OF THE  
UNIVERSITY OF HAWAI‘I AT MĀNOA IN PARTIAL FULFILLMENT  
OF THE REQUIREMENTS FOR THE DEGREE OF

CIVIL ENGINEERING

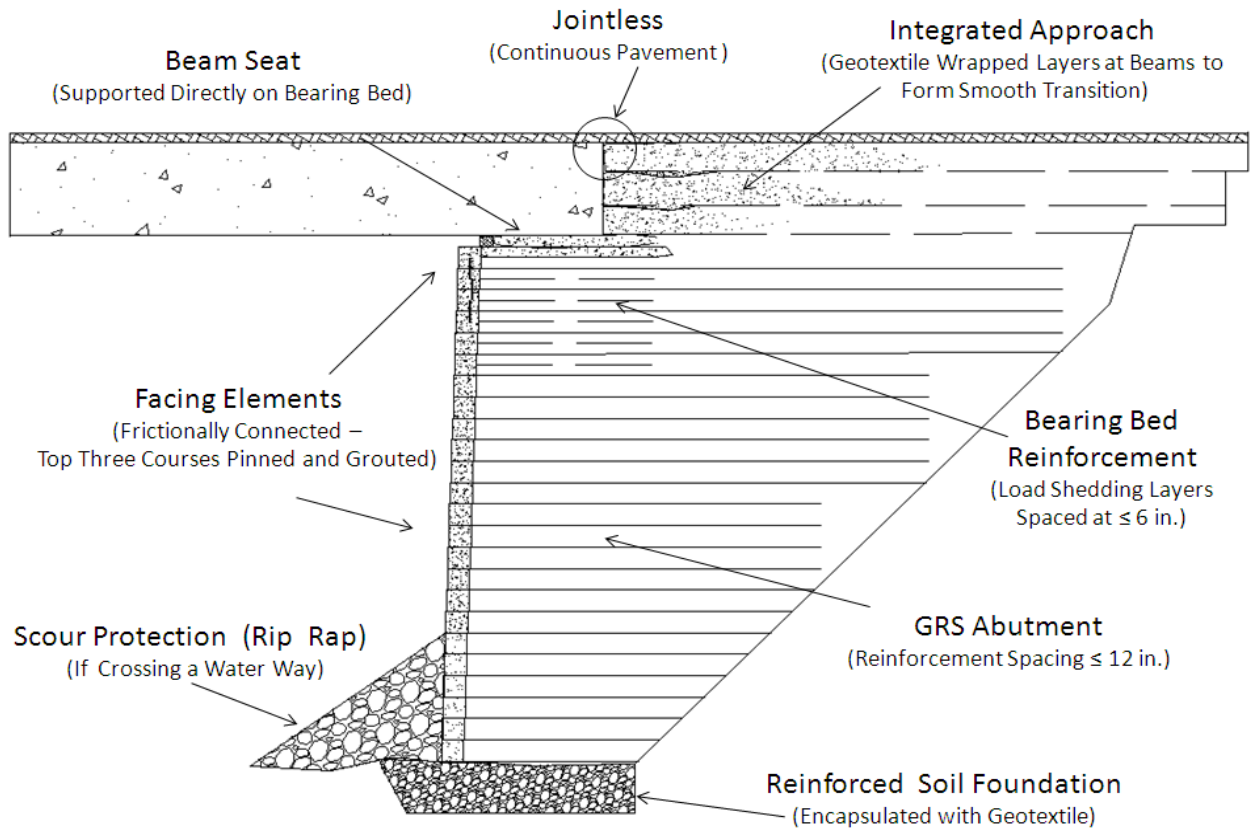
**Figure 1 Typical GRS-IBS Cross Section (Adams et al. 2011a)**

GRS-IBS consists of three main components; a reinforced soil foundation (RSF), a GRS abutment, and an integrated approach (Figure 1). The RSF is constructed using compacted granular fill reinforced with geosynthetics. The purpose of the RSF is to provide embedment and increase the bearing width and capacity. The GRS abutment is constructed using alternating layers of compacted granular fill and  $\leq 12$ -inch (typically 8-inch)-spaced layers of geosynthetic reinforcement. Every layer of reinforcement is frictionally connected to the facing element, which is typically a concrete masonry unit (CMU) block. The top 3 to 4 facing elements are normally pinned and grouted. The reinforcement spacing in the top 5 courses is usually halved to meet serviceability requirements in the lateral direction. The integrated approach is also constructed using GRS. It creates a transition to the superstructure and alleviates the “bump-at-the-end-of-the-bridge” that is caused by differential settlement of the abutment and the approach roadway.

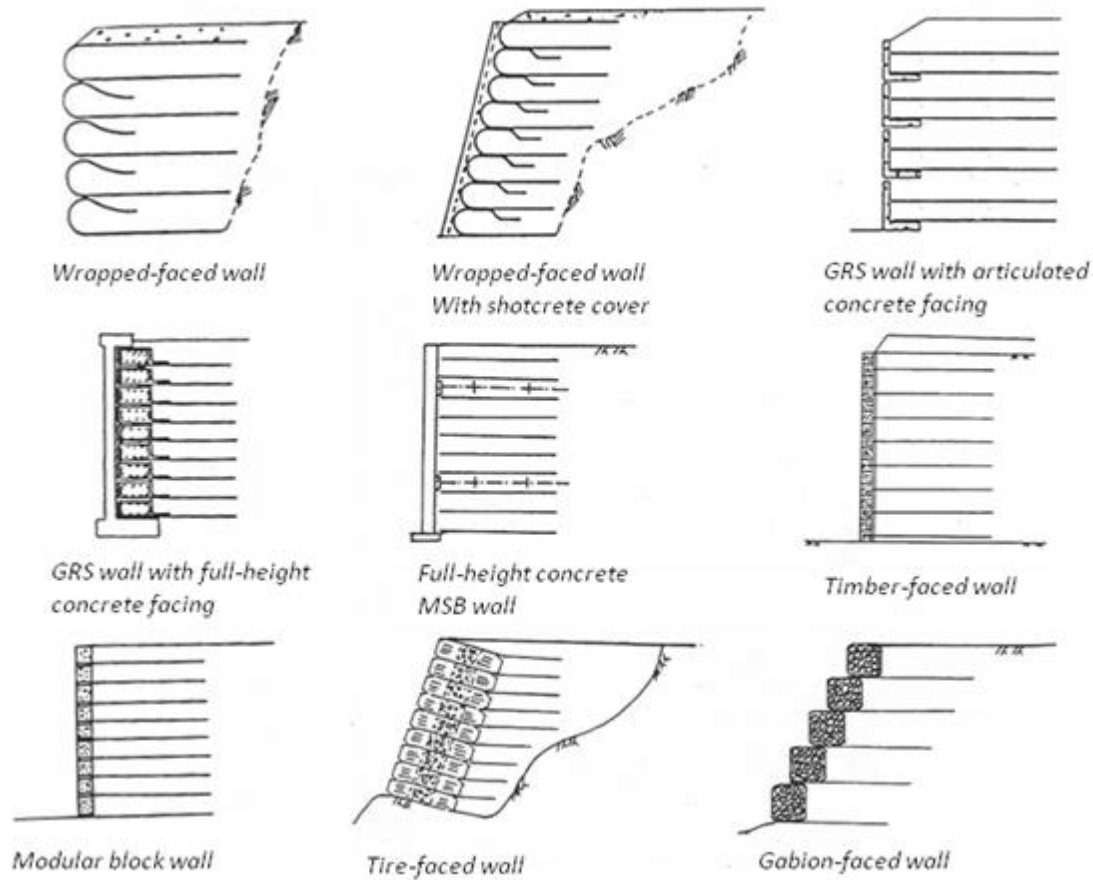
**Figure 3 GRS Walls with Different Facings. (Wu, 1994)**

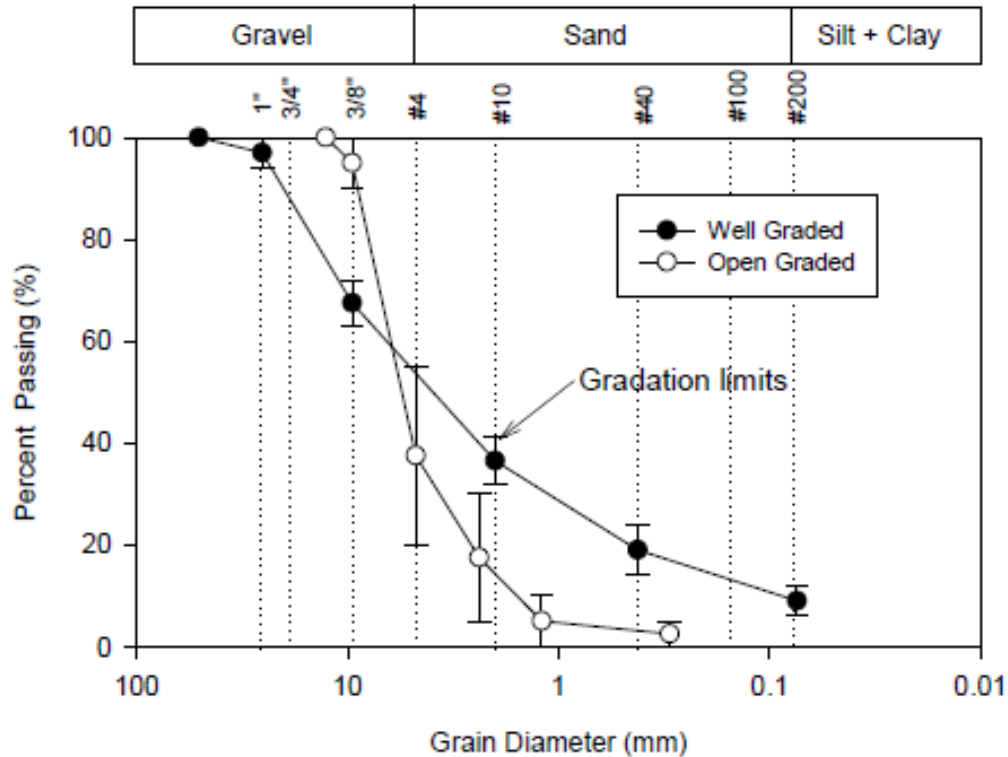
**Figure 5 Recommended Gradations for Well-Graded and Open Graded Granular Backfill (Adams et al. 2011b)**

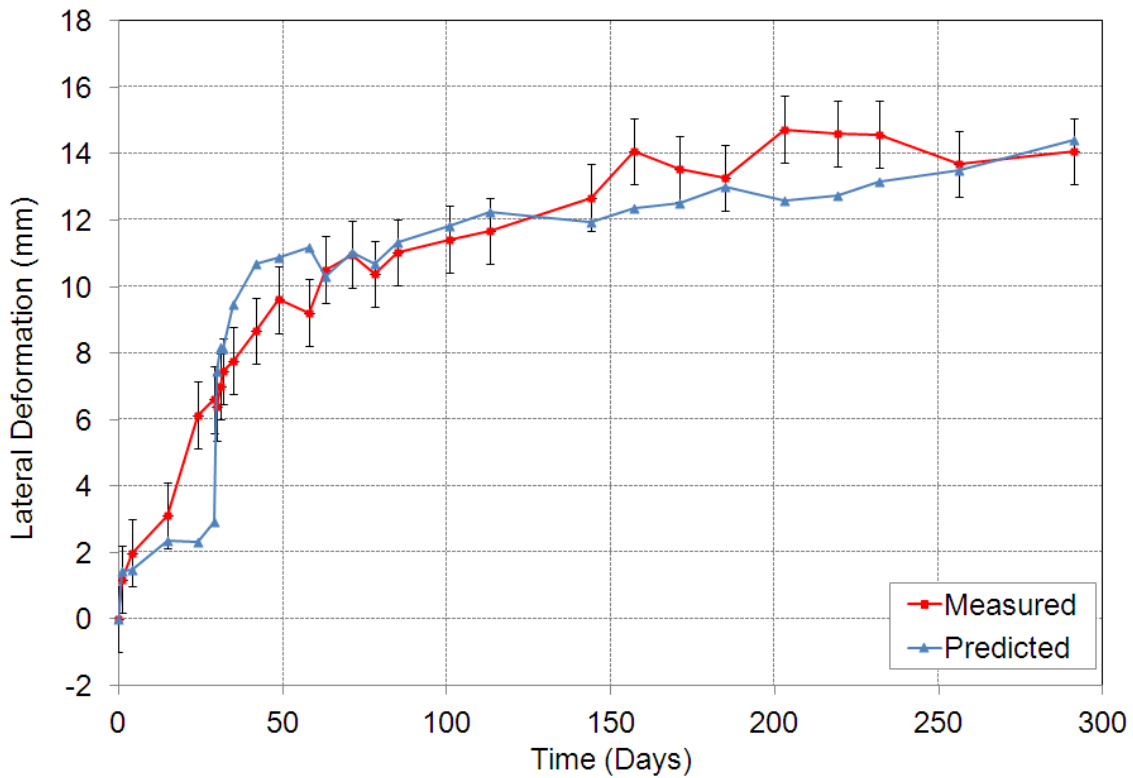
**Figure 11 Comparison of Predicted Lateral Deformation to Measured Data for an In-Service GRS Abutment (Adams et al. 2011b)**

The postulate of zero volume change has been shown to be valid for GRS structures over a large range of stresses (Figure 11).

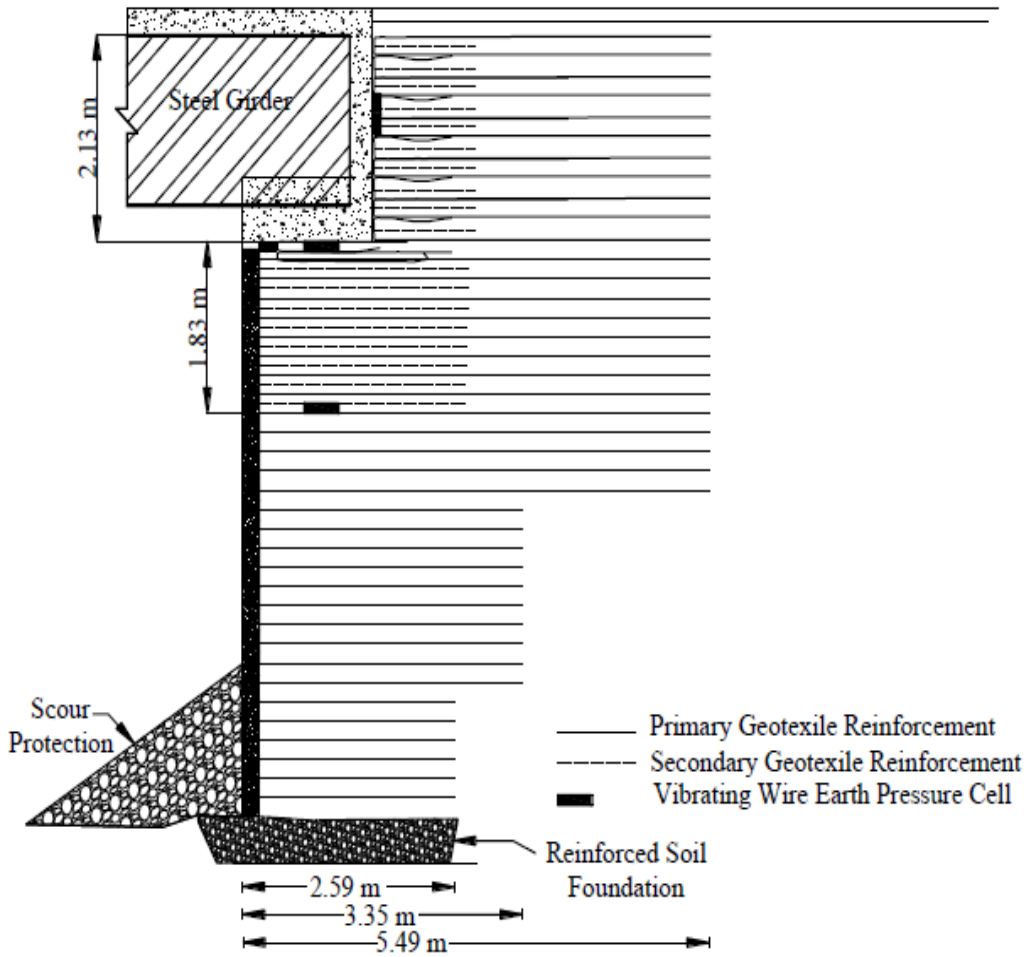
**Figure 12 Schematic of the Instrumented GRS Integrated Bridge System (Warren et al. 2010)**

The Tiffin River Bridge is currently the longest in-service GRS-IBS at a span of 140 ft (Adams et al. 2011a). The north and south abutment heights are 18 feet and 20.5 feet, respectively. For the top 5 feet of each abutment, solid core CMU blocks were utilized to prevent freeze-thaw conditions. The remainder of the abutment height utilized hollow core CMU blocks. The backfill used was AASHTO No. 89 crushed stone that was compacted to at least 95% relative compaction. Two different types of geotextile reinforcement were utilized. The primary geotextile used for every layer had a wide width tensile strength equal to 70 kN/m (4800 lb/ft). The secondary geotextile, which was installed between the primary reinforcements, had a wide width tensile strength equal to 35 kN/m (2400 lb/ft) (Figure 12).

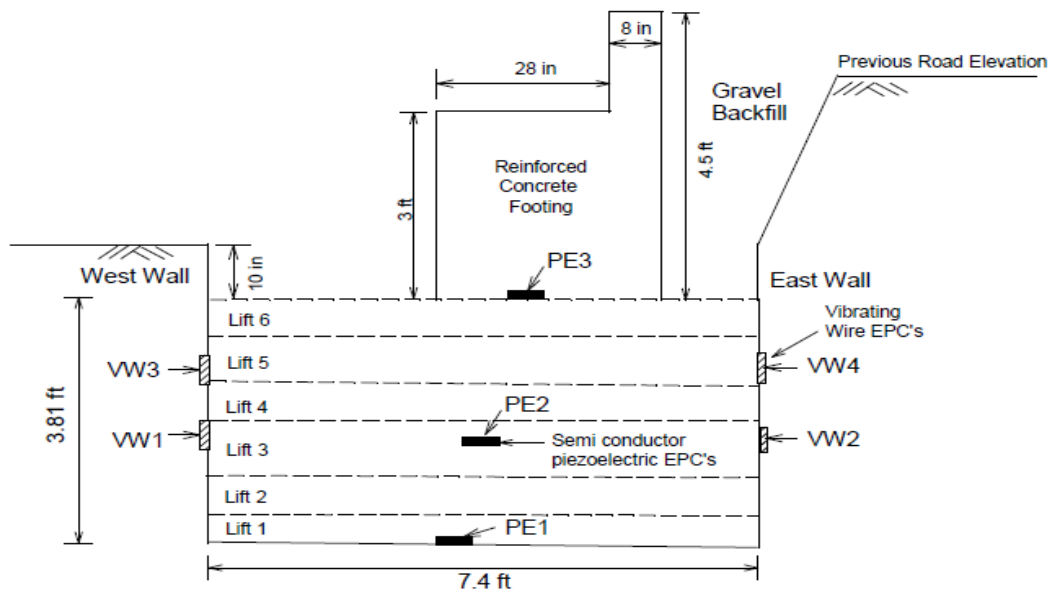
**Figure 16 Cross-Sectional View of the GRS Fill Material (Vennapusa et al. 2012)**

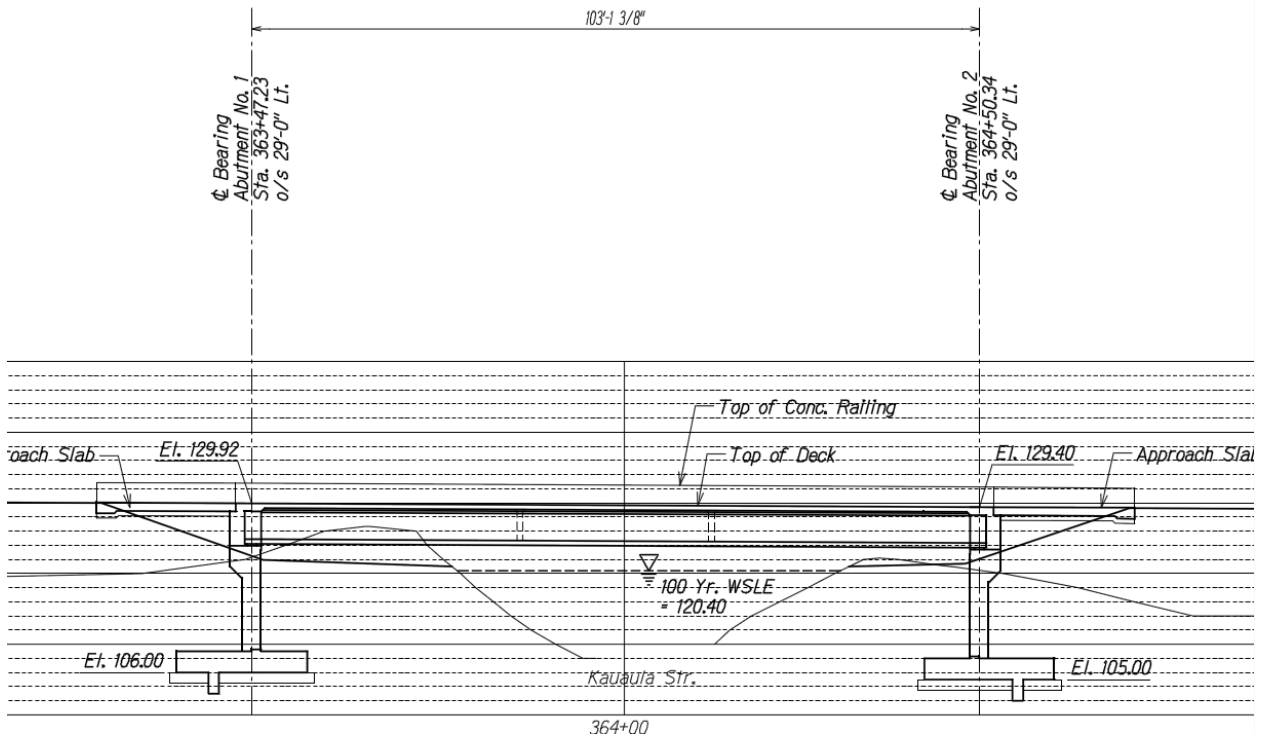
Figure 19 Original Design (Kai Hawaii, Inc. 2011)

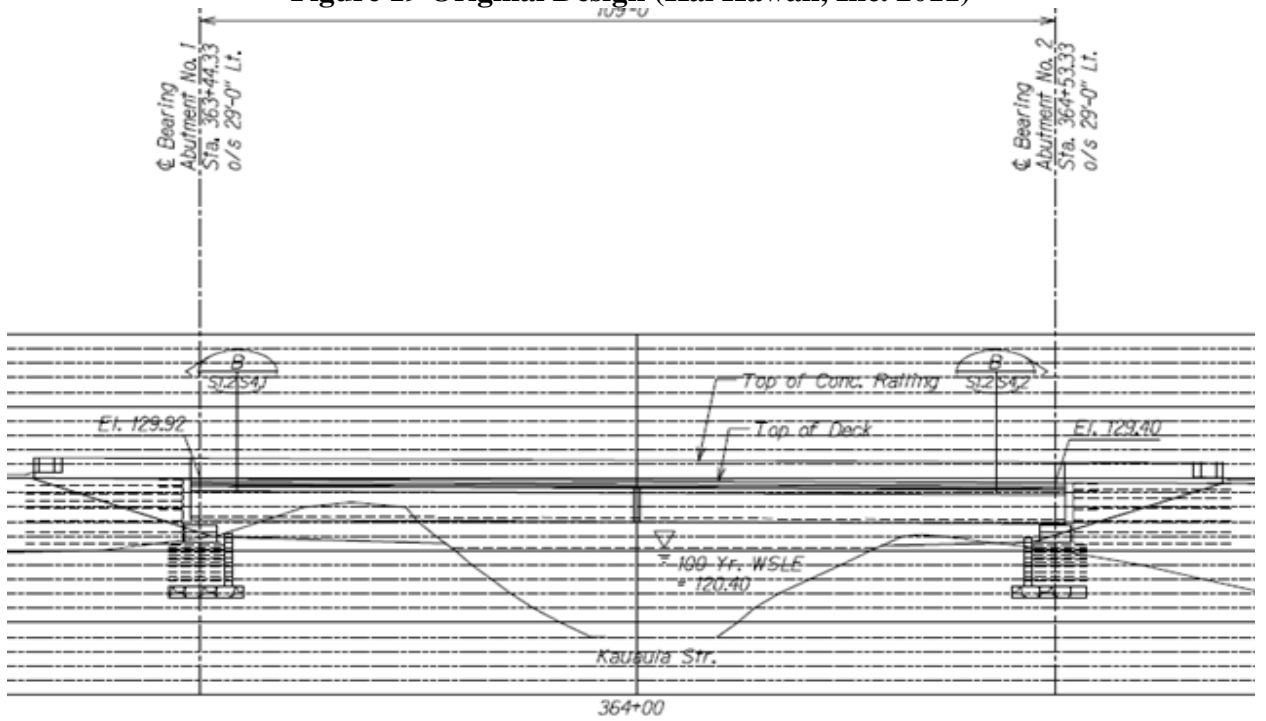
The Kauaula Stream Bridge has a single 109-foot-long span. It is skewed ( $31^\circ$ ) and super-elevated as shown in Figures 20b and c. The value-engineered bridge was designed having 3 separate tub girders as its superstructure connected by numerous precast concrete planks. A 5-inch-thick cast-in-place topping was poured on the planks to serve as the wearing surface. The tub girders/precast planks/topping are integral with the concrete footing; i.e.; there is a full moment connection between the superstructure and sub-structure.

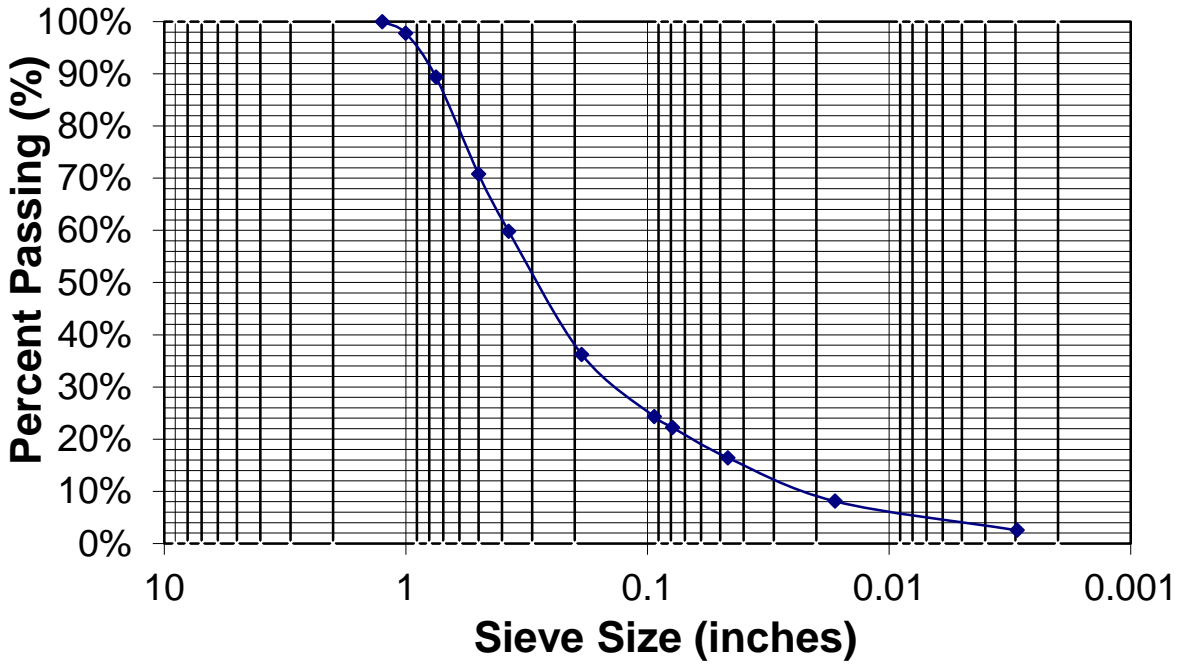
Figure 22 Grain Size Distribution of GRS Backfill

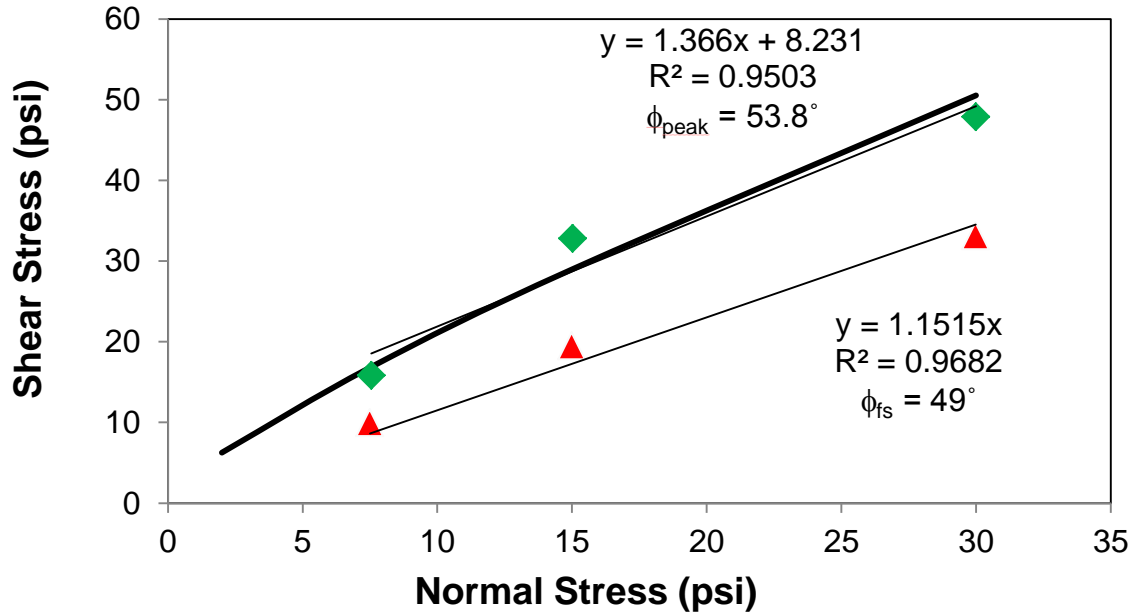
**Figure 24 Mohr Coloumb Failure Envelope for GRS backfill**

Consolidated drained direct shear tests were conducted in a 12 inch x 12 inch x 8 inch high shear box. The specimens were compacted to a relative compaction = 90% to 91% based on Standard Proctor (123 pcf – 124 pcf) at a water content of 9%. Then the specimens were saturated, consolidated, and sheared to failure. Normal stresses of 7.5 psi, 15 psi and 30 psi were applied during the consolidation phase. A gap of  $D_{85}$  (~0.63 inch) was created between the two halves of the box prior to shear and the specimens were sheared at a rate of 0.015 in/min. The shear tests resulted in a non-linear Mohr-Coulomb failure envelope (Figure 24). Assuming a linear failure envelope, the peak friction angle  $\phi_{peak}$  was determined to be  $53.8^\circ$  while the cohesion was 8.23 psi or 1185 psf. The fully softened friction angle  $\phi_{fs}$  was determined to be  $49^\circ$ .

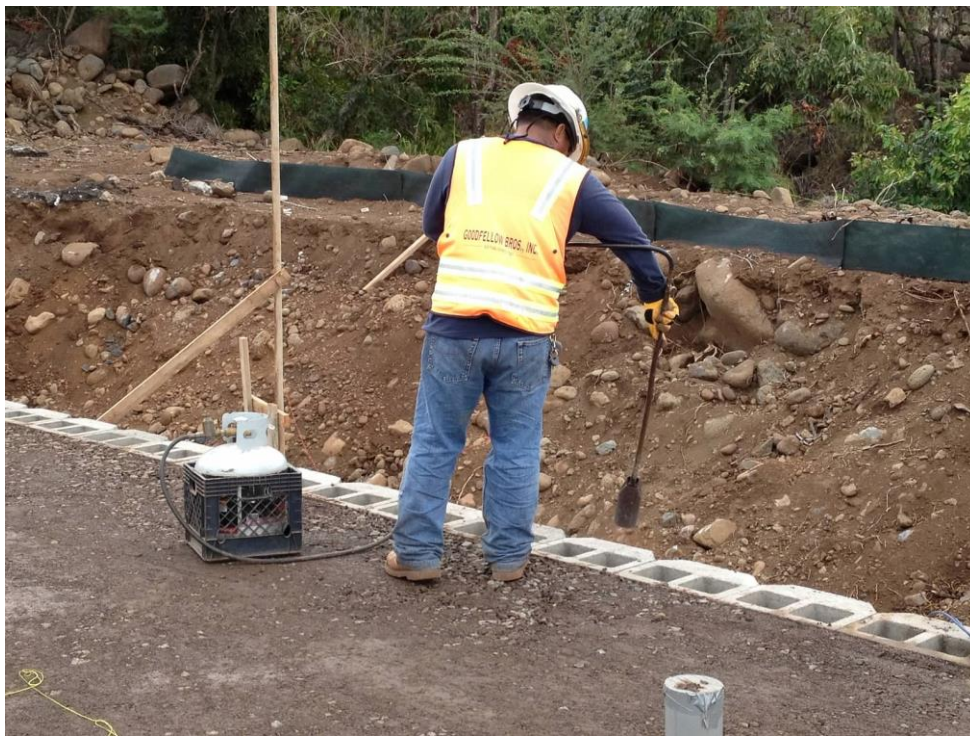
**Figure 31 Geosynthetic Burned Through Using a Torch**

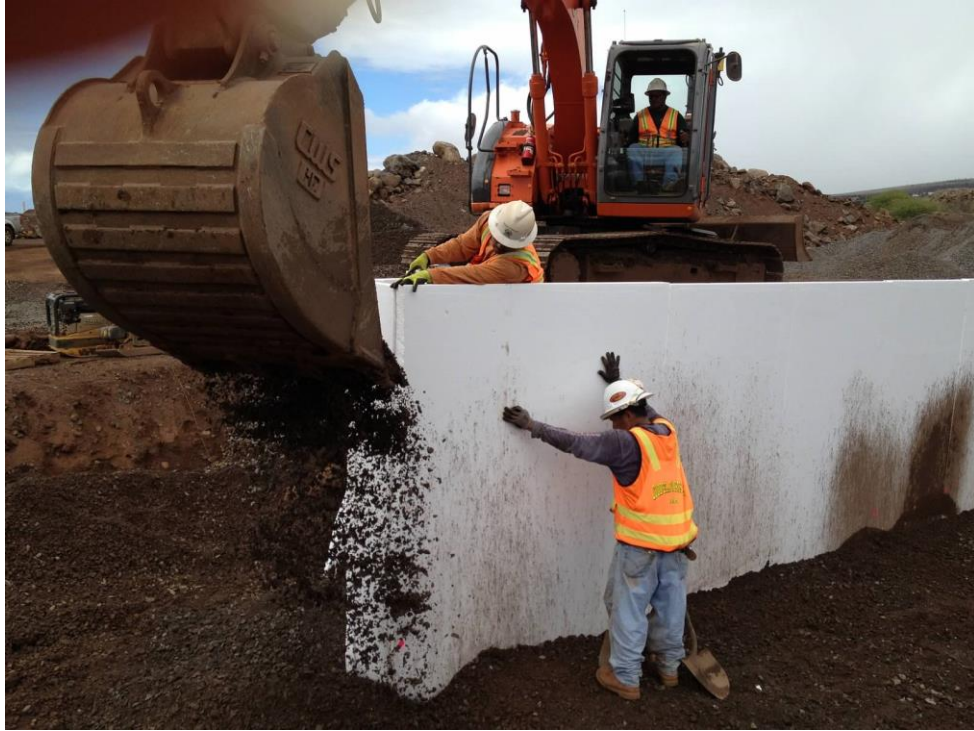
**Figure 32 Styrofoam Placed in Front of Abutment 1 Prior to Placement of Rip Rap**

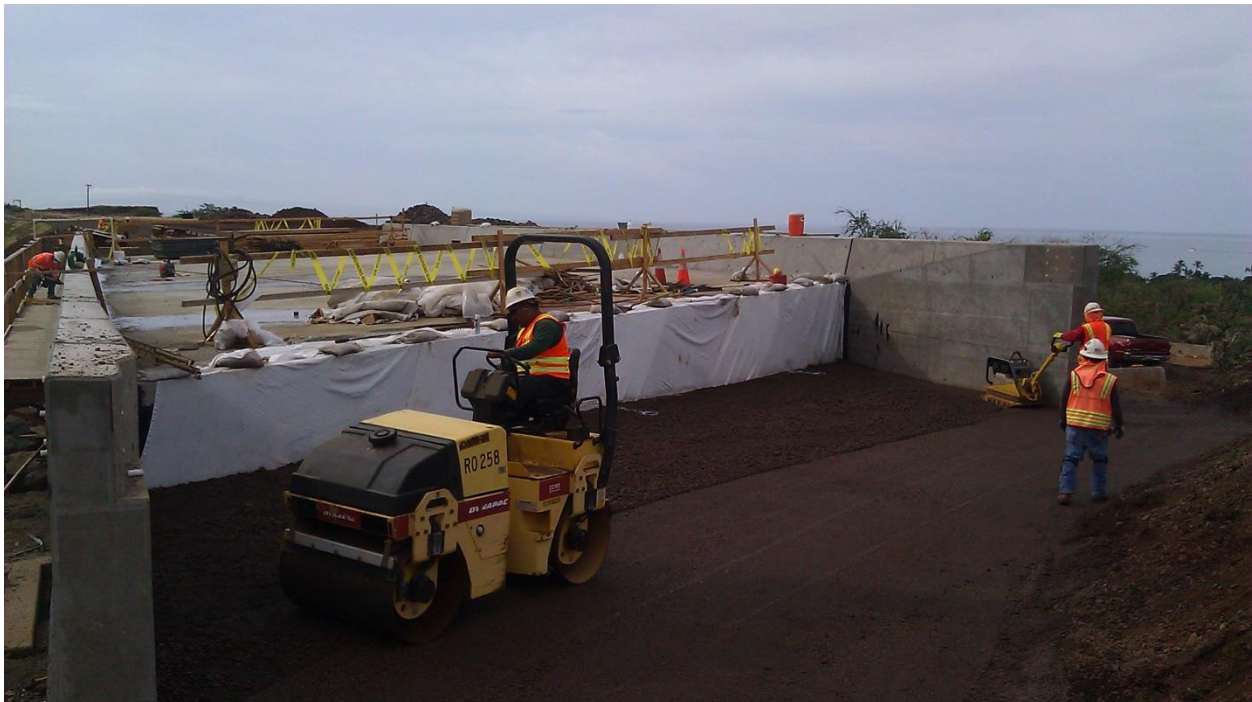
**Figure 40 Integrated Approach Construction**

After the wing and end wall concrete was properly cured, the integrated approach was compacted in 6 inch lifts using the same backfill material as the GRS abutment. Using a hand tamper close to the walls and a vibratory roller further away, each lift was compacted to at least 95% relative compaction (Figure 40). The geosynthetic spacing was 12 inches for the approach. Upon completion of the integrated approach, the guardrails were erected. Figure 41 displays the completed GRS-IBS.

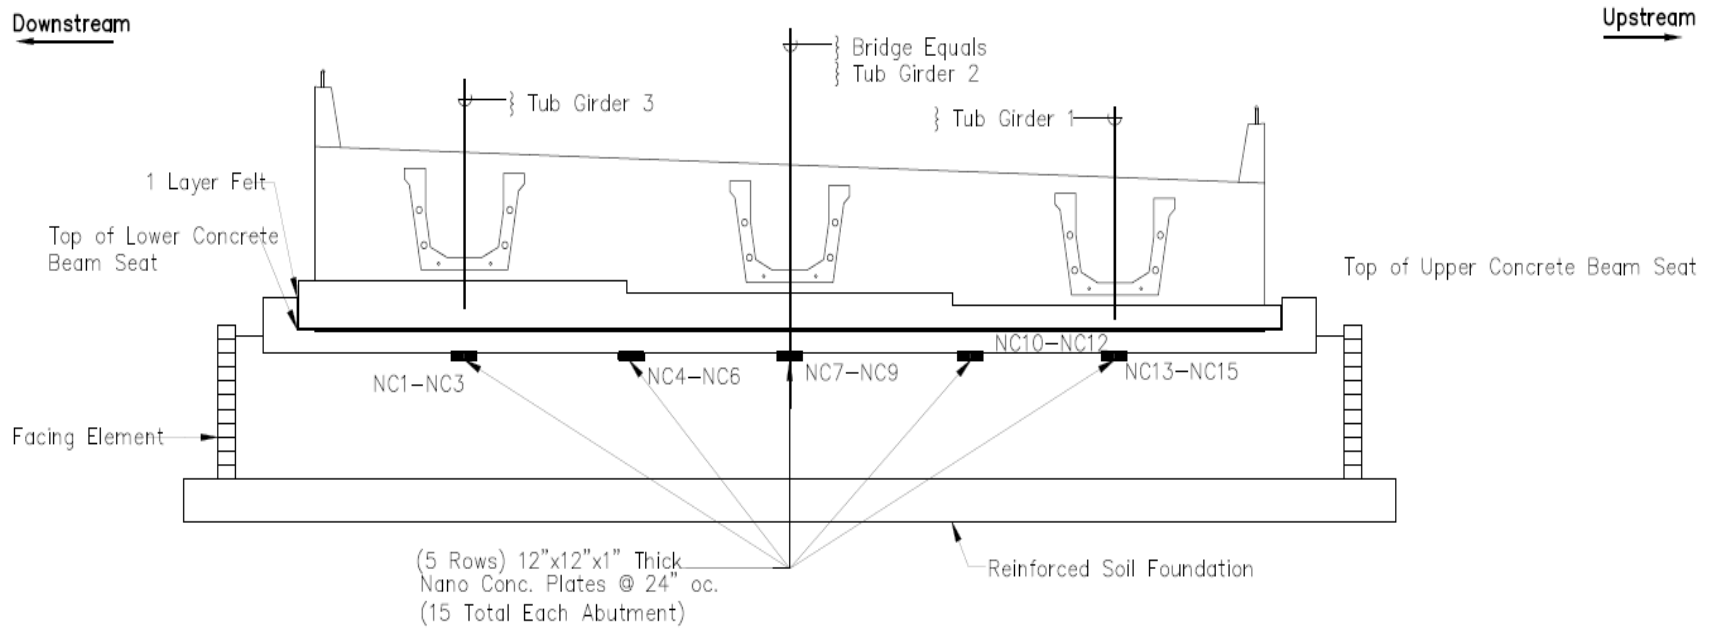
ABUTMENT NO. 1 – SECTION Nano Conc. Tile

**Figure 49 Locations of Nano Concrete Tiles at Abutment 1**

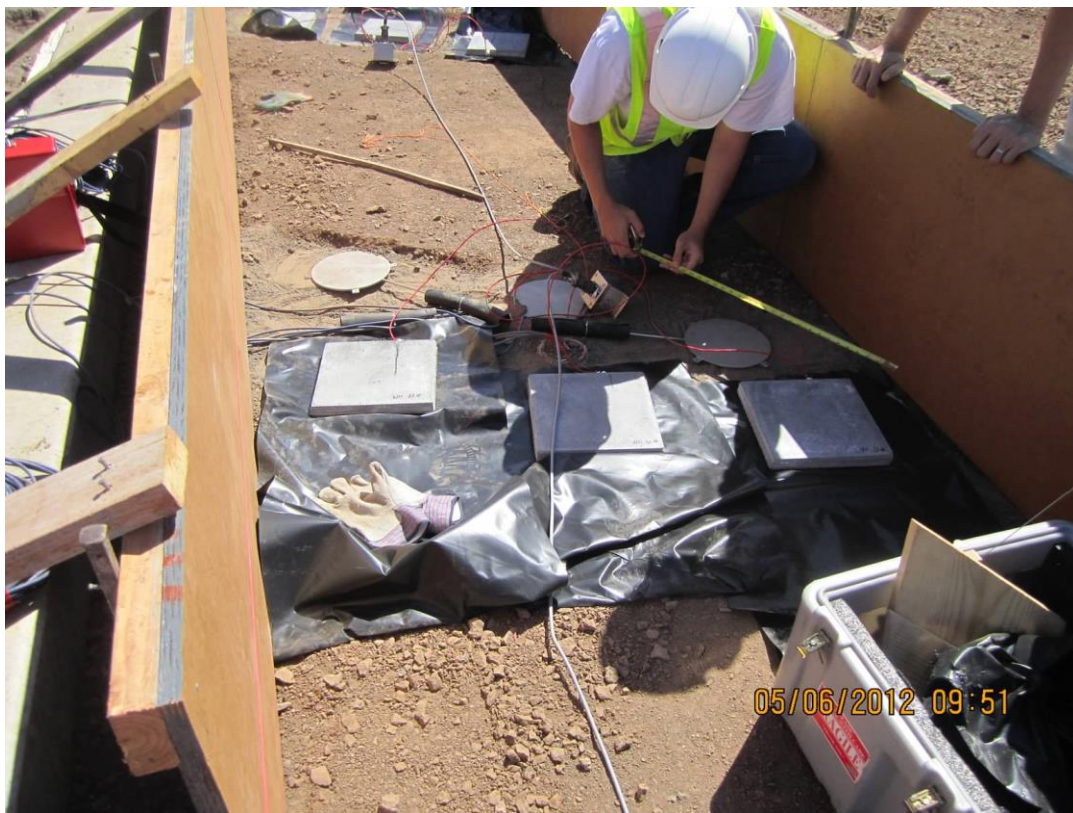
**Figure 51 Nano Concrete Tiles Set Down on Plastic Sheeting Which Was Then Folded Over To Sandwich Them**

1. Shallow holes were excavated at the desired NC tile locations. (Figure 46).
2. Each NC tile was placed between two plastic sheets to minimize any exposure to moisture. Then, a 1- to 2-inch-thick layer of sand was placed on top to create a level surface and to protect the instrument from excessive point loading from the gravelly portion of the concrete footing. The NC tiles were spaced 2 feet apart and aligned with the tub girders (Figure 51)
3. The NC cable was run to daylight on the stream side of the footing.

The NC tiles were connected in series and if any of the connections or any NC tiles along the chain were damaged, the tiles before it in the series would not work. Unfortunately this is what happened, no vertical pressures were recorded, and the NC tiles will not be discussed hereafter.

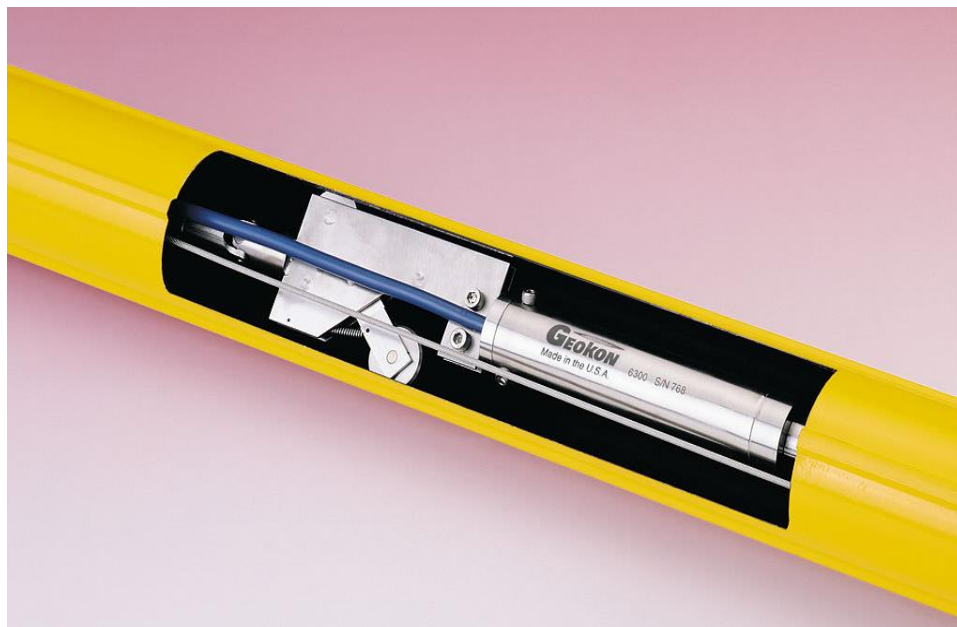
**Figure 56 Geokon 6300 Inclinometer (Geokon Inc. 2013)**

The tilt sensor consists of a pendulous mass which is supported by a vibrating wire strain gage and an elastic hinge. The strain gage senses any change in force caused by the rotation of the center of gravity of the mass (Geokon Inc. 2013). The full layout of the inclinometer system is shown in Figures 58 and 59. The inclinometers were spaced closer together (every 2 feet) in the upper 10 feet of the GRS abutment facing, which is considered the zone of interest, and further apart (every 4 feet) below that.

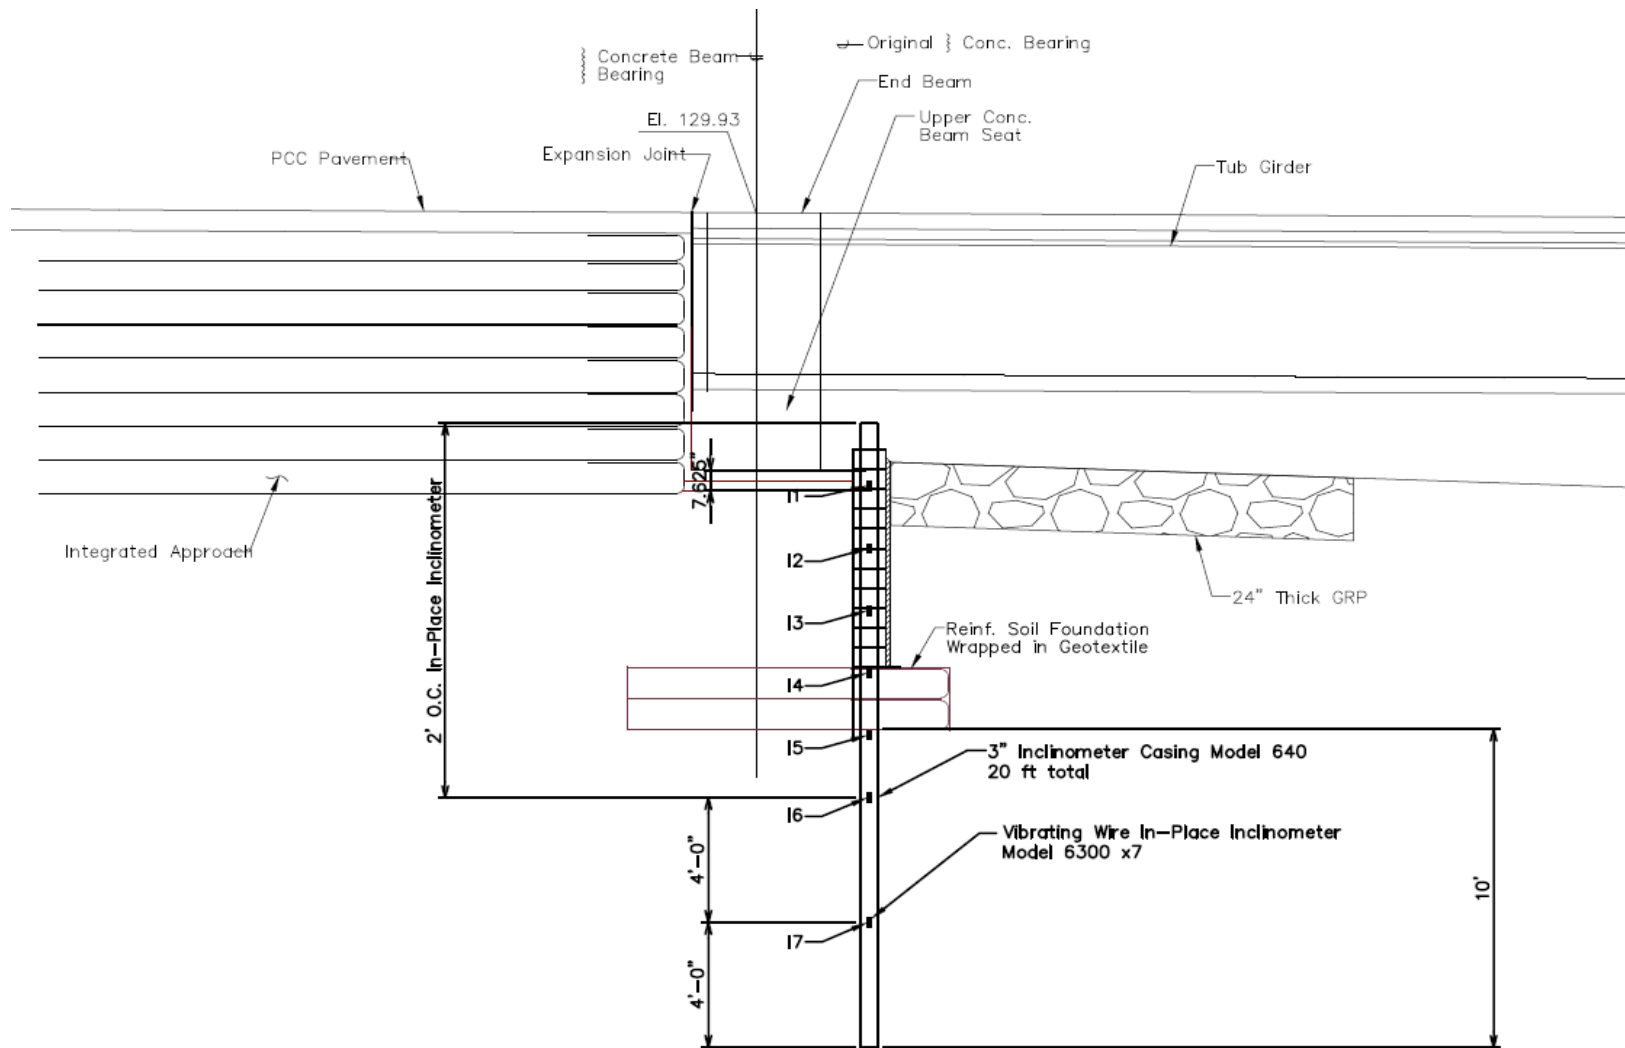
**Figure 58 Abutment 1 Inclinerometer Layout**

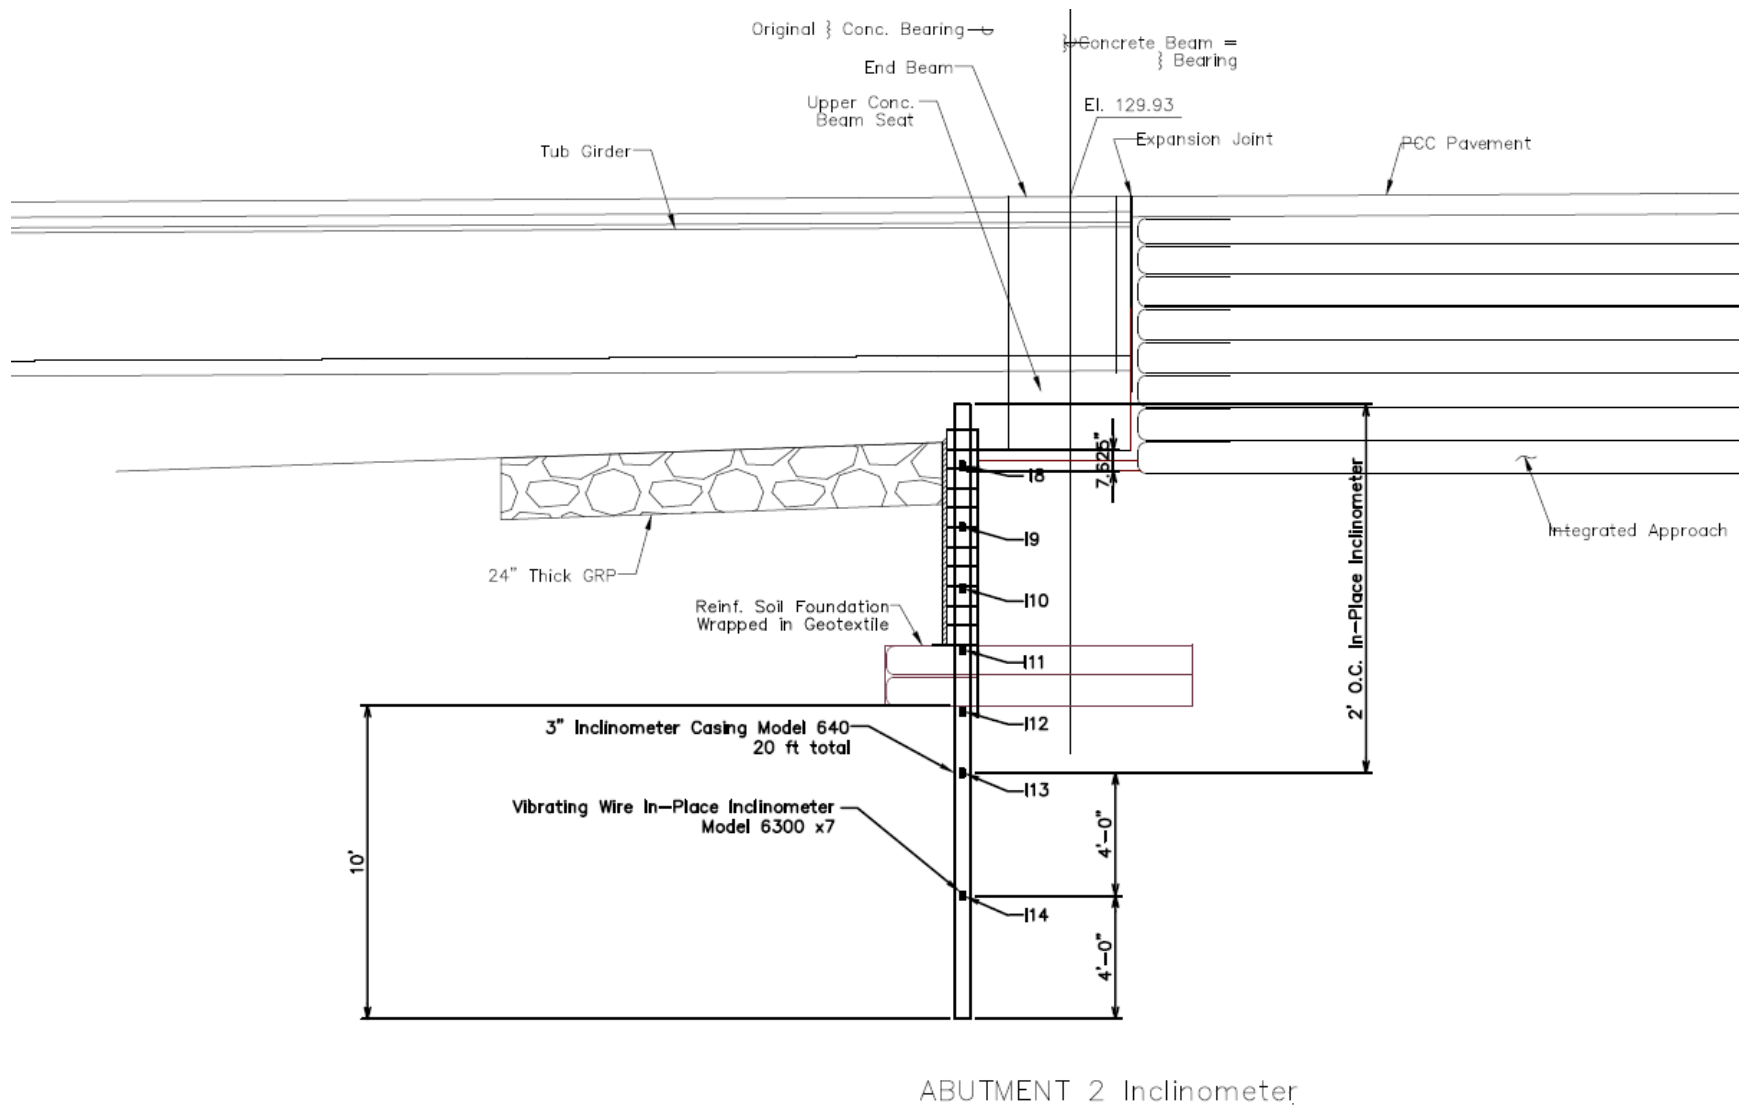
**Figure 59 Abutment 2 Inclinometer Layout**

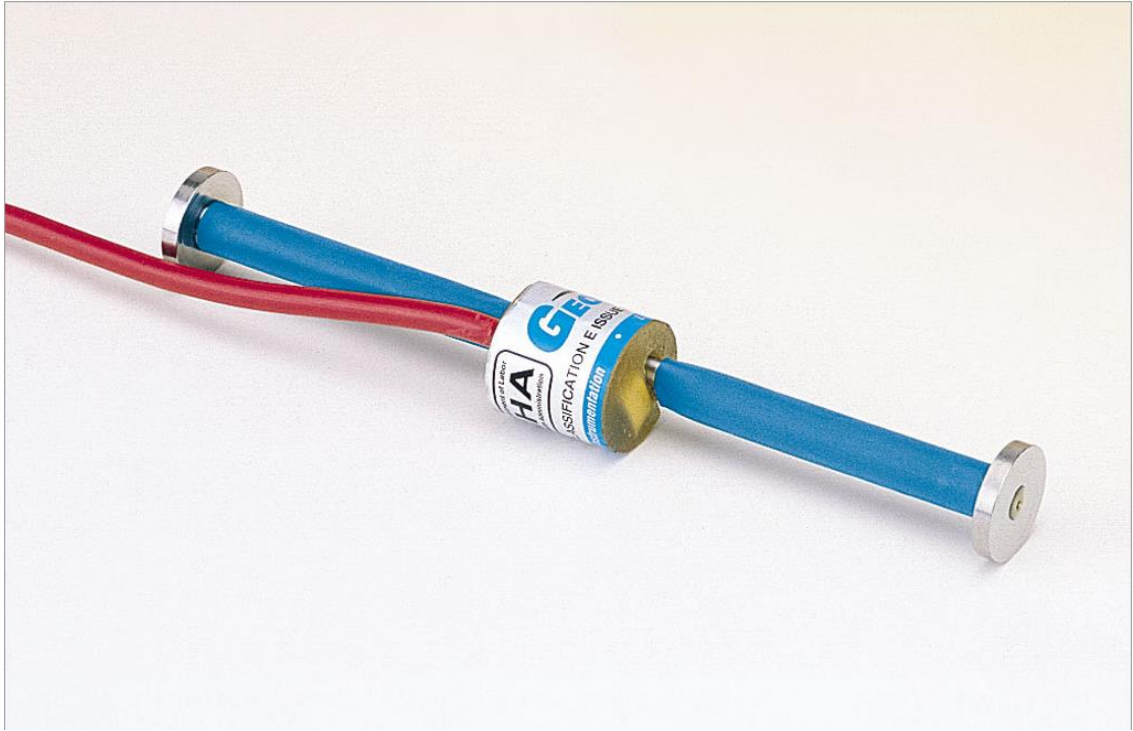
**Figure 62 Geokon 4200 Concrete Embedded Strain Gage (Geokon Inc. 2013)**

- (1) The 28-day design compressive strength is 6000 psi; and
- (2) 4 lbs of 1/8-inch Anticrak Hd and 6 lbs of 67/36 Anticrak Hd alkali resistant glass fiber were added per cubic yard of concrete.

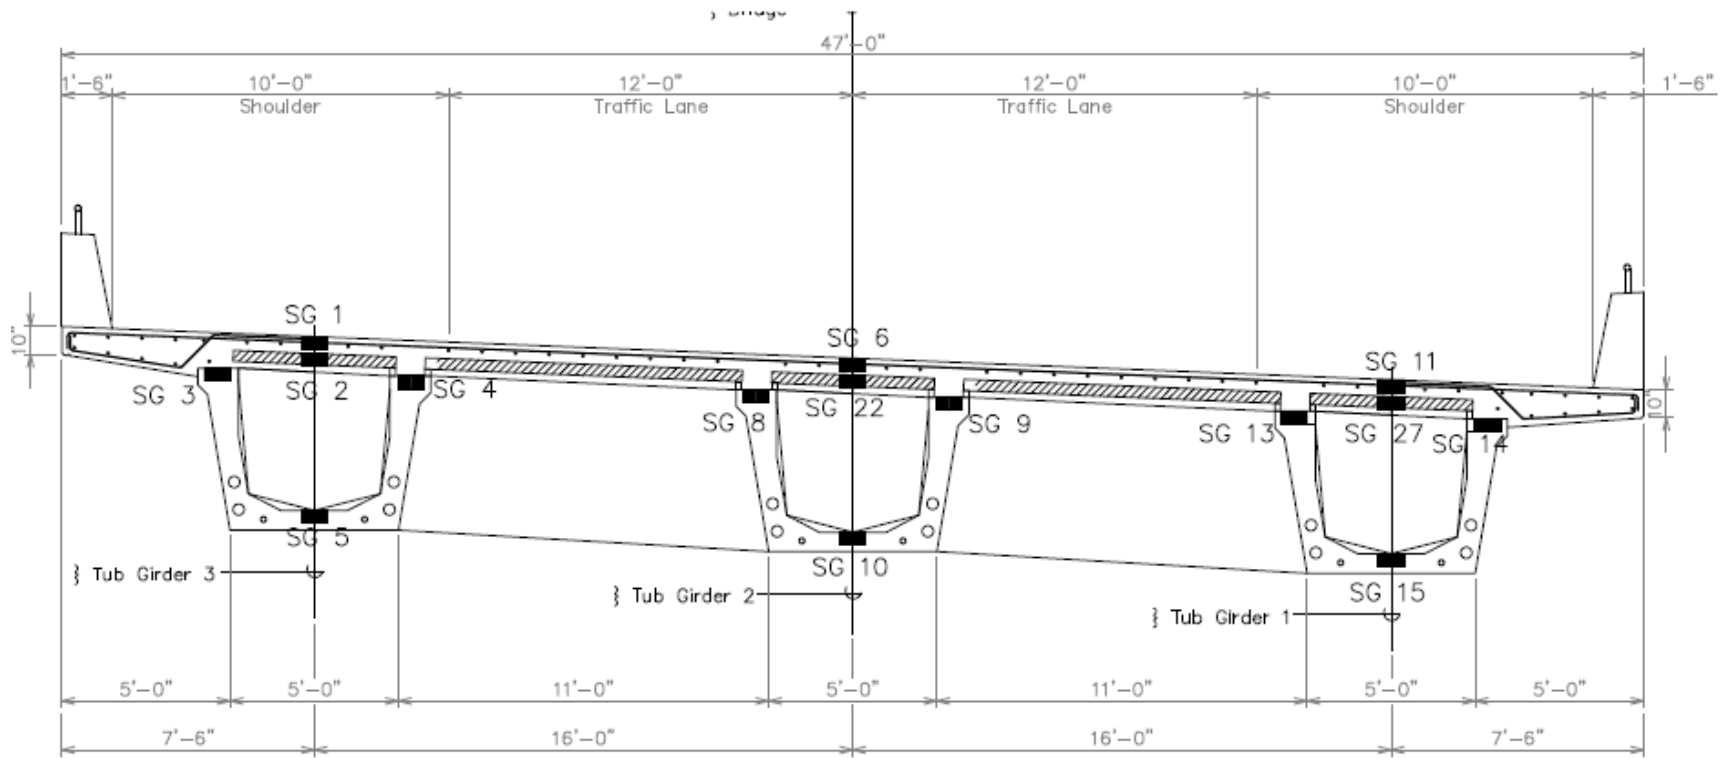
**Figure 63 Abutment 1 Strain Gage Layout**

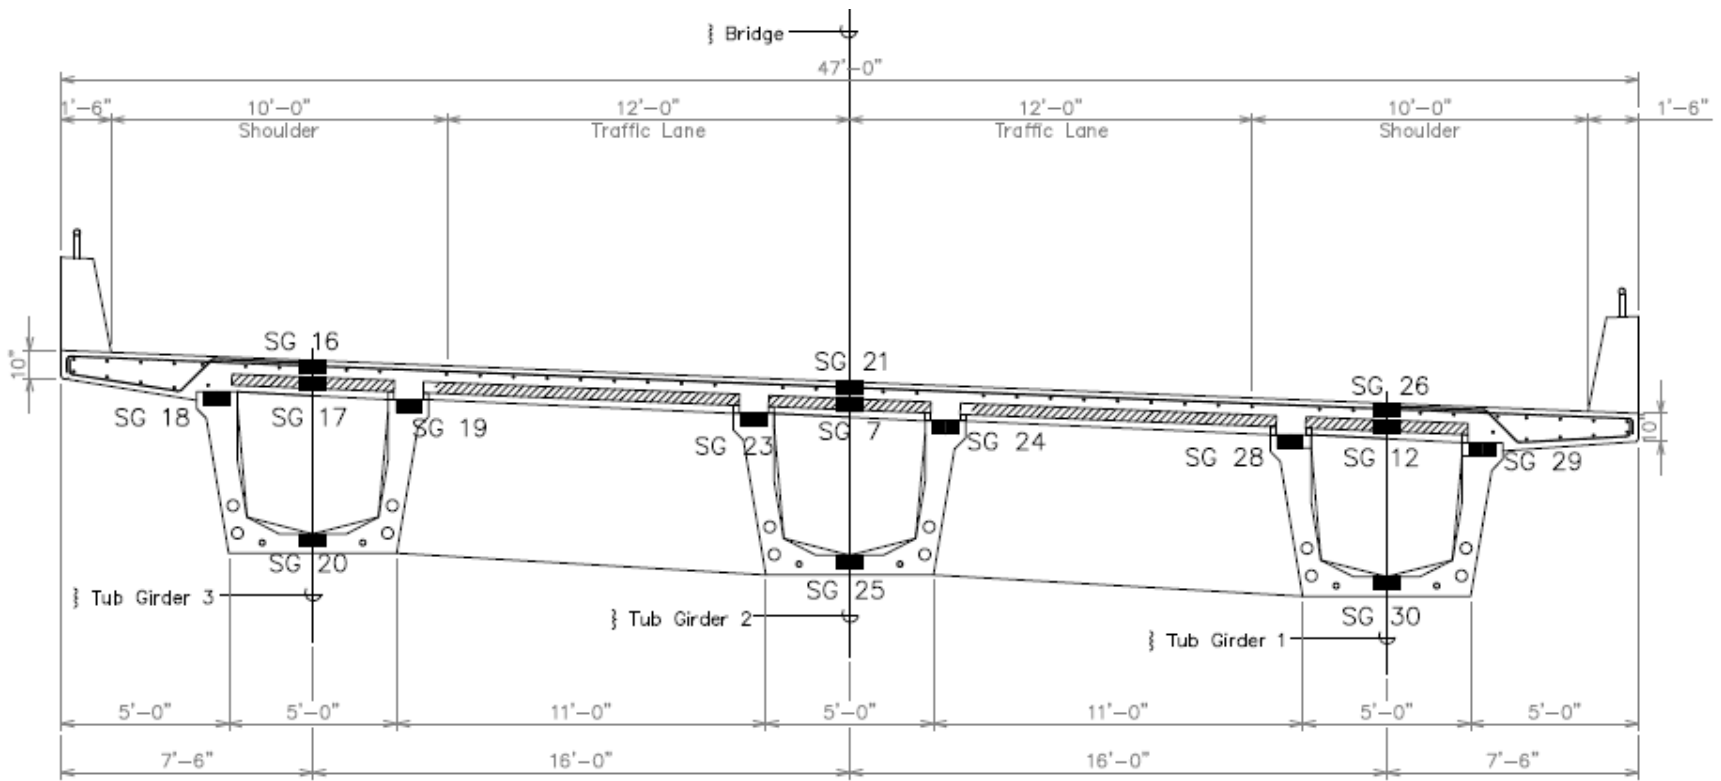
**Figure 64 Abutment 2 Strain Gage Layout**
