STRUCTURAL HEALTH MONITORING OF THE FIRST GEOSYNTHETIC REINFORCED  
SOIL – INTEGRATED BRIDGE SYSTEM IN HAWAII

A THESIS SUBMITTED TO THE GRADUATE DIVISION OF THE  
UNIVERSITY OF HAWAI‘I AT MĀNOA IN PARTIAL FULFILLMENT  
OF THE REQUIREMENTS FOR THE DEGREE OF

CIVIL ENGINEERING

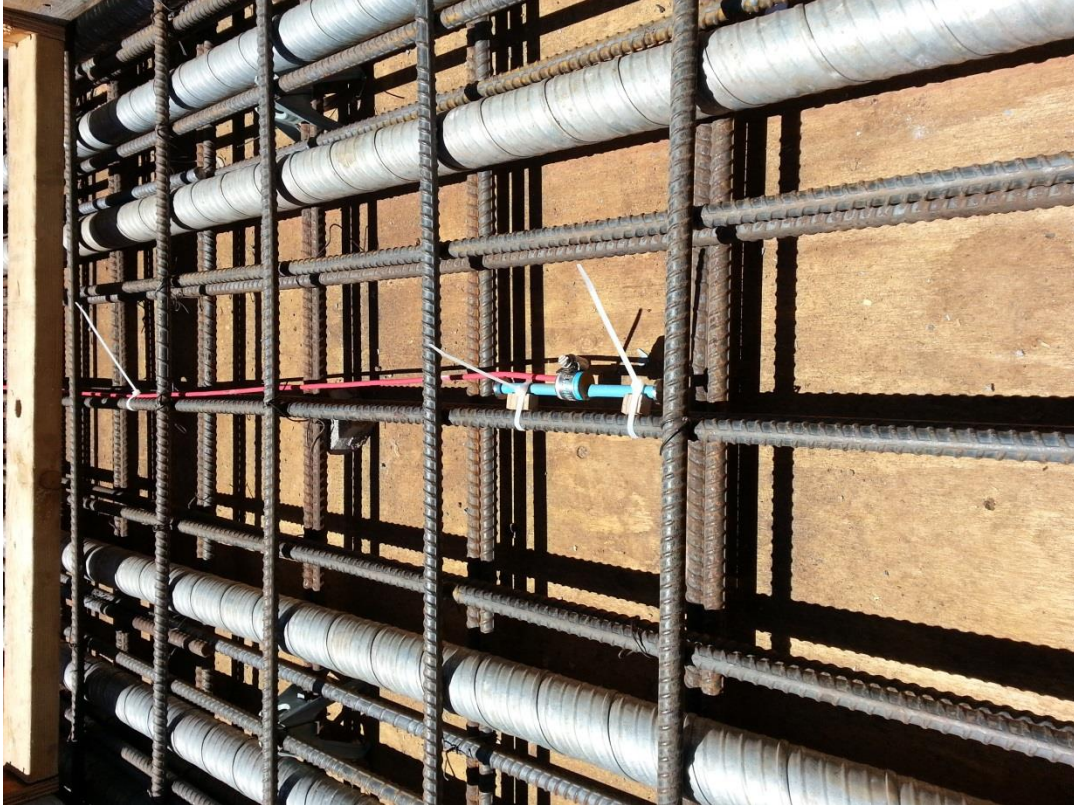
**Figure 66 Strain Gage Fastened to Rebar Using Plastic Straps**

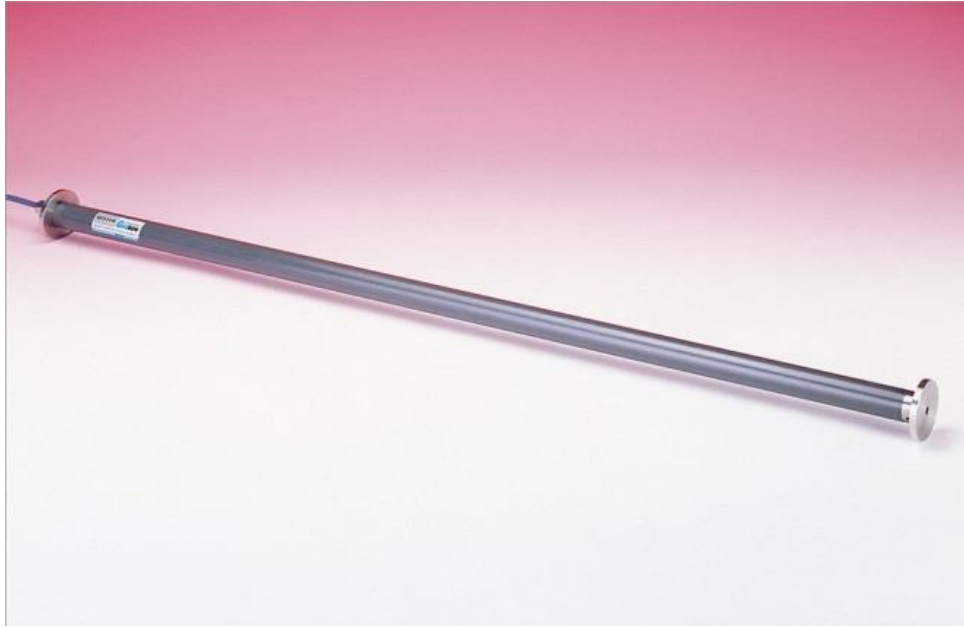
**Figure 68 Geokon 4430 Deformation Meter (Geokon Inc. 2013)**

Three Geokon 4430 deformation meters were installed below the center of each footing at each abutment (Figure 68) to measure the compression over the depth of the GRS. The deformation meter sensor is attached to a 2-inch-diameter flange at one end and connected to another flange at the other end inside a 2-foot-long, 1-inch-diameter rod. The sensor and rod are covered by a PVC tube. Any vertical ground deformation will cause the flanges to move. This movement is detected by the sensor and conveyed to a readout system. The deformation meters were installed in a 2.5 inch PVC pipe filled with grout to keep the deformation meters in place. The layout of the deformation meters is shown in figures 69 and 70 for abutments 1 and 2, respectively. However, shrinkage of the cement gout meant that caused the PVC pipe experienced the majority of the compression and the deformation meters read mostly 0. The deformation meters will not be discussed hereafter.

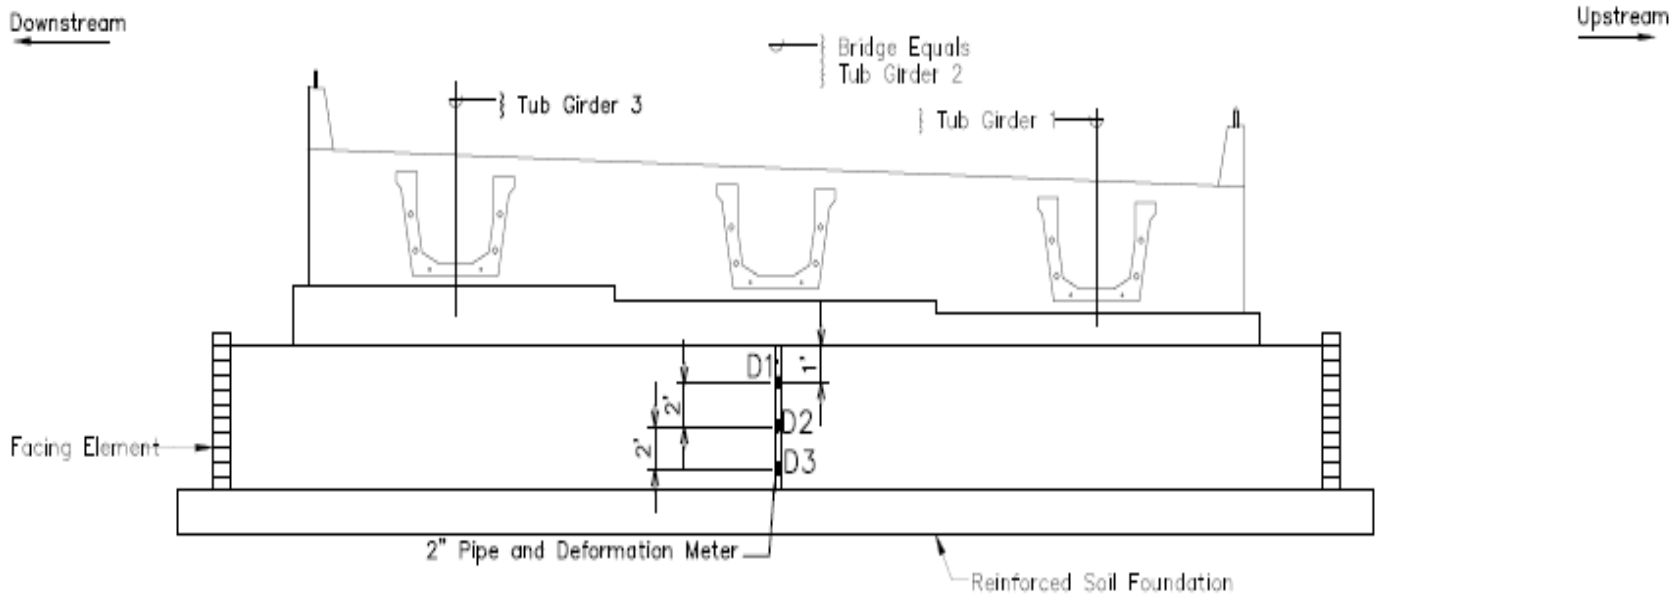
ABUTMENT NO. 1 – SECTION Deformation Meter

**Figure 69 Abutment 1 Deformation Meter Layout**

1. The GRS backfill was compacted around a 2.5-inch diameter Schedule 80 PVC pipe at the center of each abutment footing. With the bottom of the PVC pipe located on top of the RSF, this pipe is used to house the three deformation meters stacked consecutively on top of each other giving a total GRS monitored height of about 6 feet.
2. After consecutively stacking the deformation meters in a line, the instruments were lowered into their proper places inside the PVC pipe.
3. The PVC pipe was grouted using a 50:50 mix of cement and water by volume as shown in Figure 71.
4. After the grout cured, the deformation meter cables were bunched up with the FB, inclinometer and EP cables, and then run through a PVC pipe to the data acquisition system as described in Section 4.5.

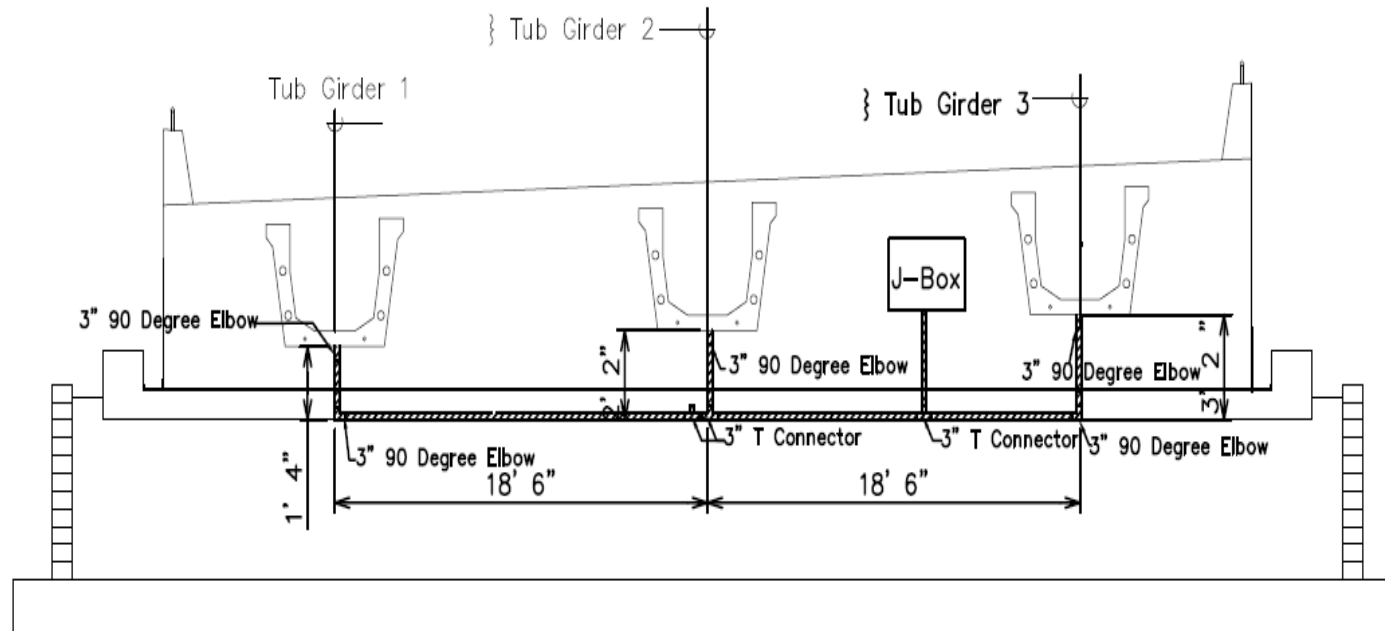
▨ — 3" PVC Pipe

**Figure 74 Typical Layout of PVC Pipe System for Rach Abutment**

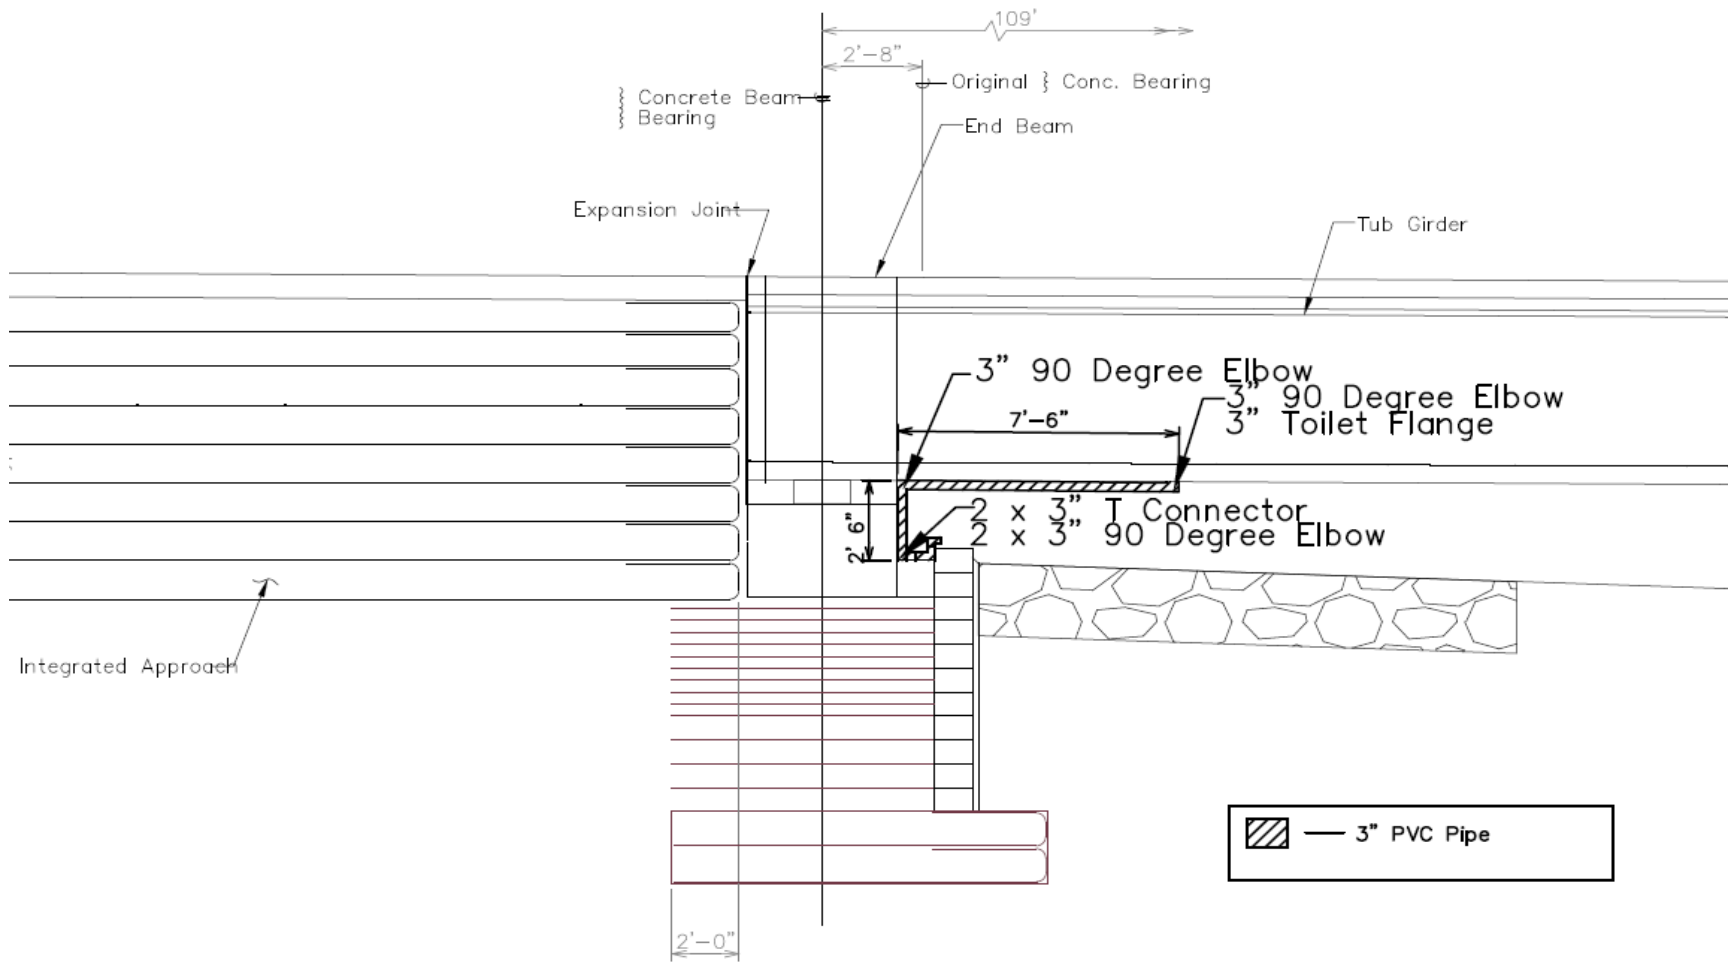
TYP Middle Tub  
NOT TO SCALE

**Figure 75 Typical Cross-Section of Middle Tub Girder's PVC Pipe Layout**

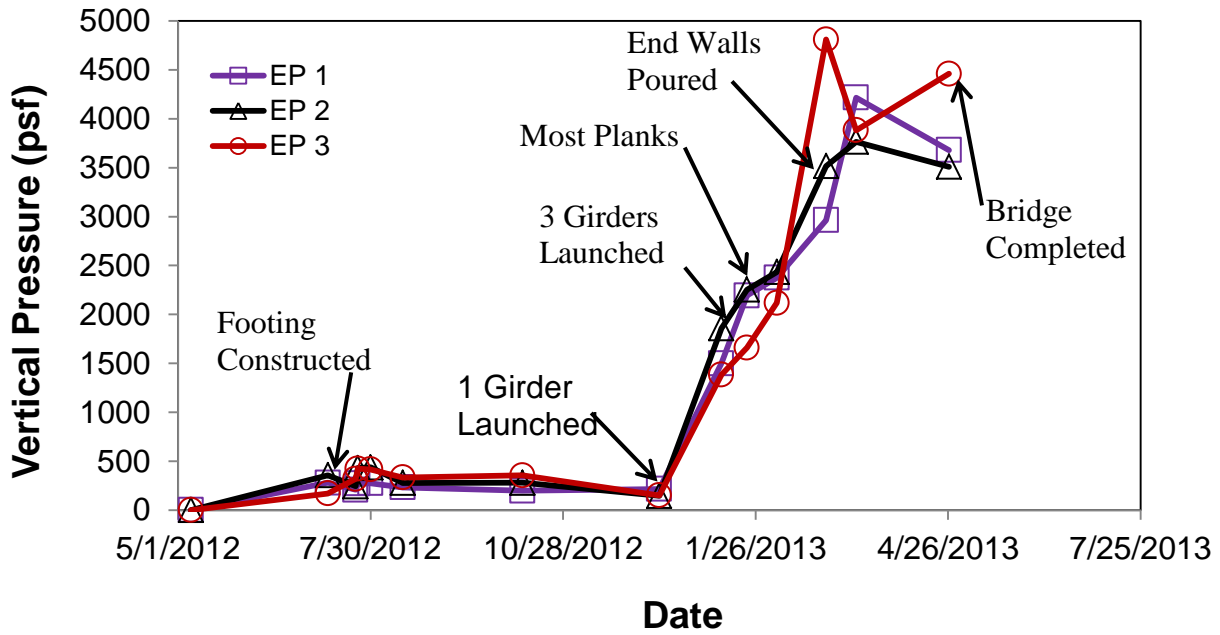
Figure 89 Vertical Pressure for Each EP Cell During Construction

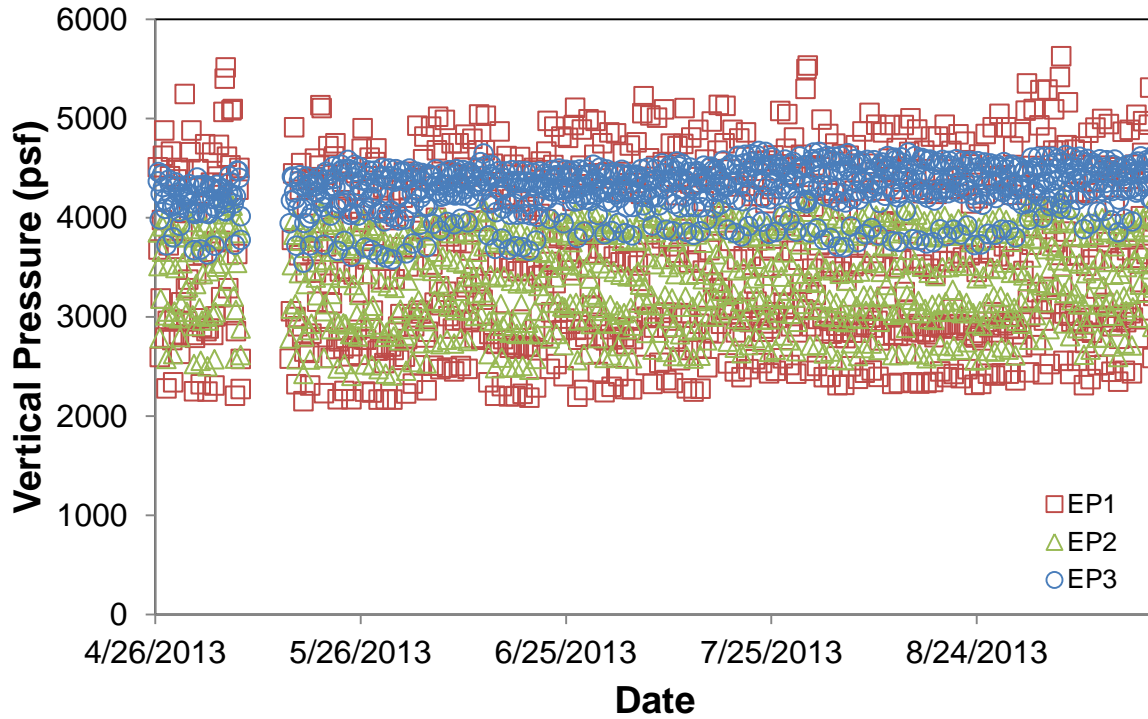
**Figure 91 Vertical Pressure as a Function of Time**

considered as reasonable as it is within the range of daily pressure fluctuation observed at the bridge as shown in Figure 91.

period. A possible explanation for these fluctuations is provided below. A summary of the monthly EP data can be found in Table 10.

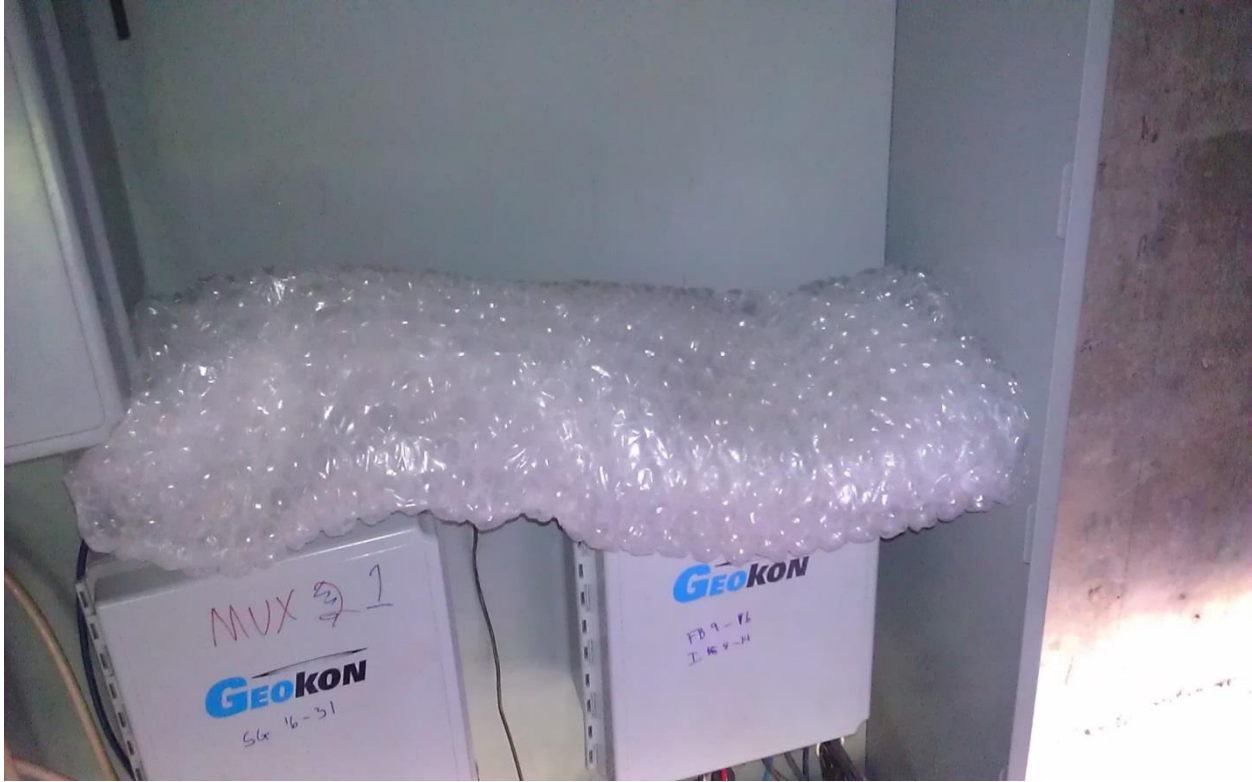
**Figure 93 Dummy EP Cell**

to 30.6 °C. The ambient pressure ranged from 22 °C to 30 °C. The dummy cell data suggests that there is little noise from the data acquisition system and the vertical pressure fluctuations in EP cells 1 to 3 appear to be temperature-induced.

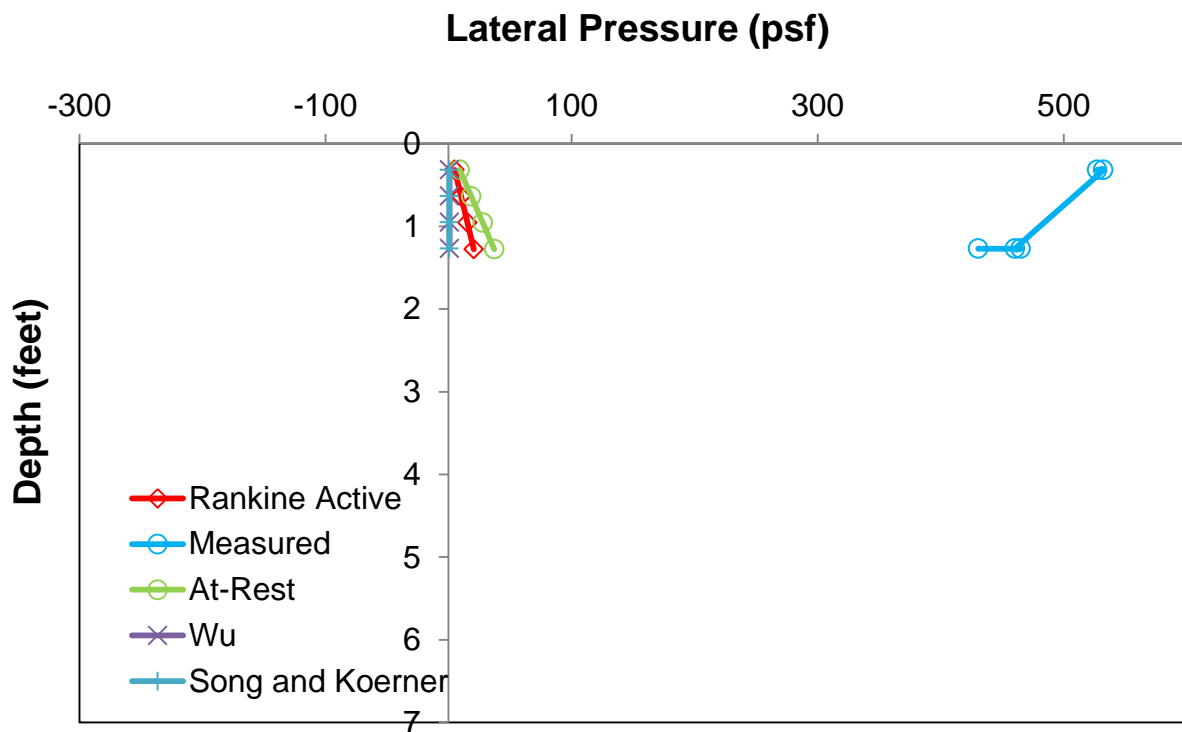
**Figure 97 Measured Lateral Pressures vs Rankine Active, At Rest Pressures, Wu, and Soong and Koerner Estimations (FB 6 at Abutment 1)**

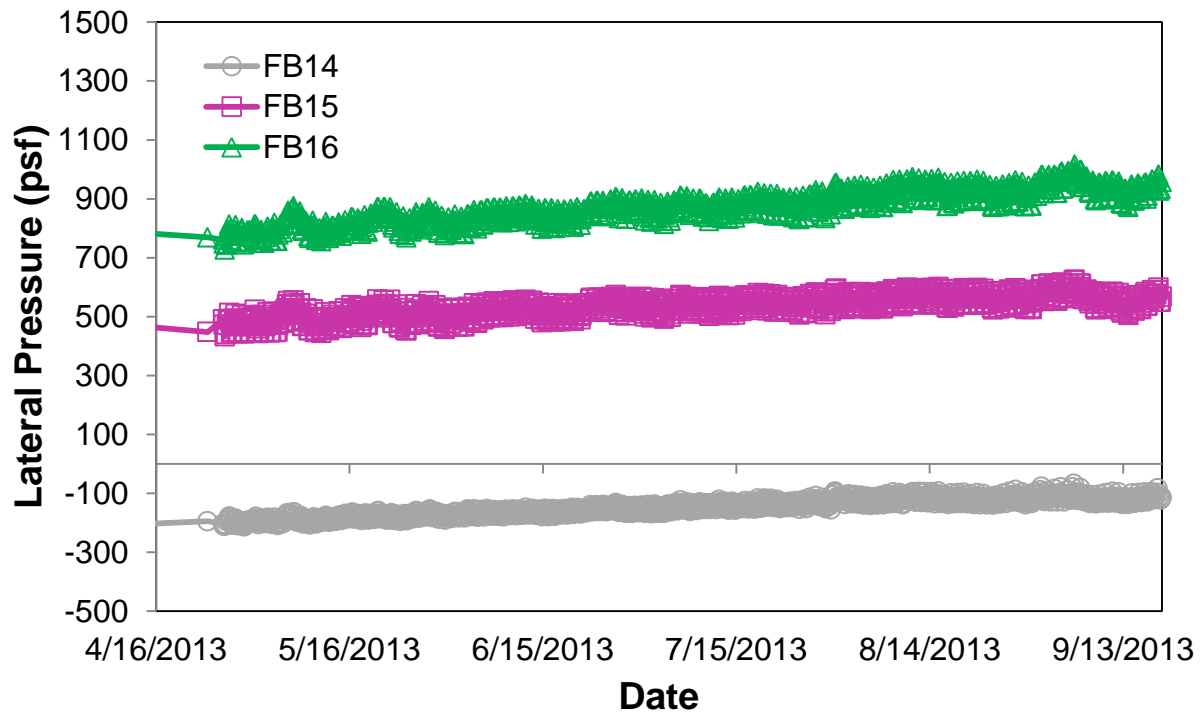
**Figure 103 Abutment 2 Lateral Pressure as a Function of Time**

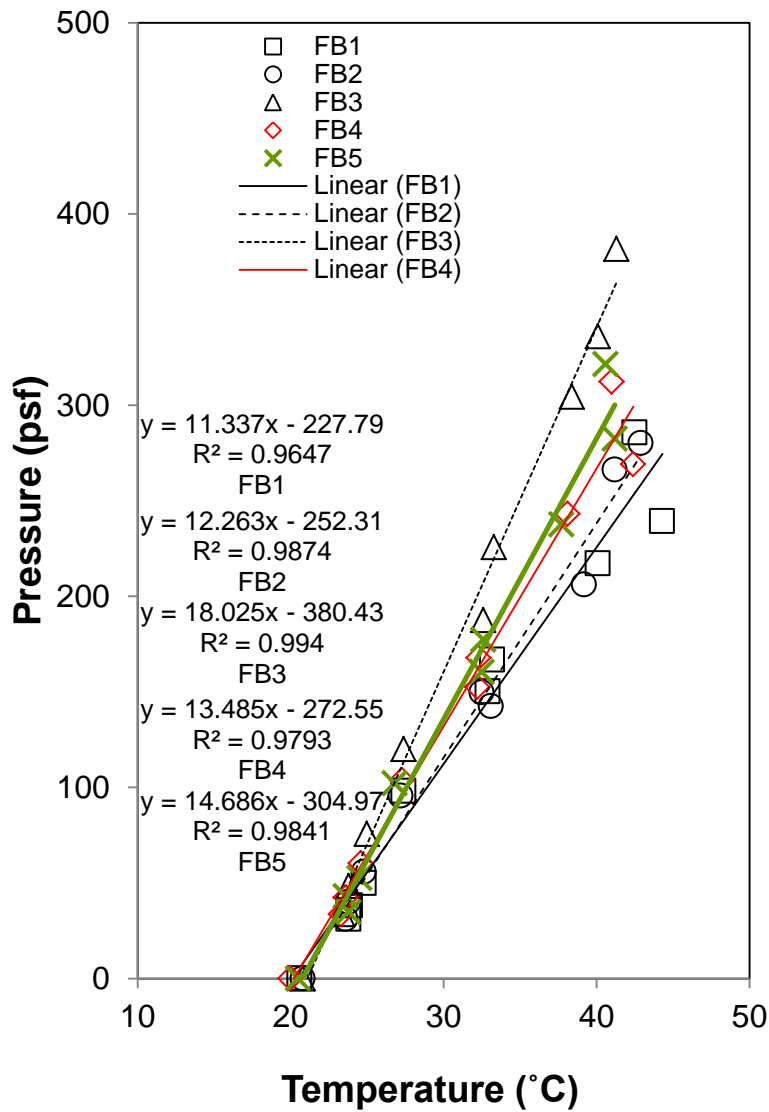
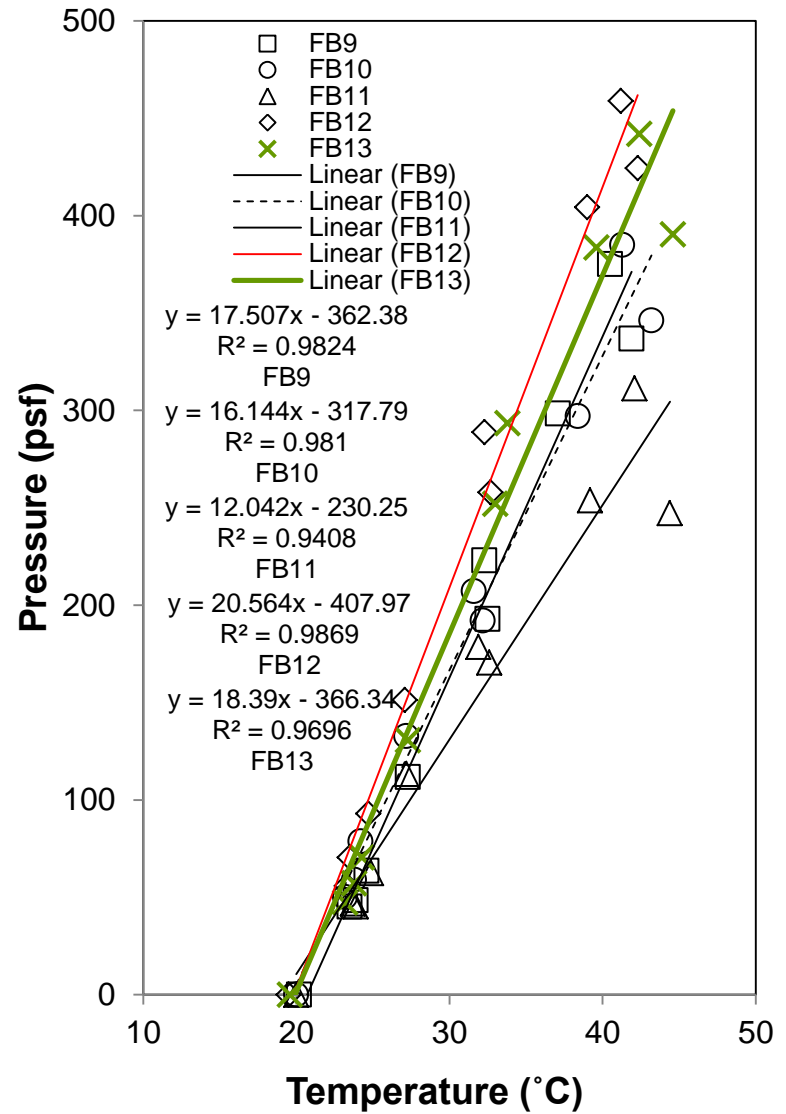
Figure 108 Measured Pressure vs Gage Temperature

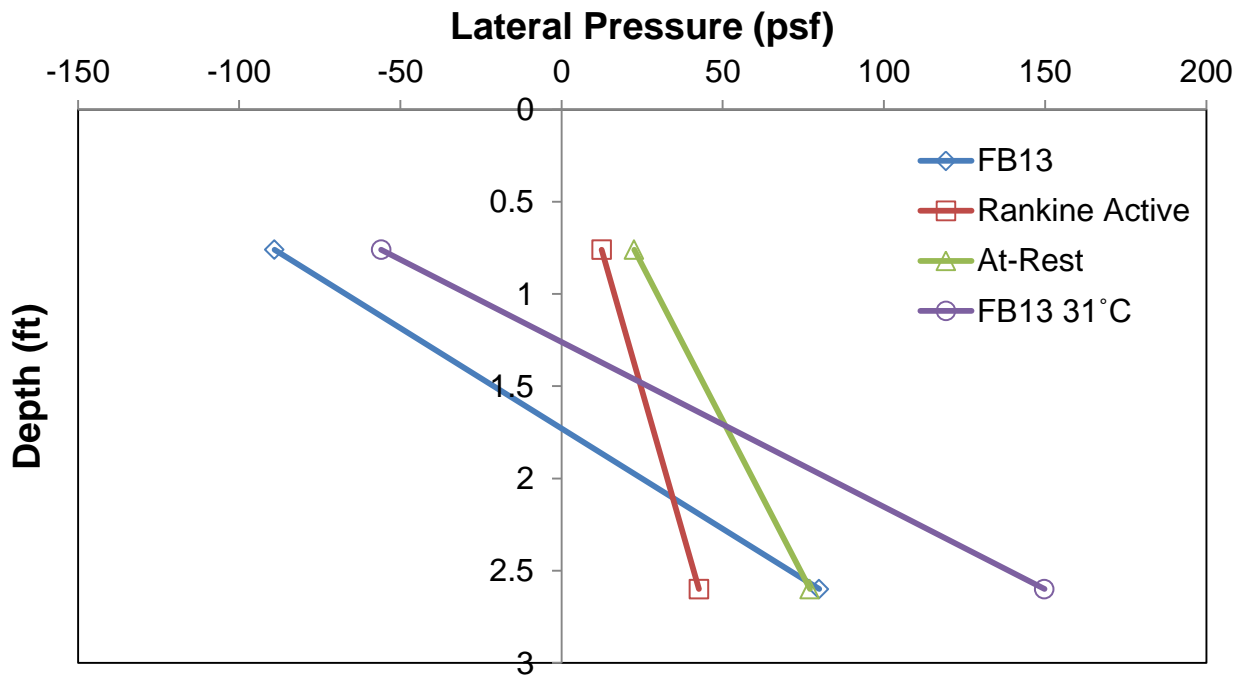
**Figure 113 FB13 Lateral Pressure vs Depth**

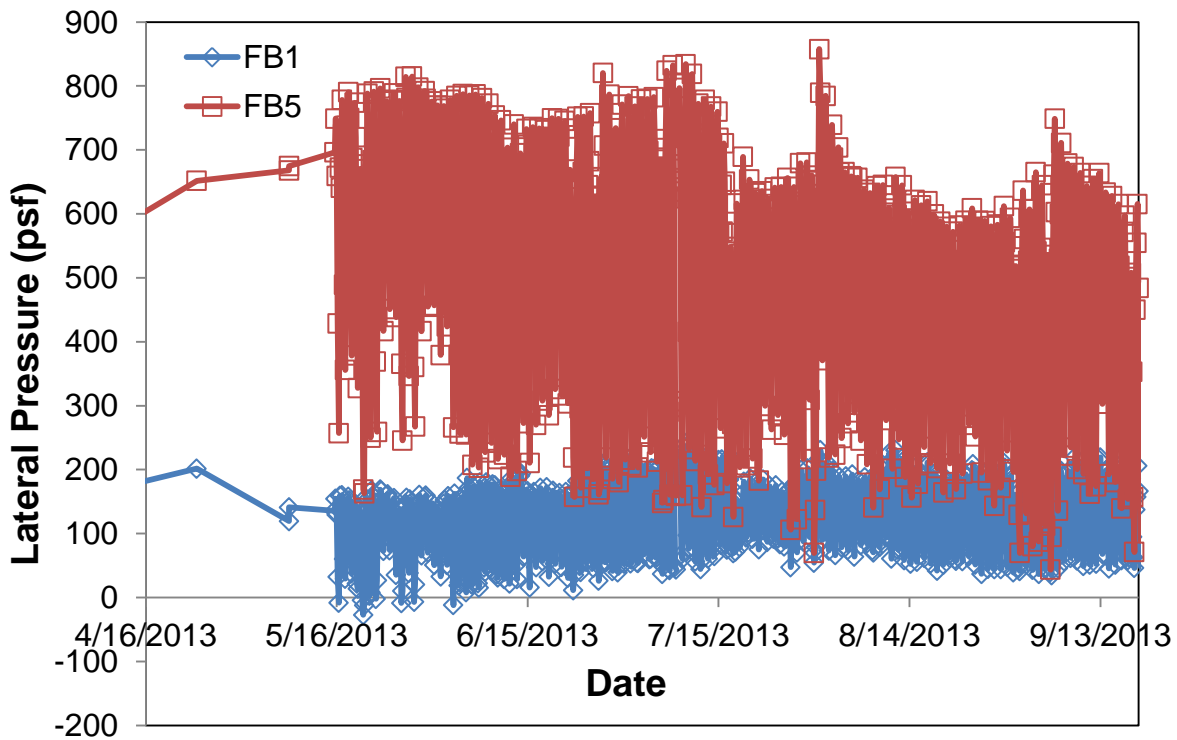
Figure 114 Abutment 1 Outer Tub Girder Lateral Pressures as a Function of Time

Figures 114-117 display the post-construction FB readings behind the end walls starting on April 26, 2013 till September 19, 2013. The average lateral pressures in 7 of the 10 FB cells decreased with time. For example FB13 recorded an average lateral pressure of 176 psf in May. Then in September, the average lateral pressure decreased by 172 psf to 4 psf. It is postulated that the stress reduction is due to shrinkage of the superstructure concrete with time as seen in Figure 127 and explained in Section 5.5. The average lateral pressures in the remaining three FBs (1, 9 and 10) exhibit some erraticism but overall remained fairly constant. A summary of the monthly FB data can be found in Tables 20-23.

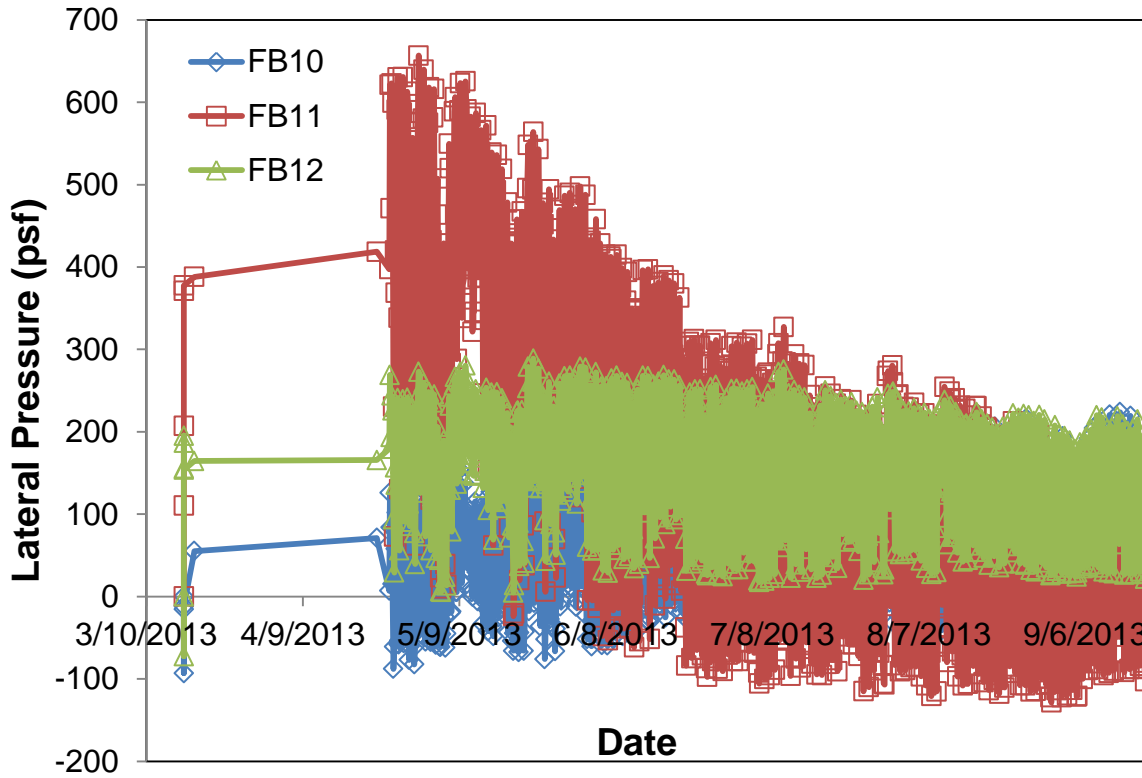
Figure 117 Abutment 2 Middle Tub Girder Lateral Pressures as a Function of Time

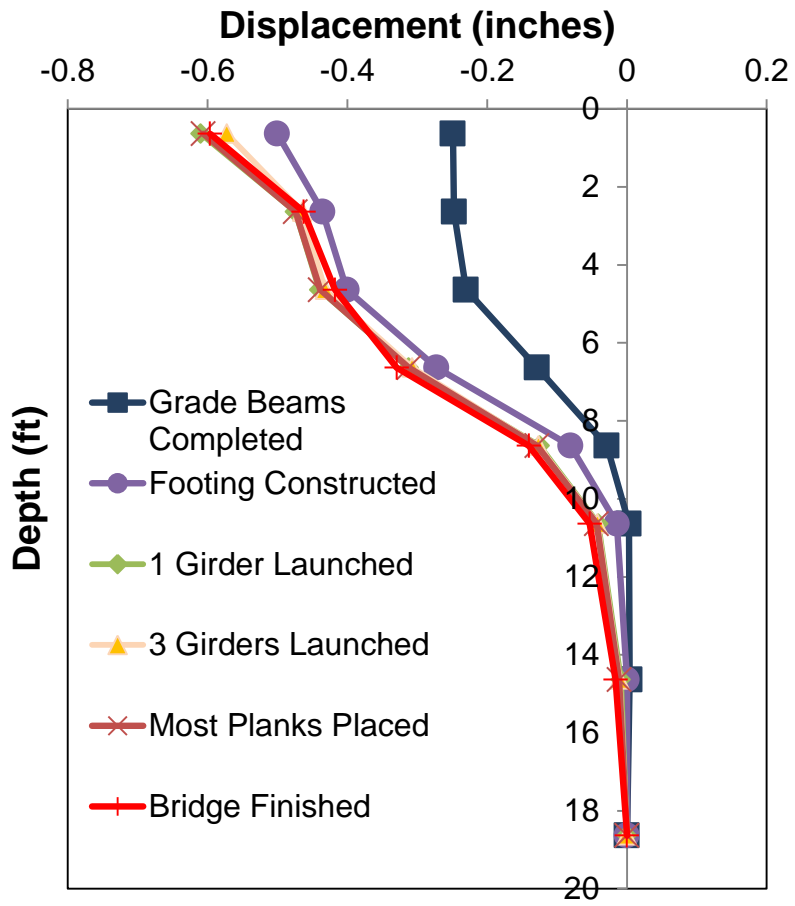
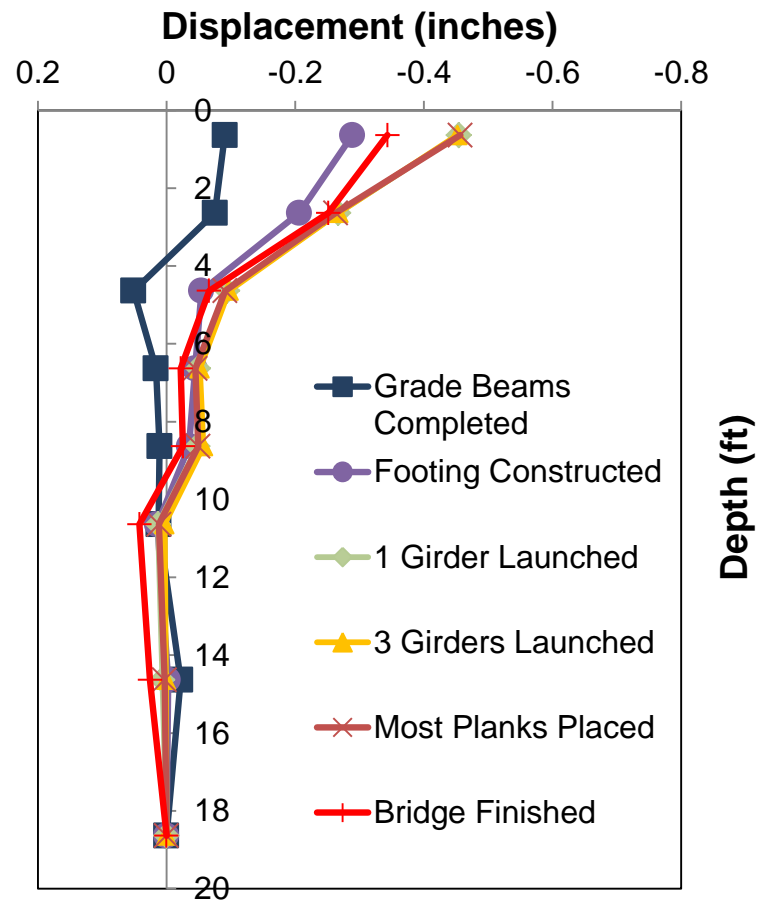
(a) (b)  
**Figure 124 Lateral Deflection vs Depth During Construction at (a) Abutment 1 and (b) Abutment 2**

movement is consistent with observed increases in lateral pressures behind the CMU as seen in Figures 100 and 101. After completion of the footing, lateral displacements towards the GRS fill increased to 0.5 inches and 0.29 inches for Abutments 1 and 2, respectively. The lateral displacement in Abutment 1 was 0.6 inches after the first tub girder was launched and remained constant till bridge completion. Abutment 2 saw an increase to approximately 0.46 inches of lateral displacement after the first tub girder was launched. After the bridge was completed, the lateral displacement was fairly close at 0.34 inches.

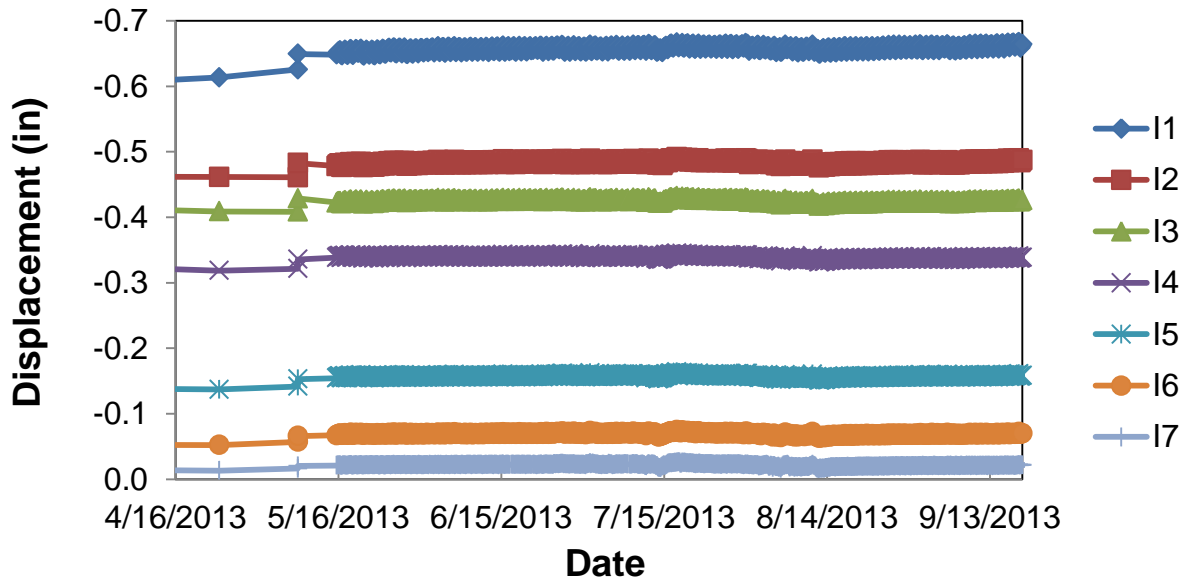
Figure 125 Abutment 1 Lateral Displacement as a Function of Time

The lateral displacements recorded in Abutment 1 remained fairly constant and essentially did not exhibit significant cyclic behavior (Figure 127). However the lateral displacements in Abutment 2 cycled more (Figure 128). Lateral displacements at Abutment 2 appear to have a direct relationship with the ambient temperature. When temperature was highest, the lateral displacement was as well and vice versa.

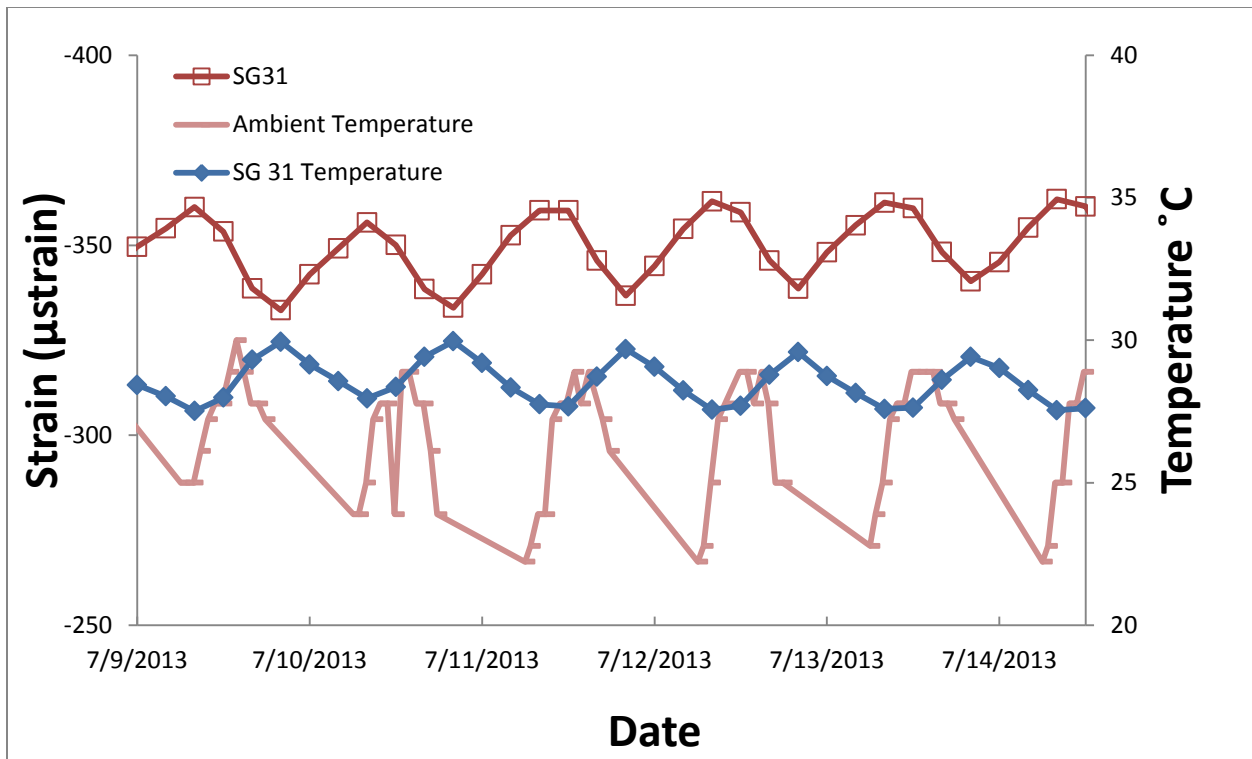
**Figure 130 Concrete Cylinder (SG 31) Strain and Ambient Temperature vs Time**

Month	Strain Range (- $\mu\epsilon$ )		Strain Avg. (- $\mu\epsilon$ )
	SG31		SG31
	Max	Min	
May	365	322	344
June	365	332	350
July	367	331	351
August	374	336	357
September	381	337	362

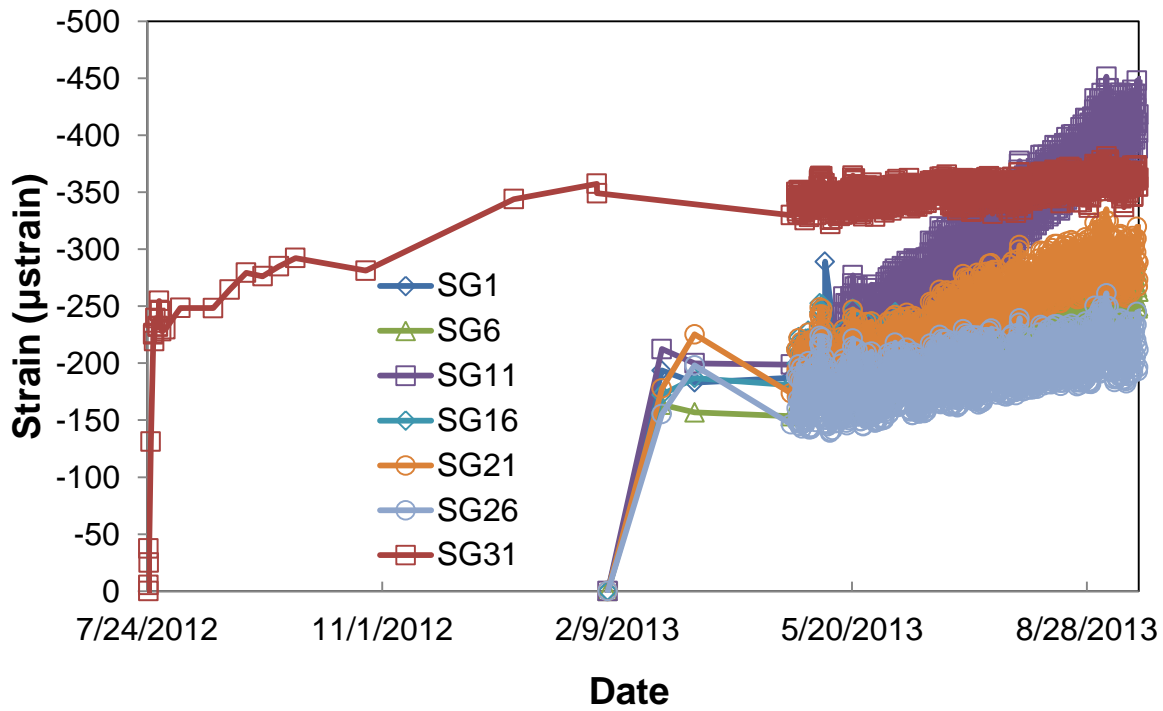
Figure 131 Strain in Top Surface vs Time

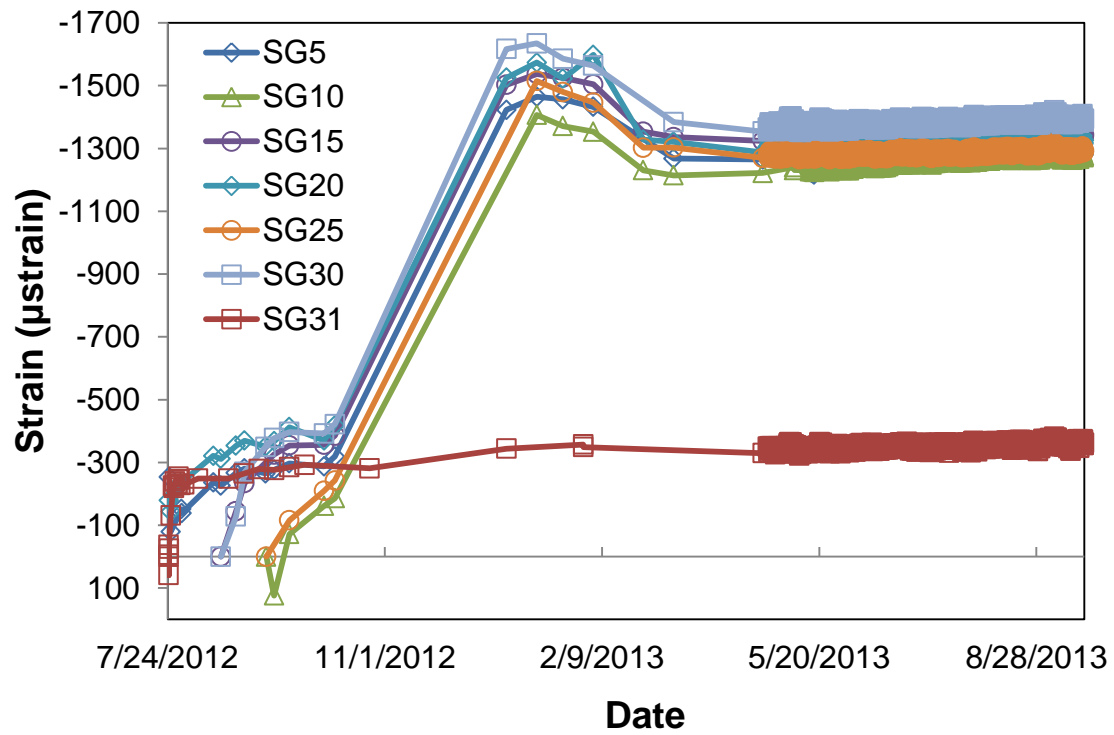
Figure 135 Strain in Floors of Tub Girders vs Time

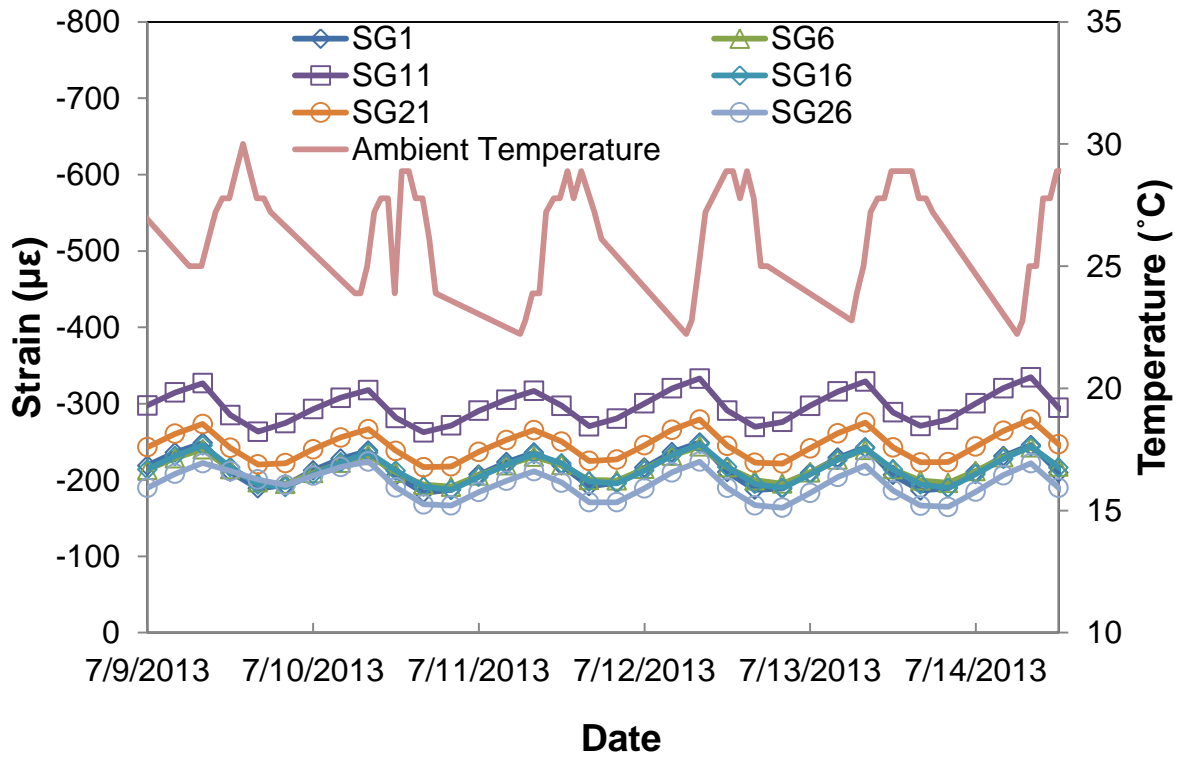
Figure 136 Wearing Surface Strain and Ambient Temperature vs Time

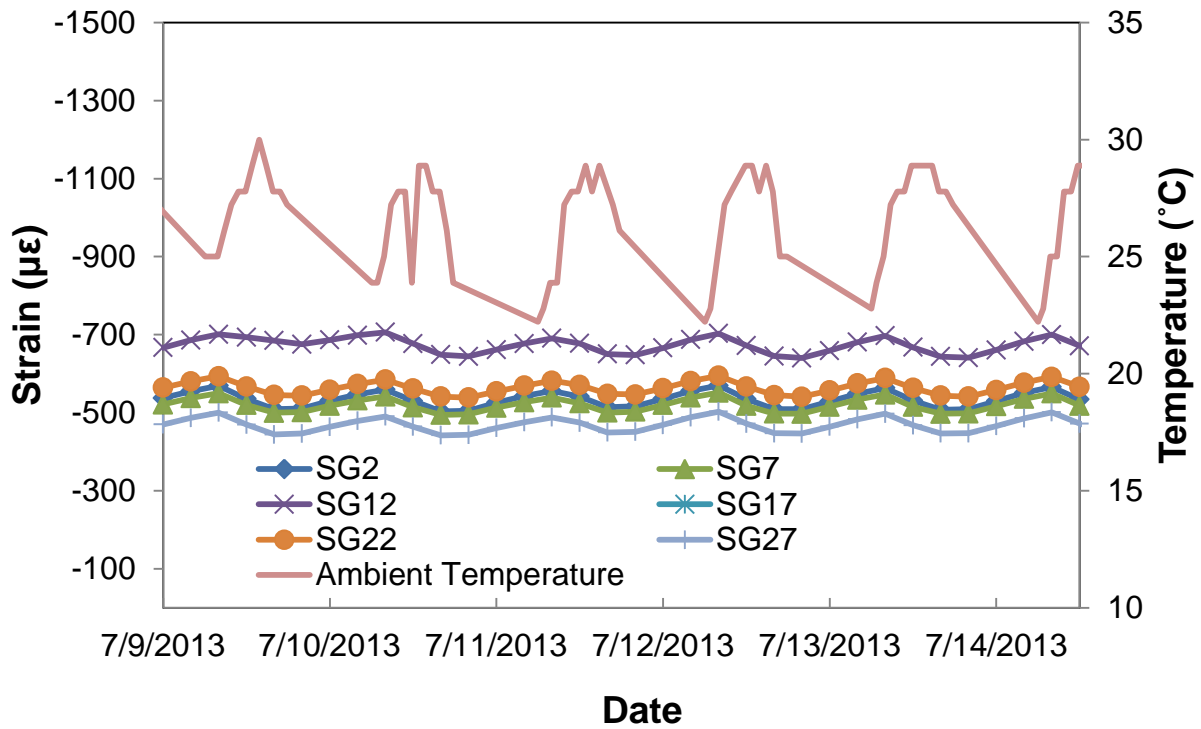
Figure 137 Pre-Cast Plank Strain and Ambient Temperature vs Time

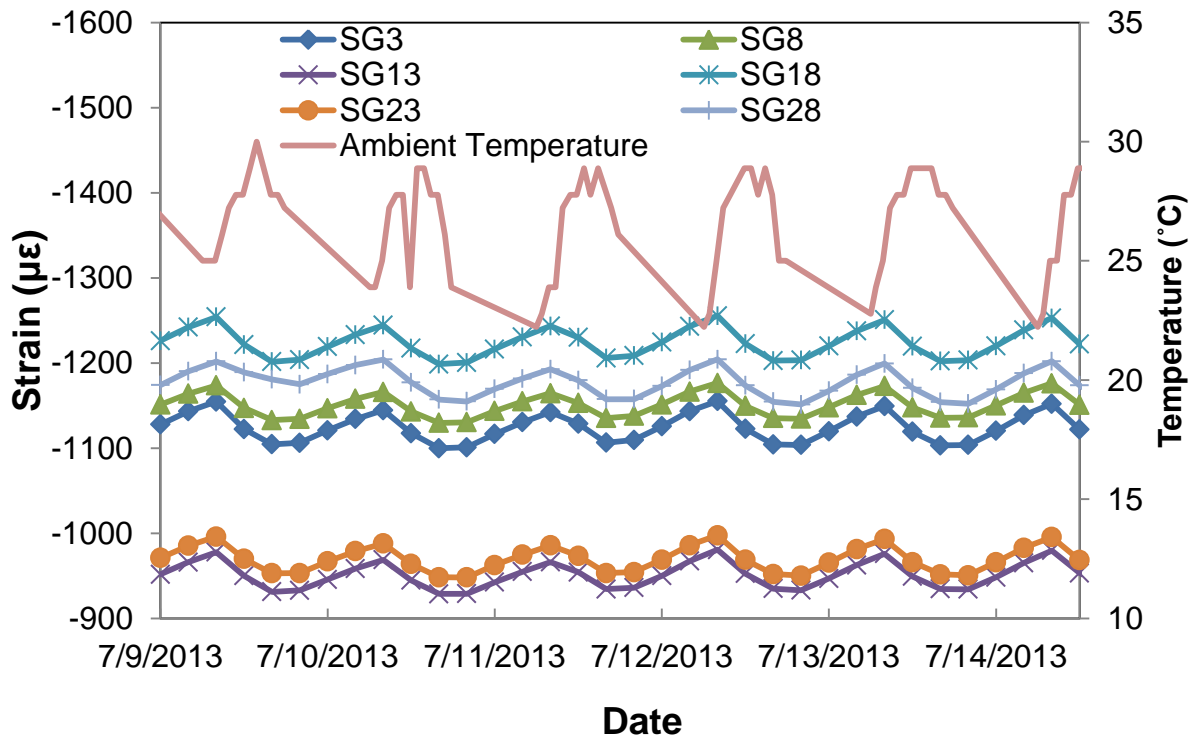
Figure 138 West Wall Strain and Ambient Temperature vs Time
