STRUCTURAL HEALTH MONITORING OF THE FIRST GEOSYNTHETIC REINFORCED  
SOIL – INTEGRATED BRIDGE SYSTEM IN HAWAII

A THESIS SUBMITTED TO THE GRADUATE DIVISION OF THE  
UNIVERSITY OF HAWAI‘I AT MĀNOA IN PARTIAL FULFILLMENT  
OF THE REQUIREMENTS FOR THE DEGREE OF

CIVIL ENGINEERING

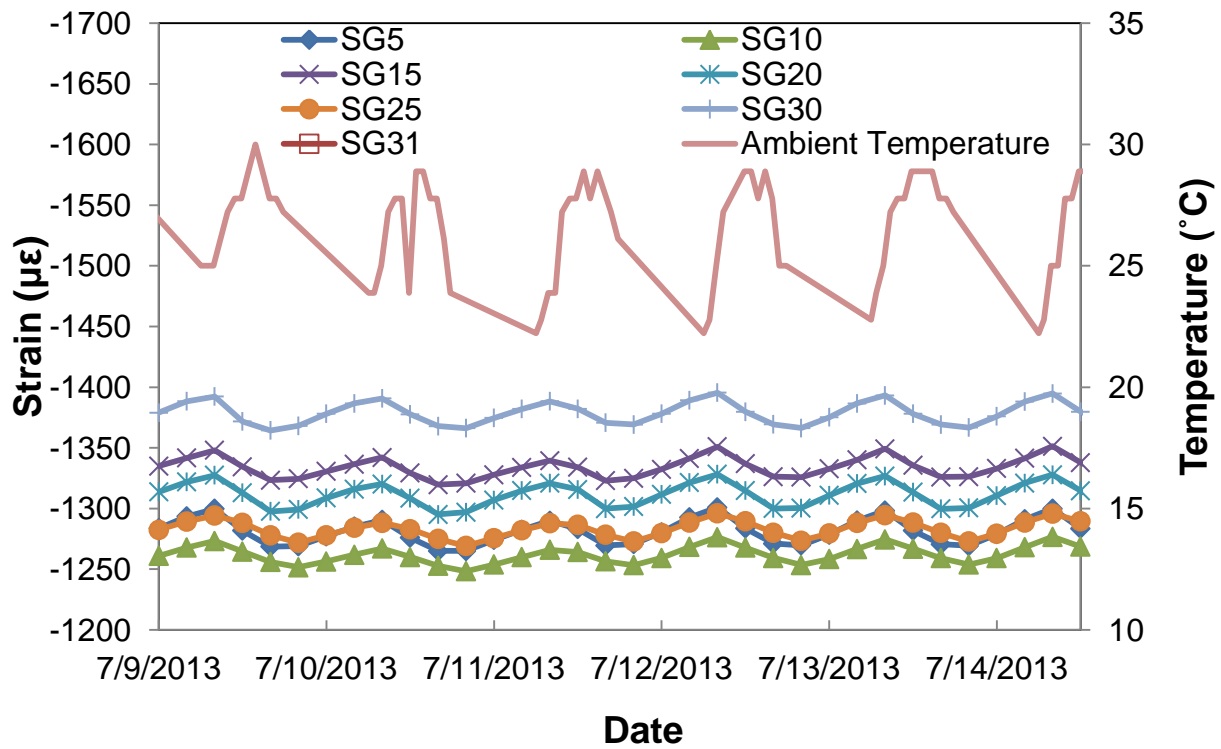
Figure 140 Tub Girder Floor Strain and Ambient Temperature vs Time

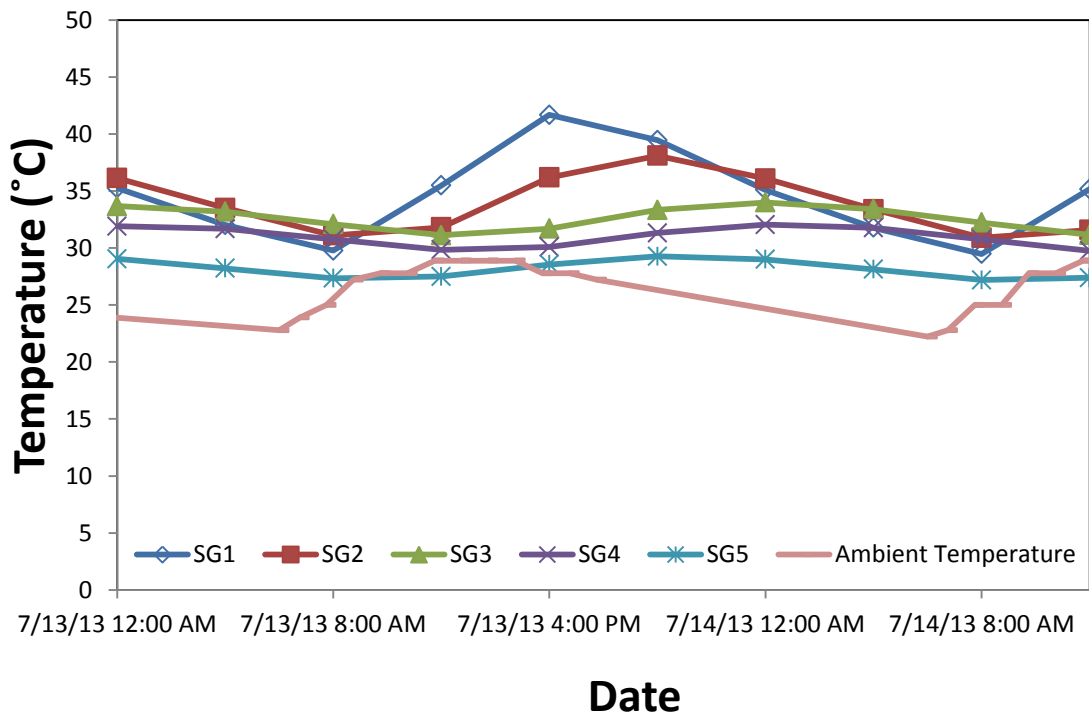
Figure 141 Temperatures in Tub Girder 3 on Abutment 1 Side

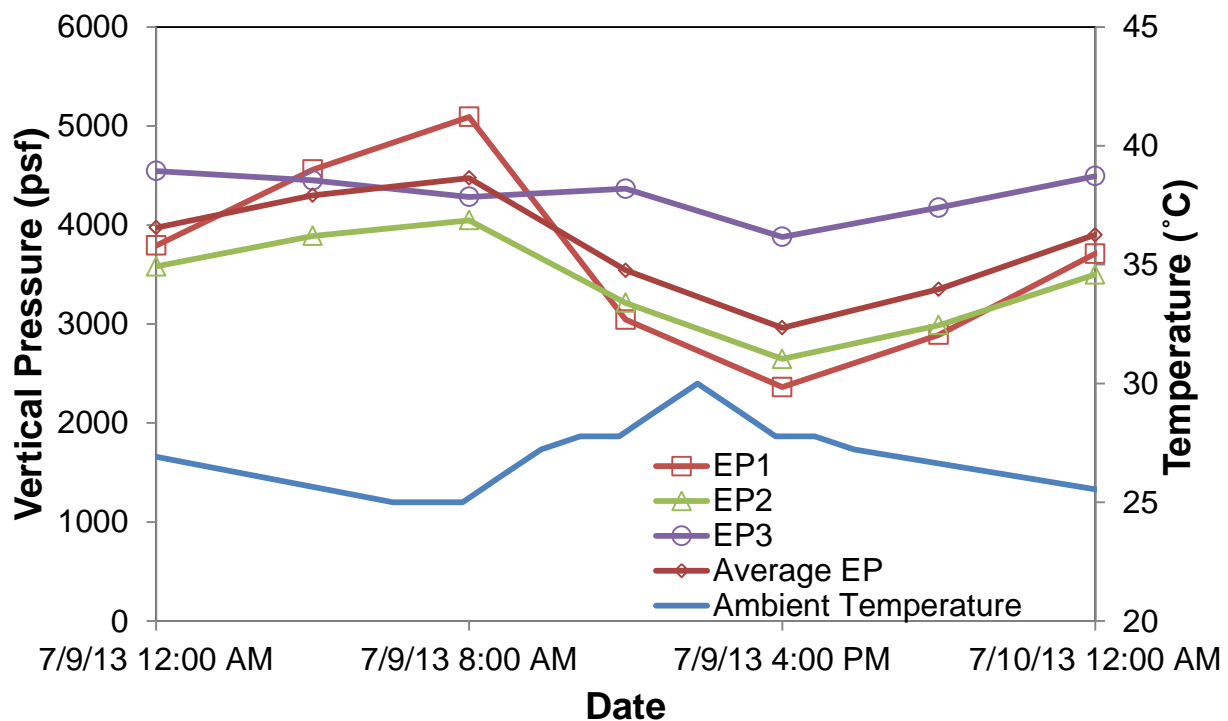
Figure 147 Vertical Pressure Variation Over One Day

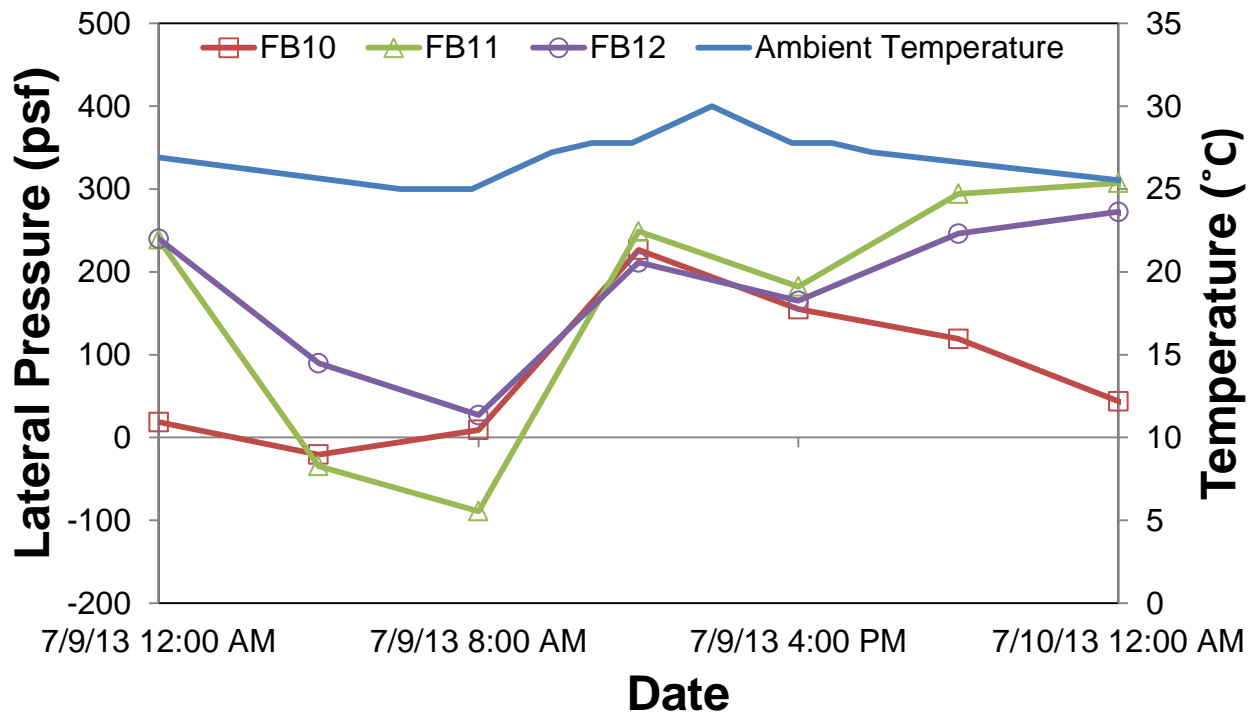
Figure 148 Lateral Pressure Variation Over One Day

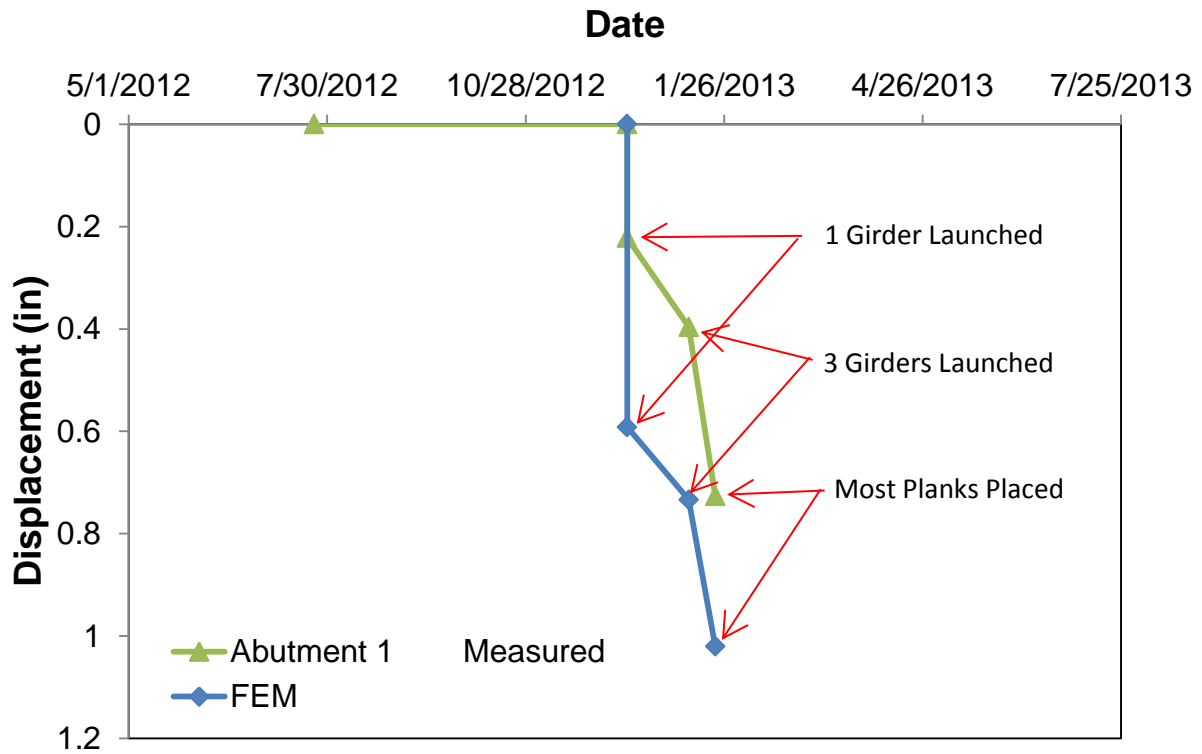
Figure 153 Calculated vs Measured Settlement
