A STUDY OF PRESERVATION AND EXPANSION OF THE  
TONGJI FACULTY CLUB

A DARCH PROJECT SUBMITTED TO THE GRADUATE DIVISION OF THE  
UNIVERSITY OF HAWAII AT MĀNOA IN FULFILLMENT OF THE  
REQUIREMENTS FOR THE DEGREE OF

DOCTOR OF ARCHITECTURE

DECEMBER 2015

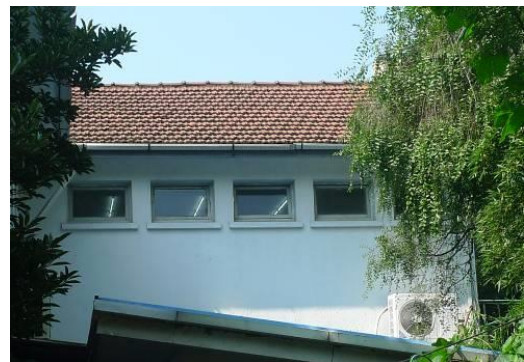
The high windows on the north wall of the reading room contribute to the visual characters of the building because of its location and shape (see fig. 2-11). They are still existing on the north wall of the reading room. Their height, location and shape should not be changed in the future. If any changes such as making the windows bigger or lower happens, the building's visual character and the use of

Figure 2-11: The North High windows of the Reading Room, 2014  
*Source: Taken by the Author.*

the reading room would both be affected.

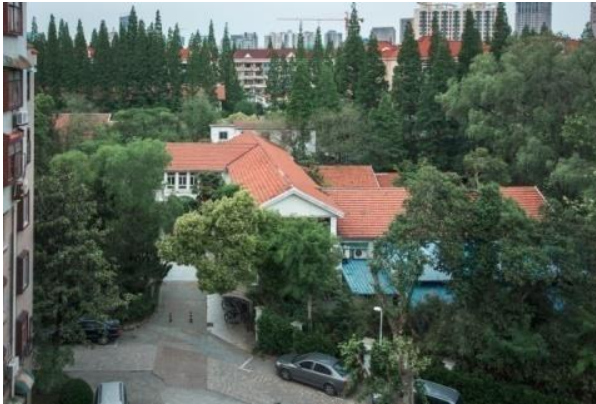
Figure 2-12: The Roof, 2014.  
*Source:* Taken by the Author.

The roof of Tongji Faculty Club is a visual feature because it is gable roof. The red tile makes it high visible. As described in the *Tongji Faculty Club* on the *Journal of Architecture*, the roof materials were "red roof tiles",<sup>15</sup> it seems like the roof material has not been changed (see fig. 2-12, 2-13). The gable roof gives people the feeling of home, and it was cheaper than a flat roof in 1950s (according to Wang).<sup>16</sup> Comparing the old and new photos of the roof above the music room, the gradient of them are the same (see fig. 2-14, 2-15). Thus, the roof structure is also not changed. Its gradient, material and color should not change in the future. If there is any changes to the roof or its material, such as changing it to a flat roof or changing the roof tiles, the character of this building would also be changed.

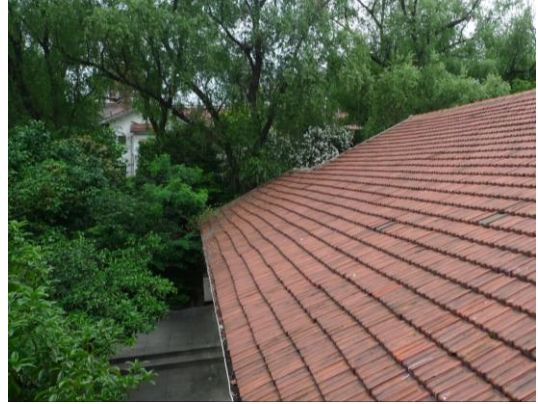
Figure 2-13: The Roof Tiles, 2014.  
*Source:* Taken by the Author.

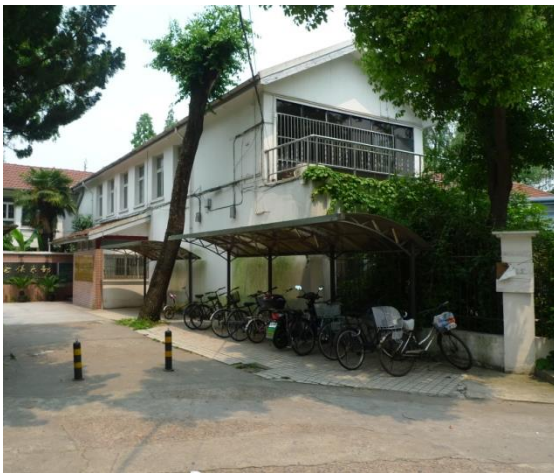
Figure 2-14: The Gable Roof, 2014.  
*Source:* Taken by the Author.

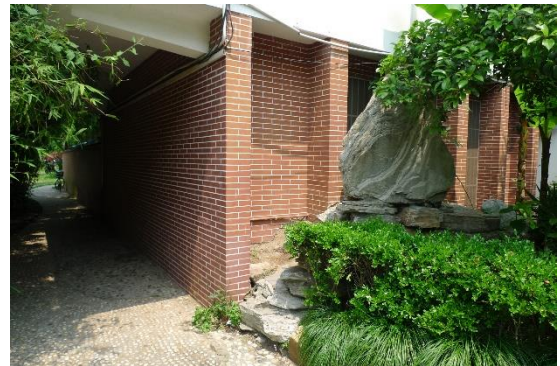
The walls on the first floor of the projection volume are one of the visual features of the Tongji Faculty Club. These walls are also exterior walls of the pool room. The west wall extends from the building to the north, connecting to the dining hall, and also exceeds a little out of the south wall. There are other five pilasters uniformly

Figure 2-16: The Poolroom Exterior, 2014

makes the lawn a half enclosed space. The north extension part of the west wall defines the boundary of the garden outside of the rest rooms. The uniformly distributed pilasters create a pattern together with the south exceeding part of the west wall, and imply the extension in the north-south direction is very important in the this part of the building. The form of these walls are the same as their original status and should not be changed in the future. If any changes like cutting out the extension of the west wall or removal of the pilasters happens, the character of the building will be seriously affected (see fig. 2-16).

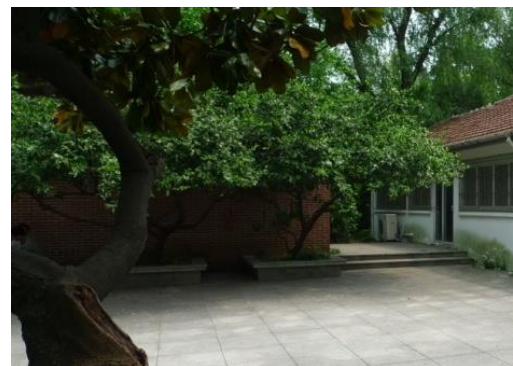
The wall on the east of the patio extends from the windows of the lounge to the south. The color, location, material, height and thickness add to the visual character. It defines the boundary of the patio and should not be changed in the future. If any changes like adding coatings on it or moving it to the west or east happen, the visual character of the building would be changed (see fig. 2-17).

Figure 2-17: The East Wall of the Patio, 2014

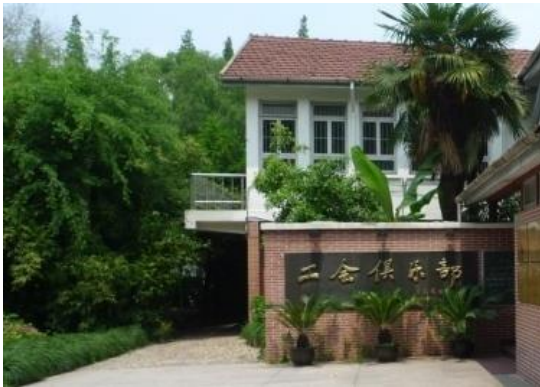
The balcony on the west side of the reading room is one of the visual characters of the building because of its location, size, shape and the view of the lawn it provides to the visiting guests. It is still existing but the form and material of its railings have been changed. The replacing railings are awkward and not as beautiful as the ones in the drawings (see fig. 2-18, 2-20, 2-21). In the preservation design, those railings should be replaced by the ones that made according to the drawings. On the other side, its size and location was not changed and should also not be changed in the future.

Figure 2-18: The Balcony of the Reading Room, 2014  
*Source:* Taken by the Author.

The wood window frames are painted into white instead of pine green (see fig. 2-18). The weather board on the south of the music room was also painted white instead of light grey blue (see fig. 2-19). They impact the visual character because of their colors.

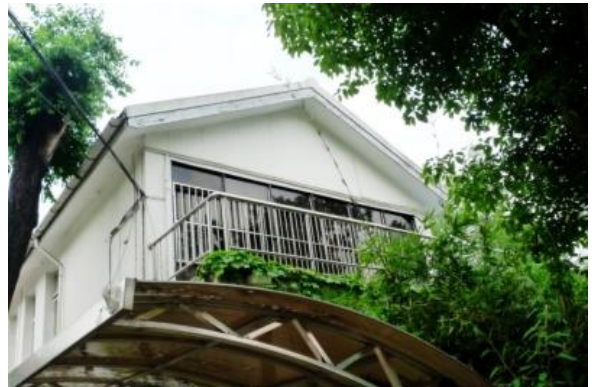
Figure 2-19: The Balcony of the Music Room, 2014  
*Source:* Taken by the Author.

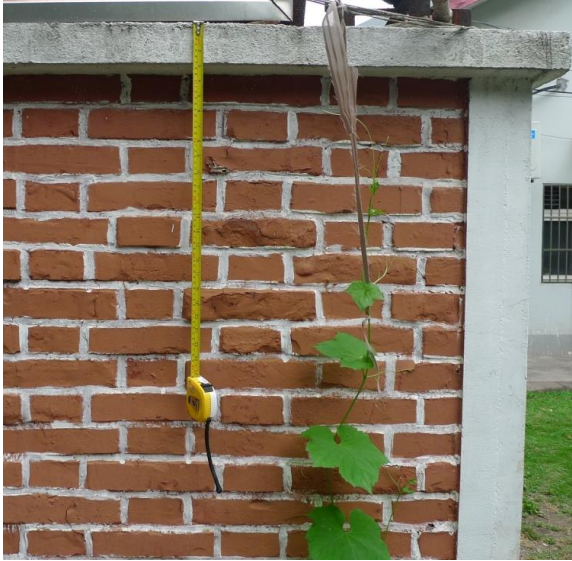
Figure 2-23: The Brick Wall only with a layer of painting.

There are still three places - the entrance, the pool room and the wall on the east of the patio - that does not have white stucco coating (see fig. 2-23, 2-24, 2-25).

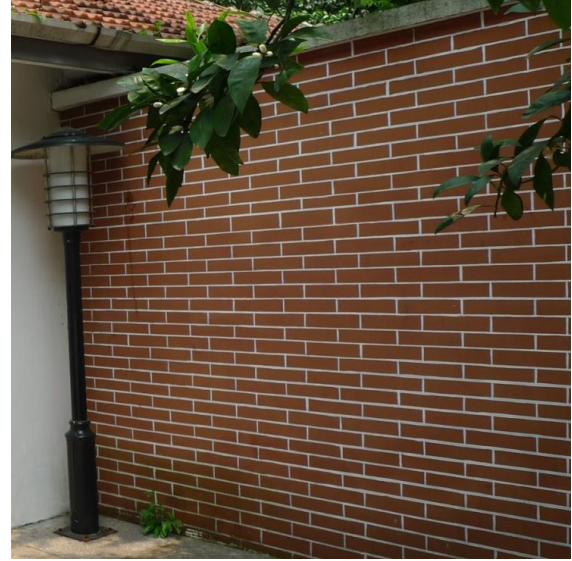
Figure 2-24: The Brick Wall with White Stucco Coating and painting.

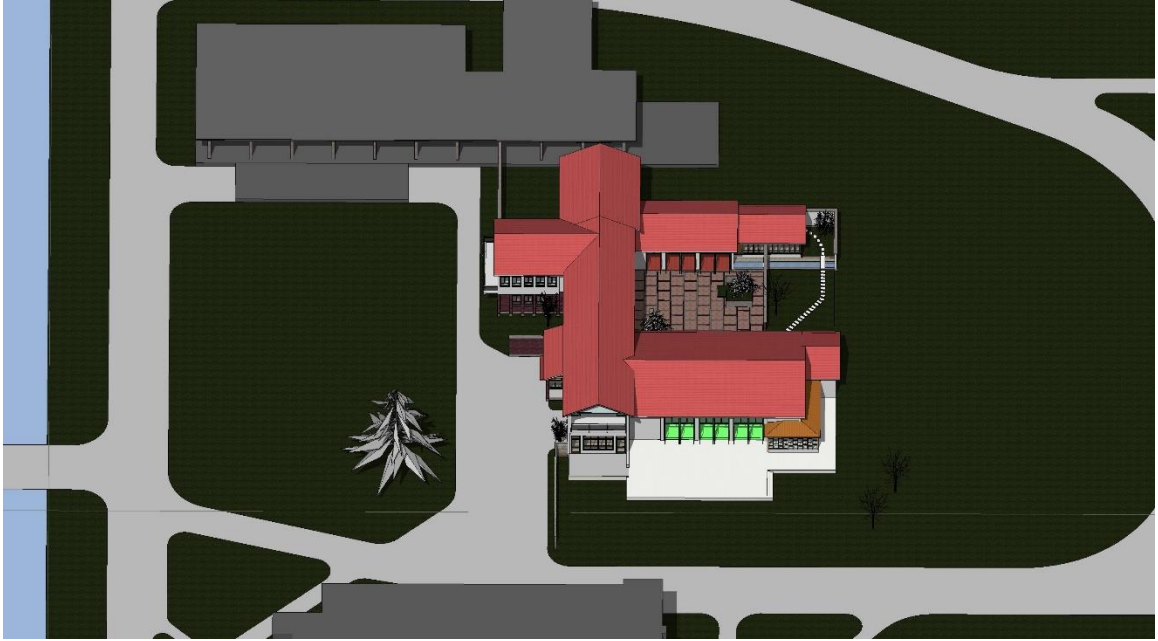
Figure 2-29: The Tongji Faculty Club, Bird's Eye View.

The lawn in the west of the Tongji Faculty Club is luxury for this high density residential area, and it is important to the overall character because of its location, size and view. The lawn provides a wide view of the building. Since the lawn blocks the front of the building entrance, a path was created on the south of the lawn and turned to north leading to the entrance. The path is also important to the character of the building because of the first impression of people entering the building. If the path is moved to the front of the entrance, it will cut the lawn in half so that the integrity and view of the lawn will be affected. It will certainly change the overall character of the building if the lawn is removed or cut in half by the path (see fig. 2-29).

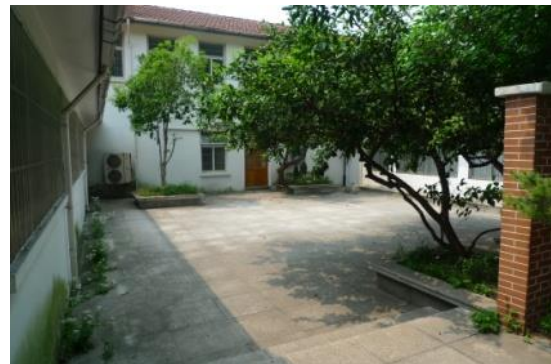
The tree pools in the patio were removed. There are new additional tree pools in the patio with rectangular shapes. Their numbers and locations are also different from the original ones (see fig. 2-31). They impact the visual character because of their locations, shapes and number.

Figure 2-31: The South-east Corner of the Ballroom, 2014

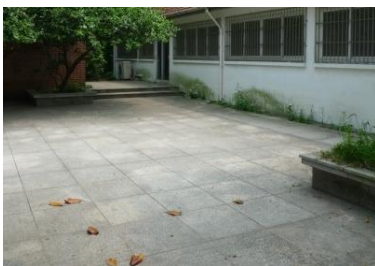
Figure 2-38: The Current  
Patio Ground Tile.

The floor tiles in the patio described above are not existing any more. They were replaced with simple aligned square tiles with invisible joints (see fig. 2-38).

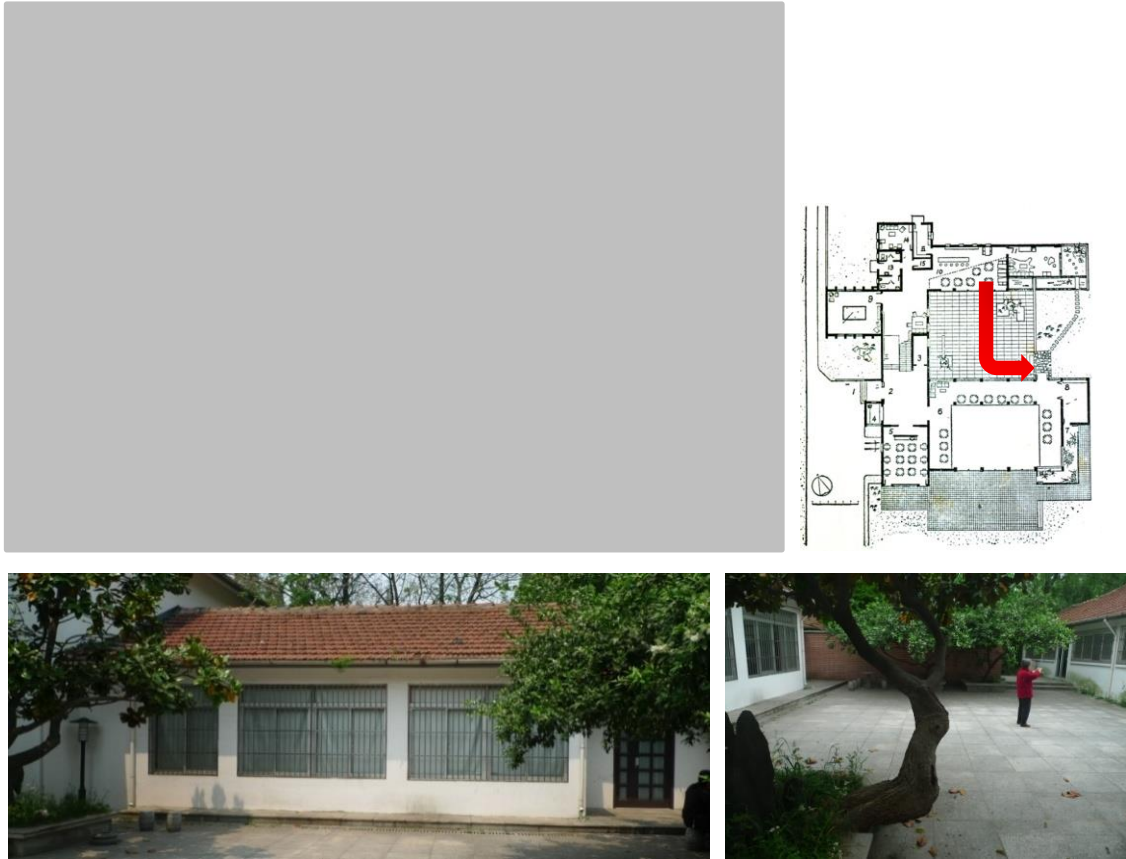
The bar and the patio were separated by five door leafs. A brick wall starts from the lounge, extends to the south, and ended ten feet away from the exterior boundary of the ball room. The bar, the opened five doors, the patio and the ten-foot break created a space sequence from the bar to the patio and to the outside garden in the east. These related spaces are very important in defining the interior character of the building. Changes such as adding a wall between the bar and the patio or a door on the break of the east wall would easily destroy the visual character of this flowing spatial sequence (see fig. 2-43).

Figure 2-43: The Bar and the Patio.

The space sequence of the first floor corridor and the bar was broken by the added door on the bar entrance. The space sequence from the bar to the patio and then to the outside was affected because of the added wall between the bar and the patio. They impact the interior visual character because they frame the spaces into a single room instead of connection each space.

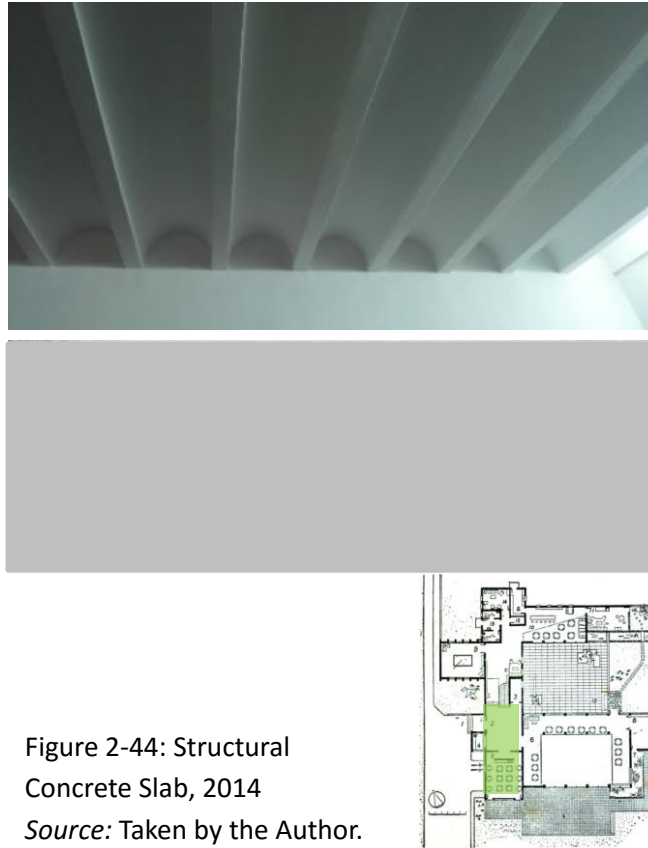
The structural concrete slab on the second floor is very important to the interior character of the building, due to the color white, the shape and the area covered from the lobby to the end of the activity room, making the two spaces visually connected. Change such as adding a ceiling below would certainly change the interior character of the building. (see fig. 2-44)

Figure 2-44: Structural Concrete Slab, 2014

This structural concrete slab is still existing on the second floor. Its location over the lobby and the activity room is also kept as original.

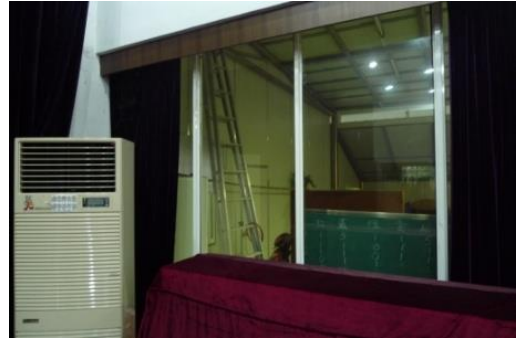
Figure 2-47: The South-east Corner of the Ballroom, 2014

The corner window of the ball room was removed. It was replaced by a window on the south wall (see fig. 2-47).

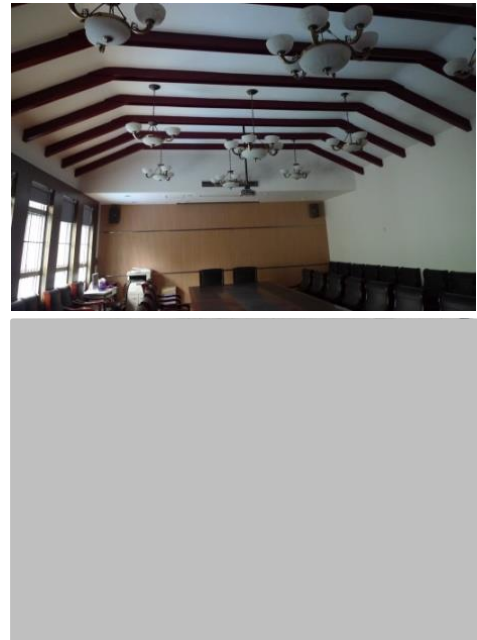
Figure 2-48: The Ceiling and Lights in the Meeting Room, 2014

The tube-lights in the meeting room were removed. They were replaced by chandeliers (see fig. 2-48).

The tube-lights in the meeting room were replaced by chandeliers. Compared with the tube-lights, the chandeliers do not go well with the simple straight lines of the timber beams. They impact the interior visual character because their positions and style.

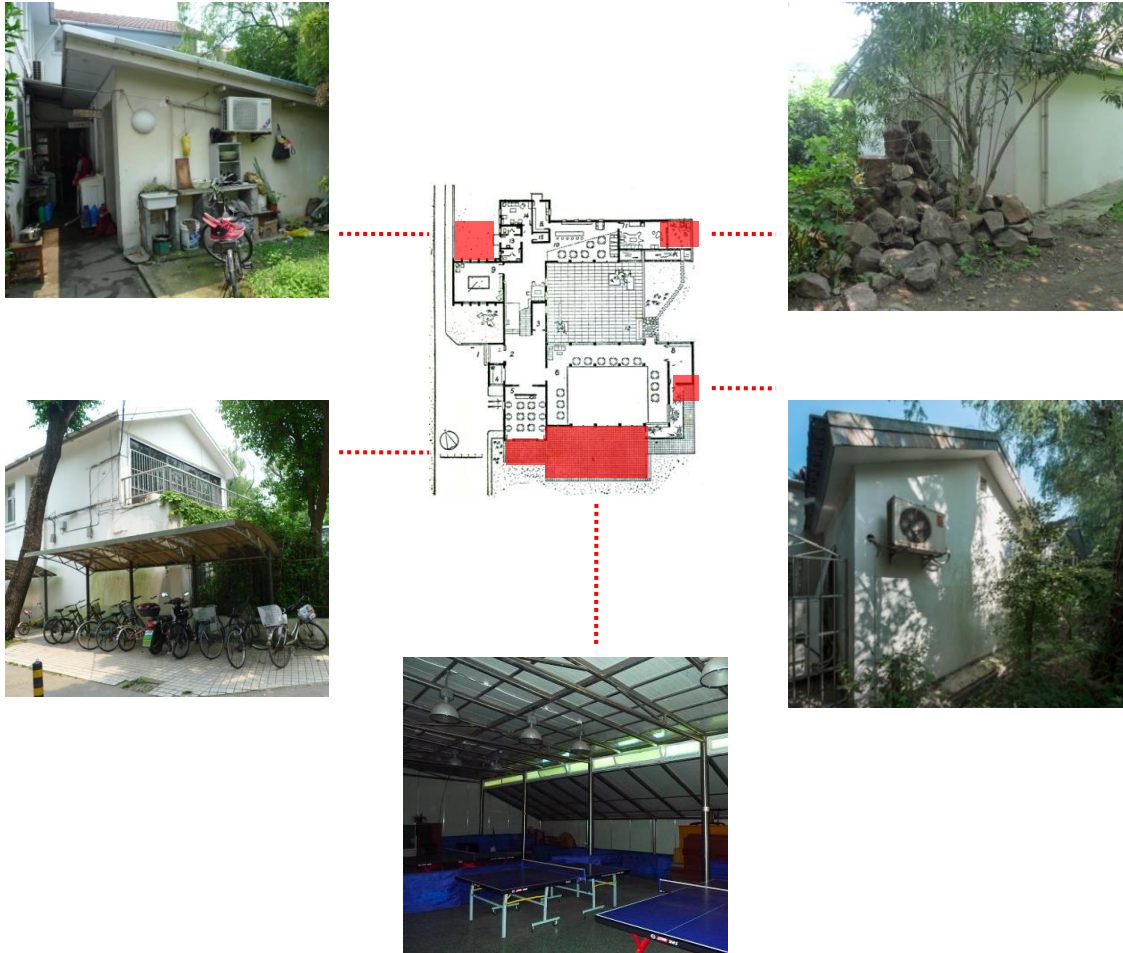
Figure 2-50: The Added Structures, 2014

The platform in the south of the ballroom was removed and replaced by a blue-roof structure used as a ping-pang room. It impacts the visual character because it took up the place of the southern garden, and cuts down the connection between the ball room and the southern garden (see fig. 2-50).

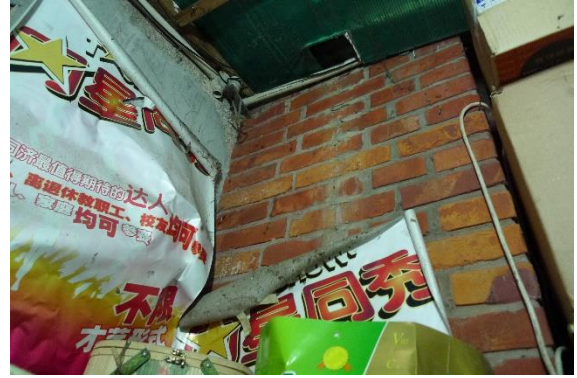
On the first floor of the building, there are six pieces of walls which look like brick walls. Most of them were painted with red and white stucco coatings and have another layer of plaster under the red coating except three surfaces (see fig. 3-4). The east surface of the west wall of the pool room and the east surface of the wall outside the patio do not have the layer of plaster but have the layer of red coating (see fig. 3-1, 3-3), and the north surface of the wall on the north side of the pool room does not have either plaster layer or red coating (see fig. 3-2). On the walls with plaster and stucco layers, the wall outside the canteen has some peeling off on its corner (see fig. 3-4, 3-5).

Figure 3-2: The North Surface of North Wall of the Pool Room, 2014

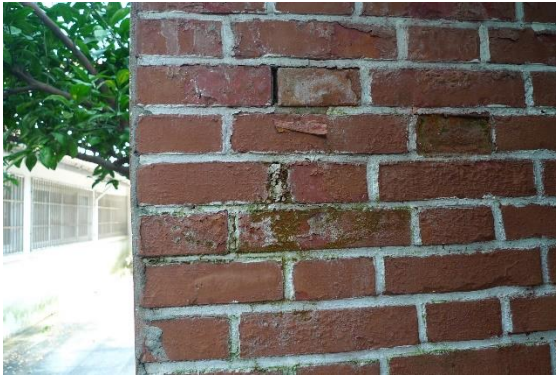
Figure 3-3: Damage on the West Wall of Canteen, 2014

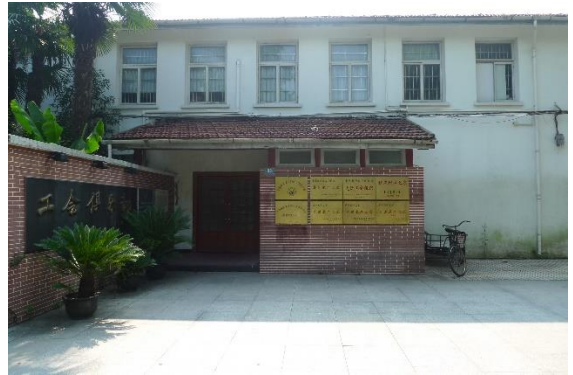
Figure 3-4: The East Surface of Wall outside the Patio, 2014

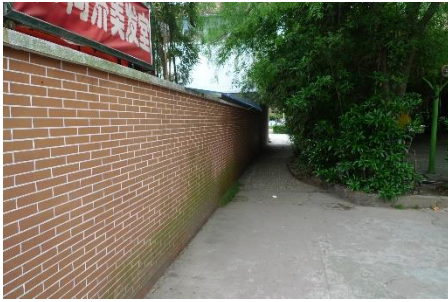
Figure 3-6: The West Wall of the Pool Room, 2014

Another damage on the wall surface is green mildew on the feet of the walls. There are three most serious parts, the west wall of the pool room, the west wall of the activity room, and the north wall of the ball room (see fig. 3-6, 3-7, 3-8).

The possible reason for the mildew on the wall of ballroom is that the moisture comes out from the sewer next to the wall. For the wall next to the bike parking, the possible cause is the rain water from the canopy.

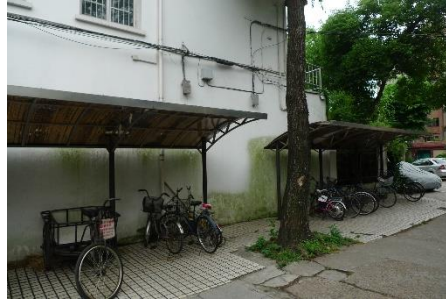
Figure 3-7: The West Wall of the Activity Room, 2014

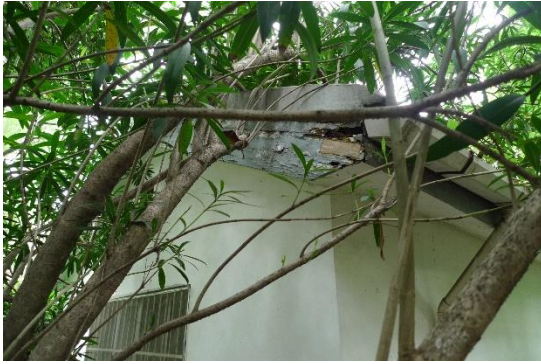
Figure 3-9: The Cornice and Gable outside the Music Room, 2014  
*Source:* Taken by the author.

The wooden cornice on the addition part on the north-east corner of the building, and the wooden cornice and gable outside the music room have some damage on them. The light blue painting on the cornices were partly peeled and the wooden materials underneath were exposed. The painting on the gable has vertical cracks along the joints of the wooden panels underneath (see fig. 3-9, 3-10).

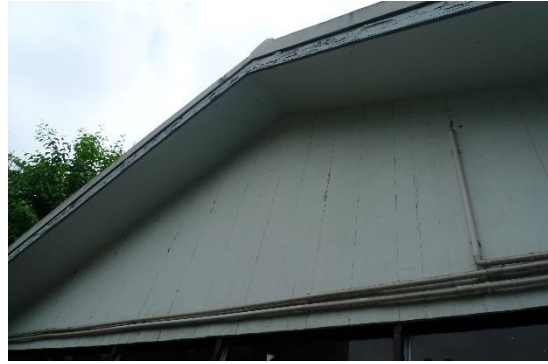
Figure 3-10: The Cornice on the Additional North-east Corner, 2014  
*Source:* Taken by the author.

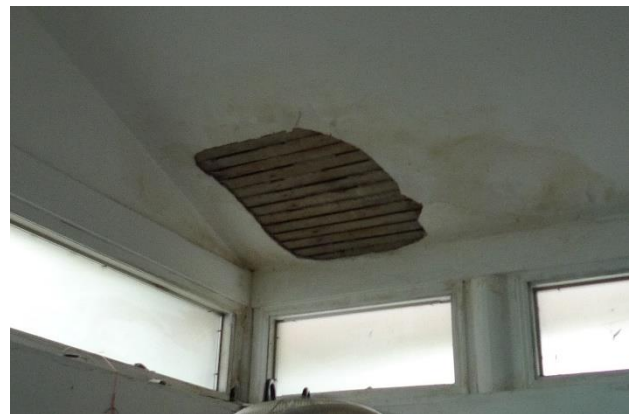
Figure 3-11: The South-west Corner of the Canteen Ceiling, 2014  
*Source:* Taken by the author.

There is a damage point on the south-west corner of the ceiling in canteen. A part of white stucco coating was peeled off, and the wooden structure under the coating was exposed. There is also light yellow mildew stains around the exposed area (see

The cause of the mildew is that it is in the corner of the roof, so it is easy to get wet by the rain water. After a long time soaking with rain water, the mildew happen and the strength of this corner of the ceiling was weaken. Finally, the stucco coating was peeled off by the gravity.

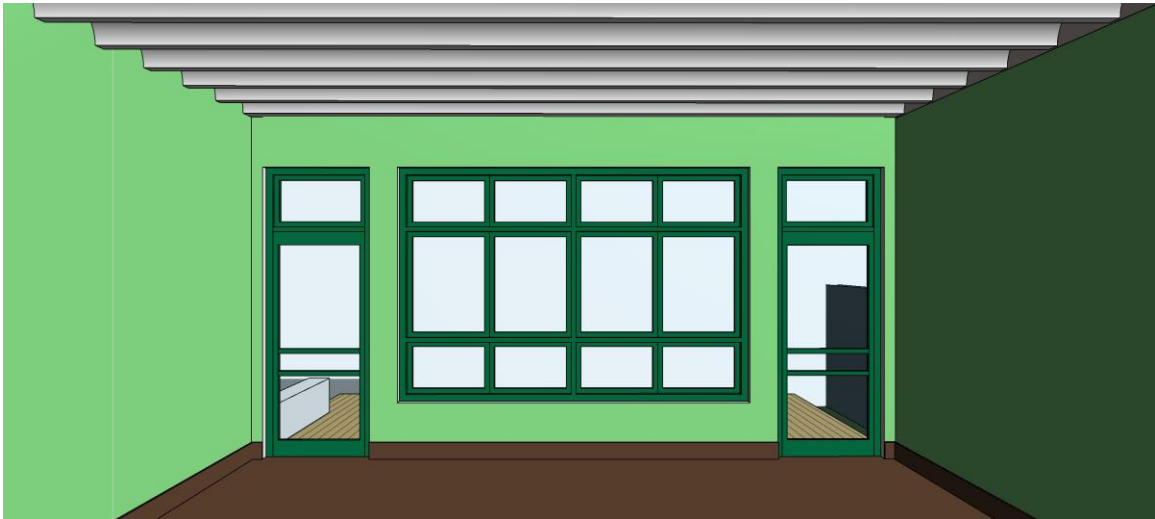
Figure 5-20: The Activity Room to the South.  
*Source:* Drawn by the Author.

6. Dismantle the closet in the south end of the activity room and replace it with a window and two side doors (see fig. 5-19, 5-20).
7. Replace the entrance of the activity room with a bigger opening and set up a screen behind it (see fig. 5-21, 5-22).

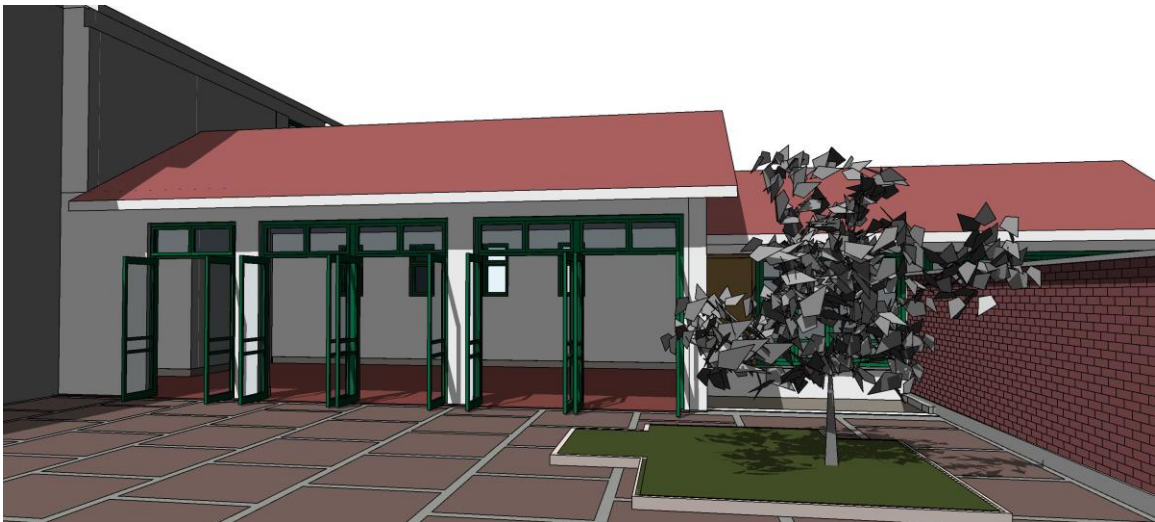
Figure 5-24: The Connection between Bar and Patio.  
*Source:* Drawn by the Author.

8. Replace the southern windows of the bar with doors (see fig. 5-23, 5-24).
9. Dismantle the north and east partitions of the second floor office (see fig. 5-25, 5-26).

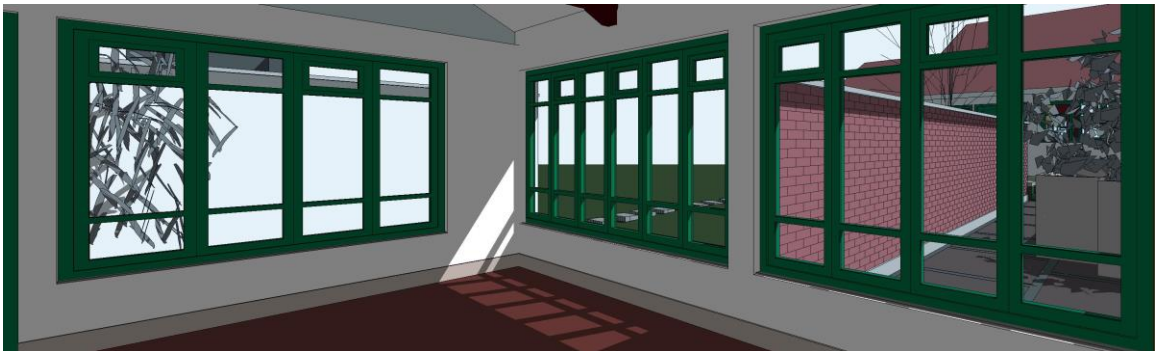
Figure 5-26: The Lounge to the East.  
*Source:* Drawn by the Author.

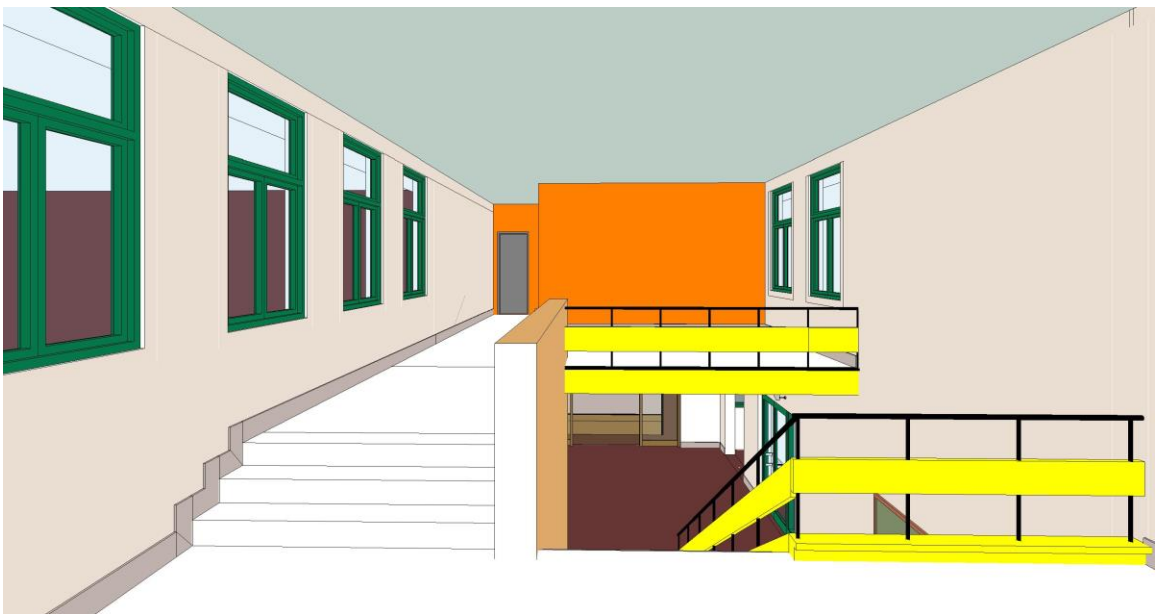
Figure 5-28: The Second Floor to the Stairway.  
*Source:* Drawn by the Author.

10. Remove the partition in the bar entrance (see fig. 5-27, 5-28).
11. Dismantle the granite panels on the ball room floor and around the indoor pillars, and

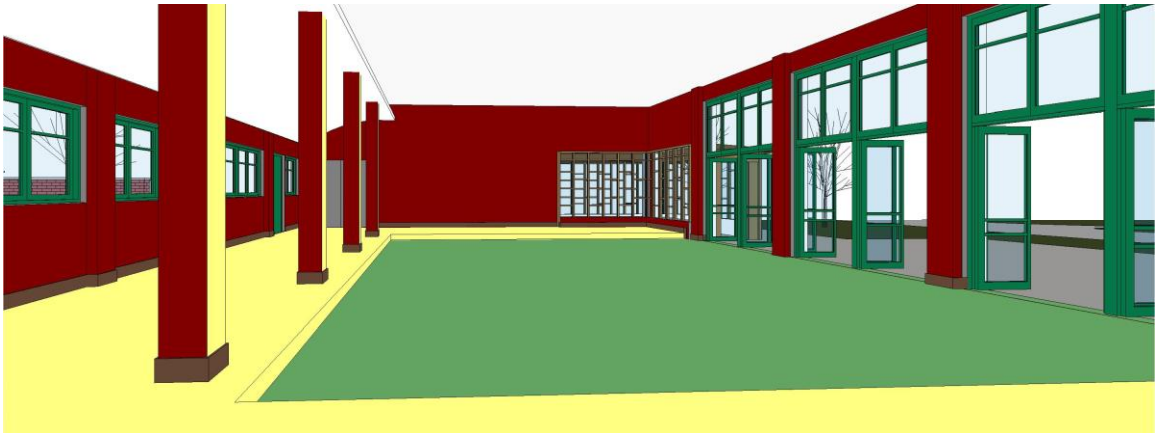
Figure 5-32: The Ball Room.  
Source: Drawn by the Author.

- paint the side walls with dark red, the pillars with dark red and yellow, and reveal the light green and yellow terrazzo floor (see fig. 5-31, 5-32).
12. Paint the building interior into designed color (see fig. 5-30, 5-34, 5-35).
  13. Remove the plaster and stucco coating on the brick walls (see fig. 5-36).
  14. Replace the railings on the balcony (see fig. 5-44).
  15. Replace the droplights in the current gym with dot lights (see fig. 5-46).
  16. Replace the droplights in the second floor meeting room with tube lights (see fig. 5-48).
  17. Reconstruct the green house (see fig. 5-49, 5-50).

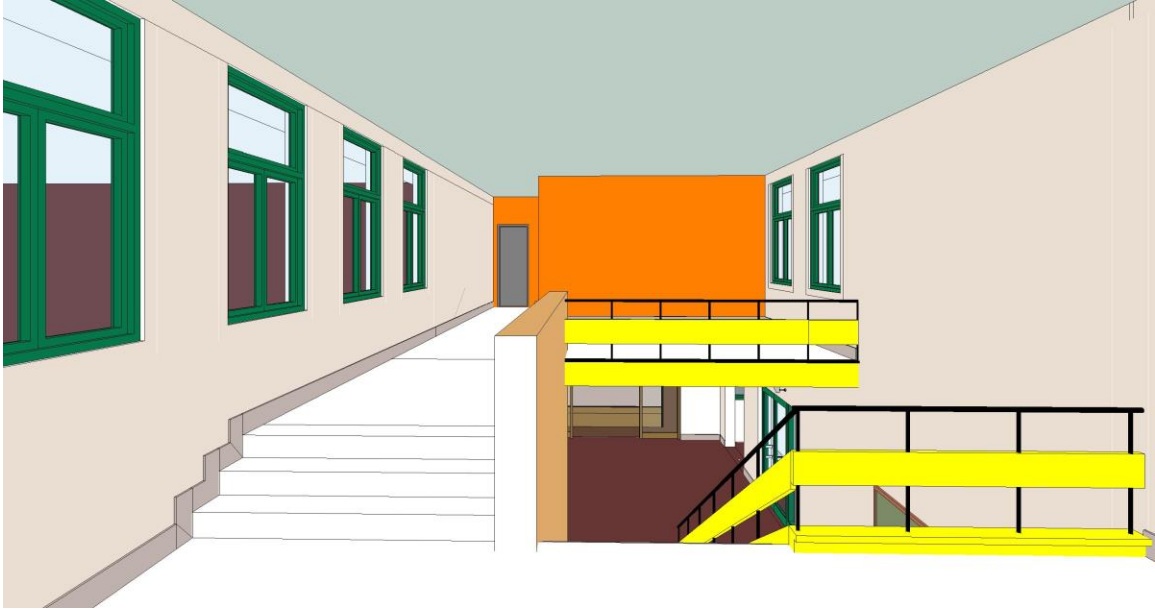
Figure 5-35: The Second Floor to the South.  
*Source: Drawn by the Author.*

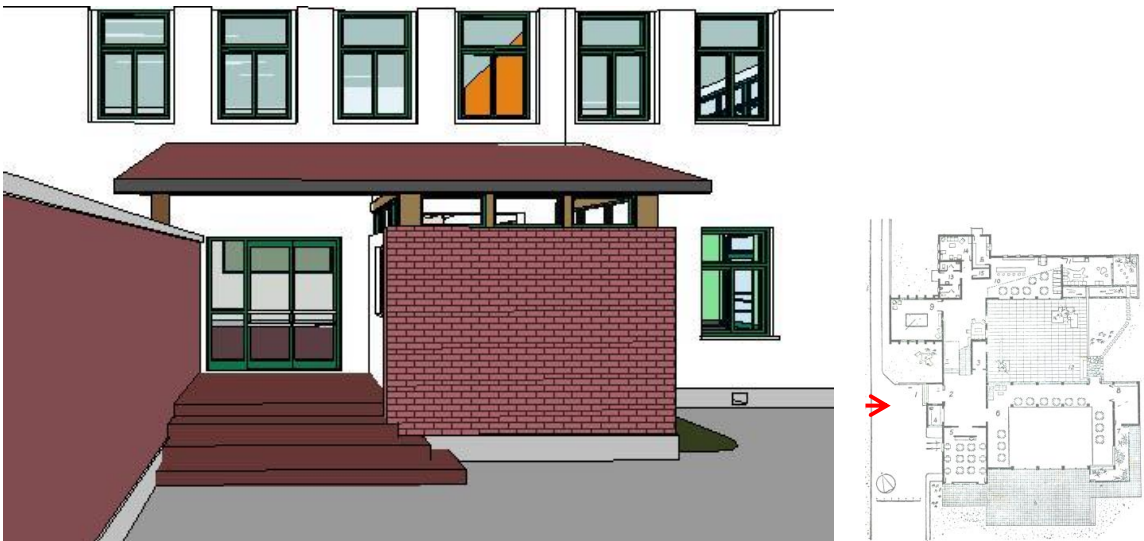
Figure 5-36: The Entrance.  
*Source: Drawn by the Author.*

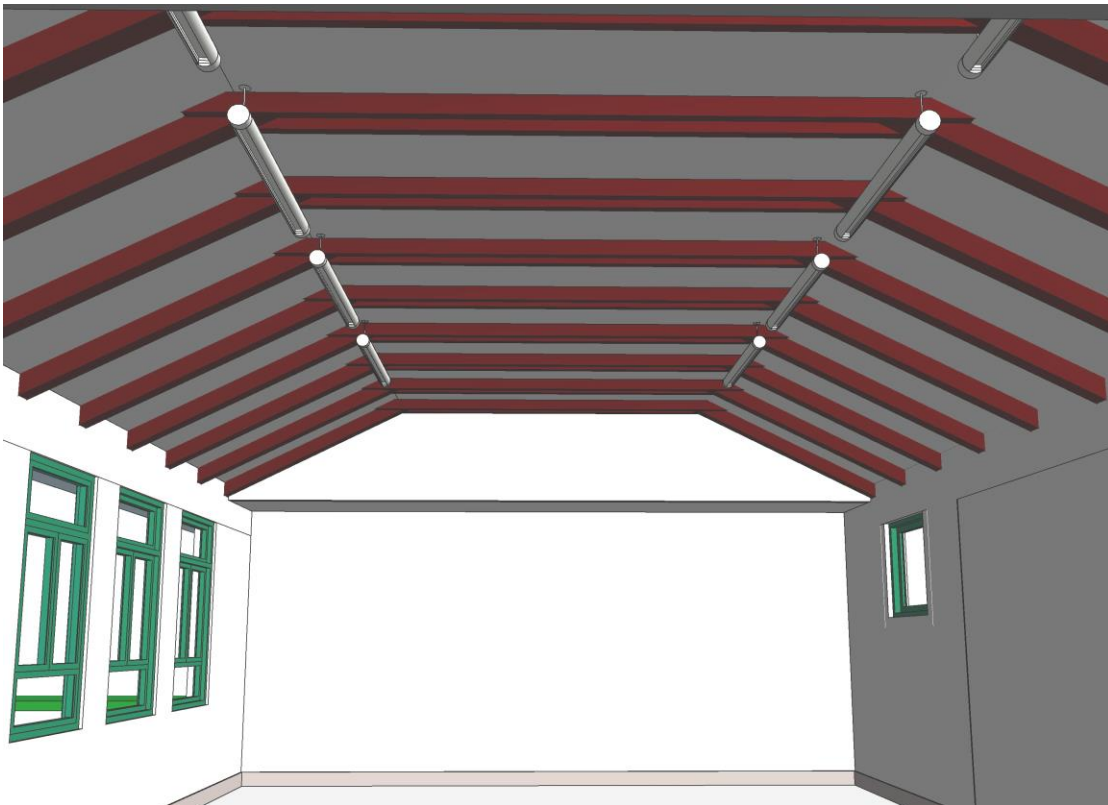
Figure 5-48: The Ceiling in the Meeting Room.  
Source: Drawn by the Author.

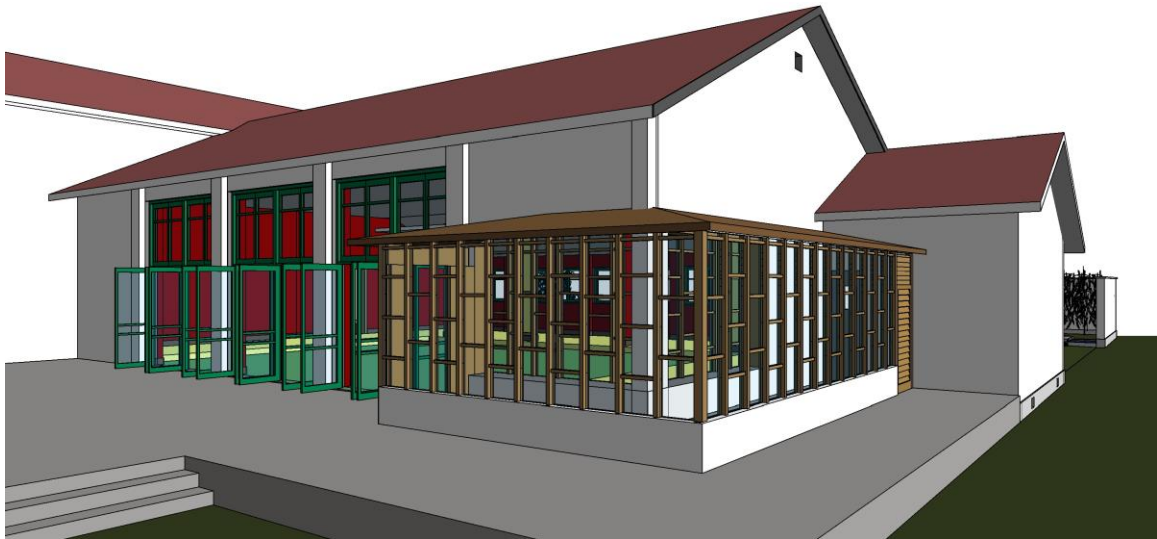
The removed functions such as the green house is not used any more. Adding this room is only to add a decoration on the building. The removed parts as the flagging and pool in the eastern garden were only built to add some interests to the building in the first place. So the rebuilding of these removed parts is not necessary, and can only be done when there is enough founding and confliction to the regulations.

Figure 5-49: The Green House.
