HAWAII DEEP WATER CABLE PROGRAM

**SIDE-SCAN SONAR AND SWATH BATHYMETRY
MAPPING SURVEY OF THE PREFERRED
CABLE ROUTE FROM MAUI TO OAHU, HAWAII**

Seafloor Surveys International, Inc.

JULY 1987

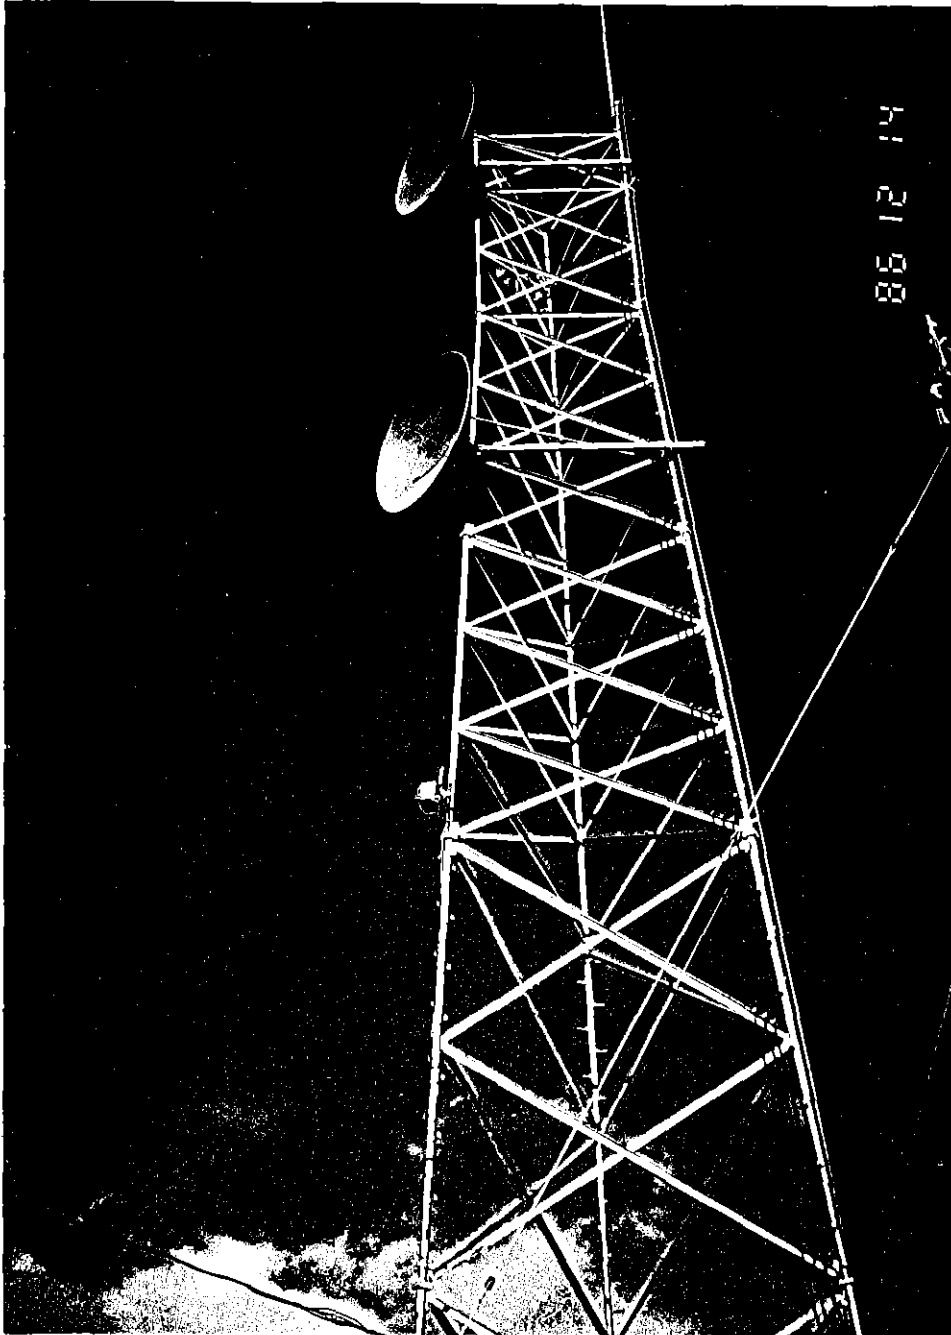
FIGURE B1-1

The transponder mounted on the
Air Inc. tower at Puu Amikopala, Molokai.

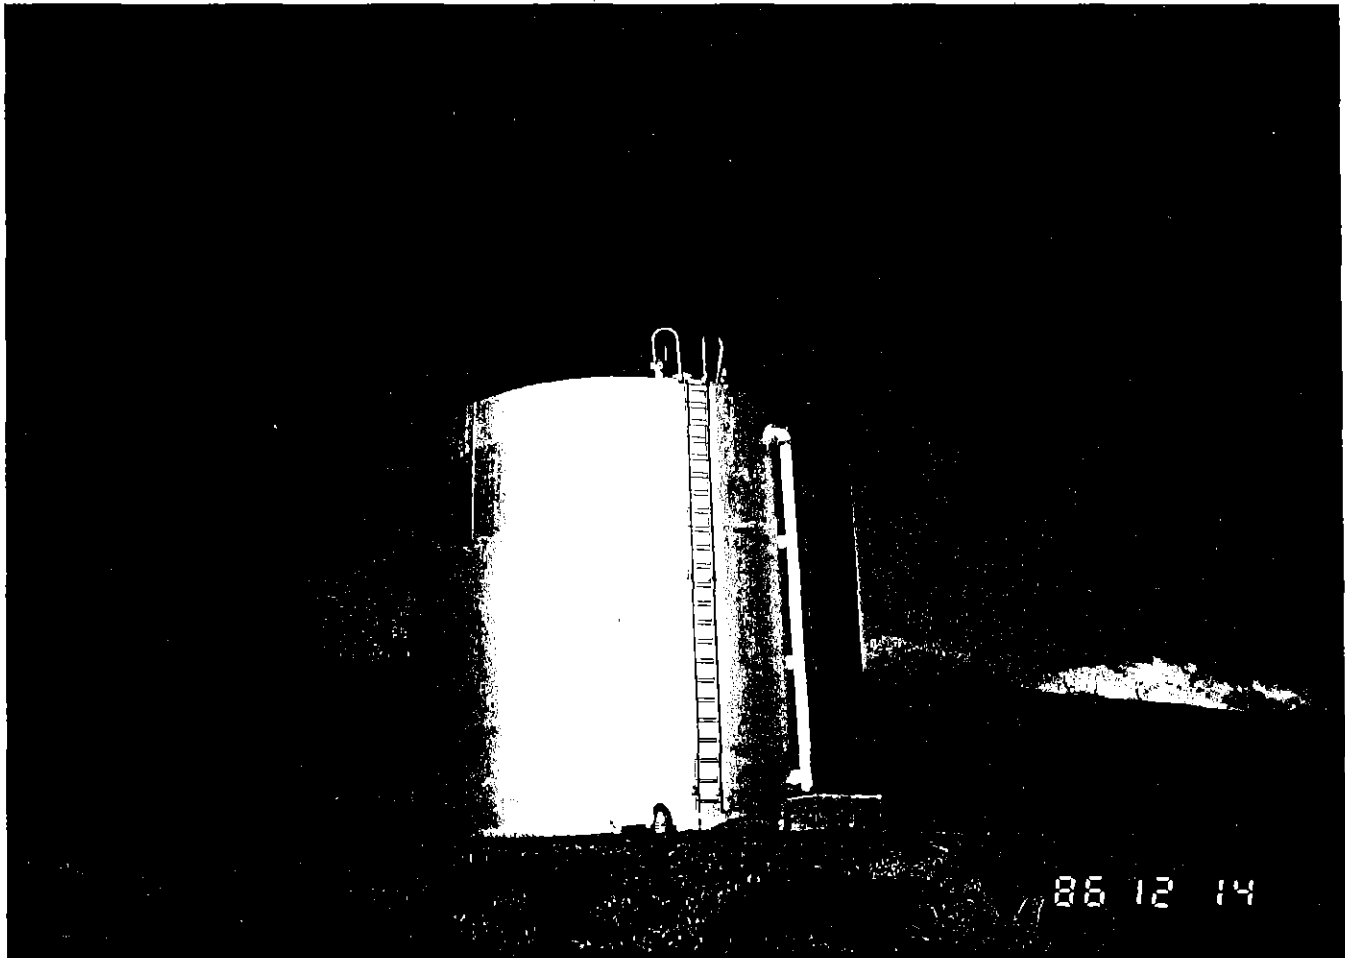
FIGURE B1-2

The transponder atop
a water tower at Kewela, Molokai.

Notes: This station is located on the top of a Maui County water tank located in the Kewela Plantation subdivision, inland of the Kewela fishpond, on the coast of East Molokai.

Permission to use this site was obtained from the Office of Water Supply in Kaunakakai (phone: 553-5857 Molokai). After translocation the final position of this station was 29 feet NW of the position used during Phase 1. Figure B1-2 shows the transponder attached to the rail at the top of the water tank.

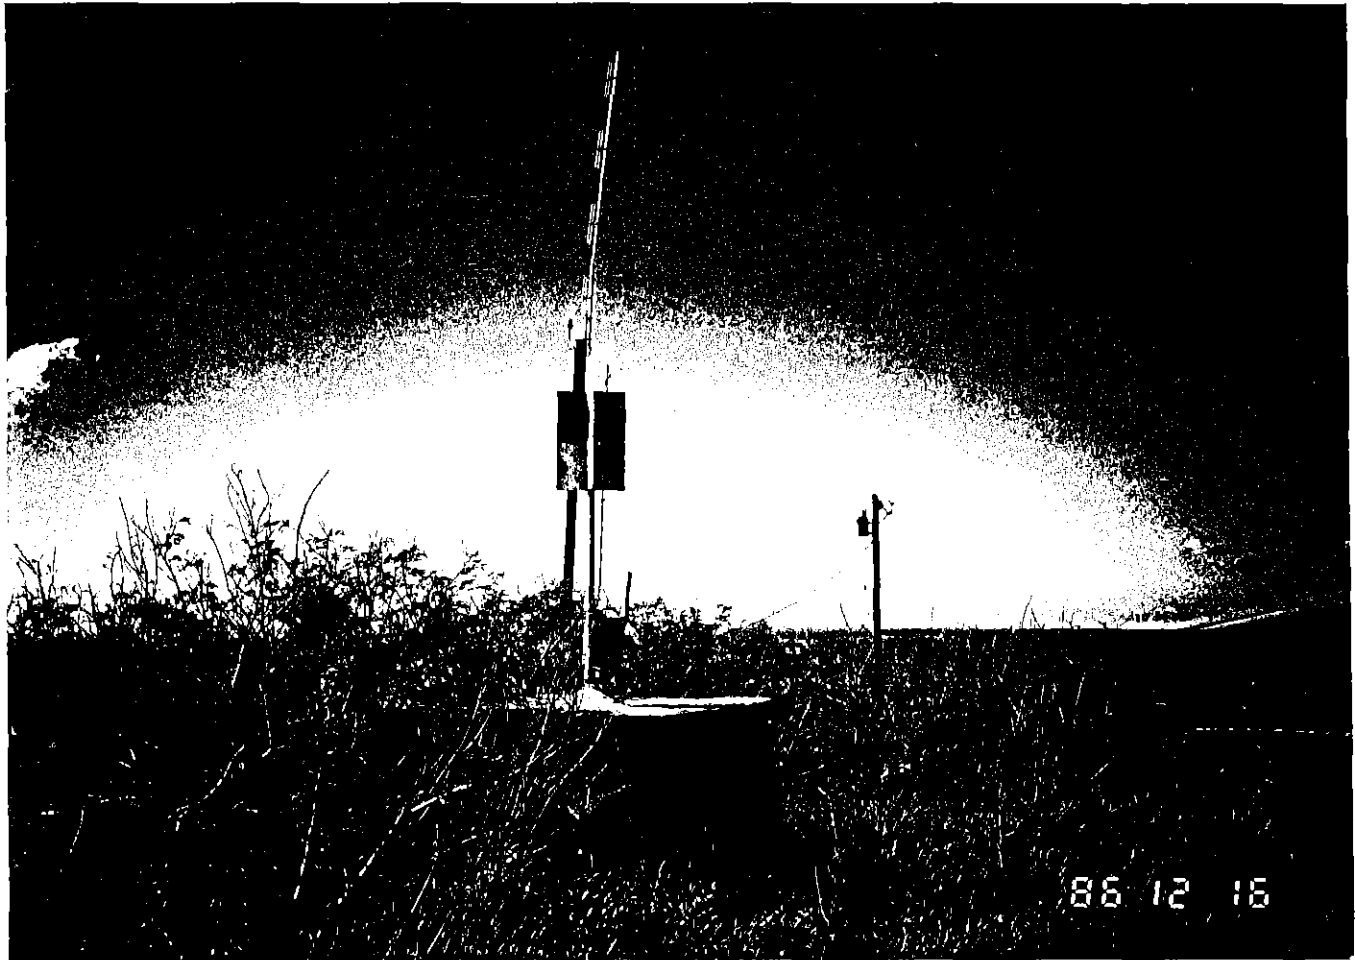
FIGURE B1-3

The transponder attached to the base of a
triangulation flag at Puu Laina, Maui.

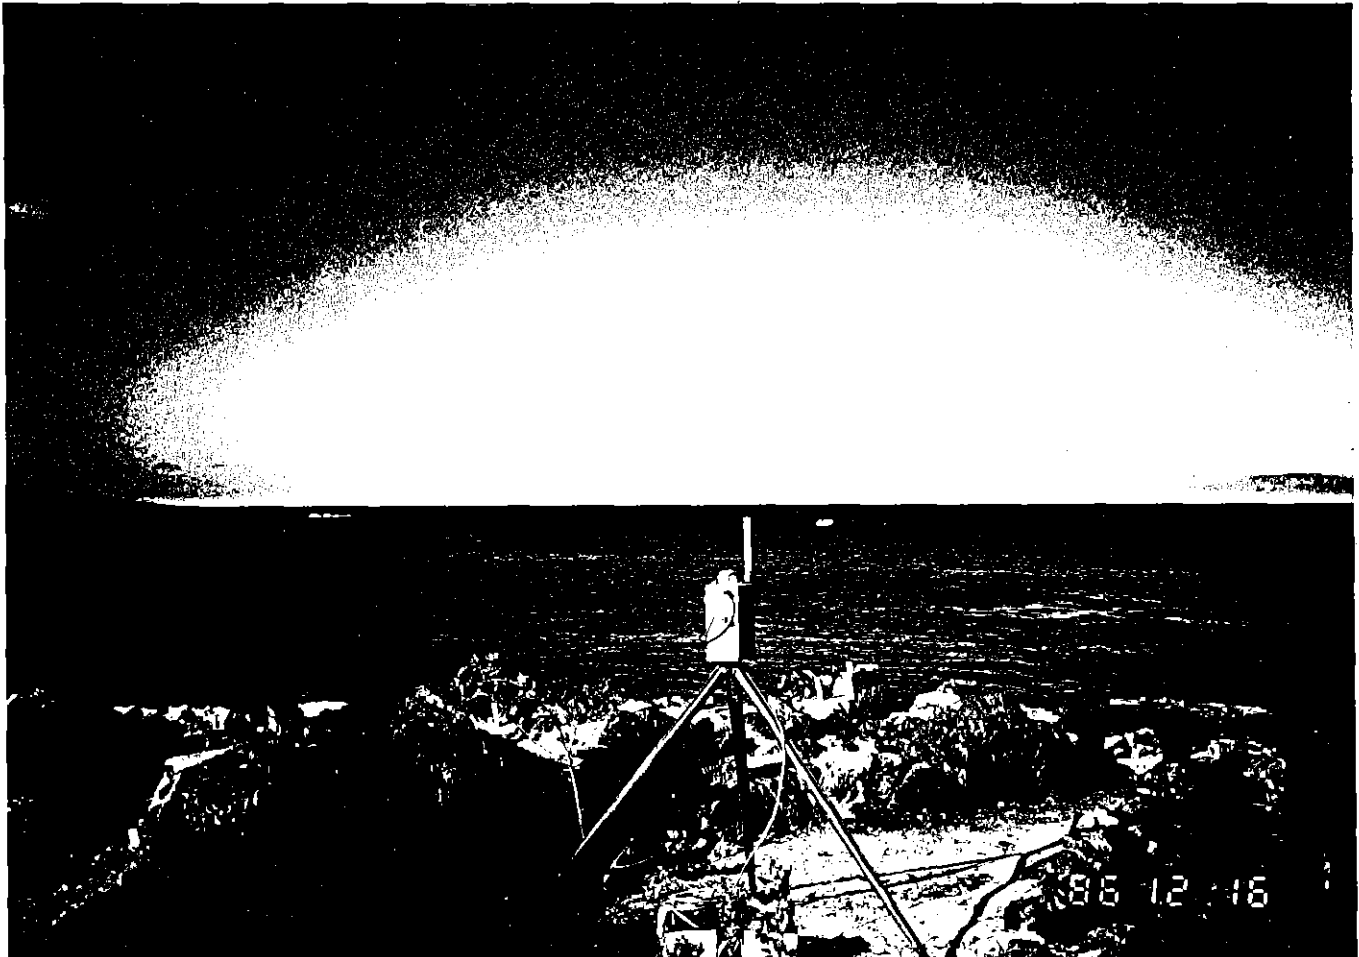
FIGURE B1-4

The transponder on a
tripod at Makena, Maui.
