MICROSTRUCTURE, TENSILE, AND CORROSION CHARACTERISTICS OF SIMILAR  
AND DISSIMILAR JOINTS OF FSW AA5086-H32 AND AA6061-T6511 FROM VARIOUS  
ATMOSPHERIC ENVIRONMENTS

A THESIS SUBMITTED TO THE GRADUATE DIVISION OF THE  
UNIVERSITY OF HAWAII AT MĀNOA IN PARTIAL FULFILLMENT OF  
THE REQUIREMENTS FOR THE DEGREE OF

MECHANICAL ENGINEERING

March 2016

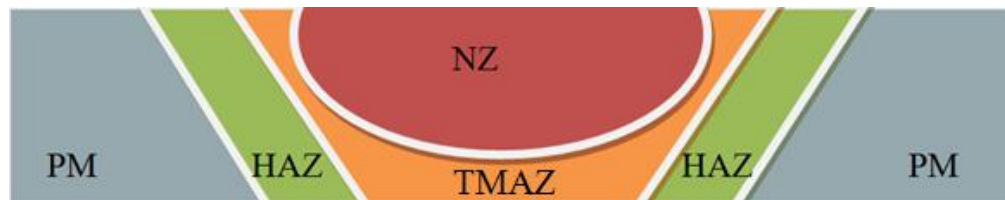
regard to their grain orientation, shape, and size. While weld parameters, such as rotational speed, probe design, and cool rate, directly impact the morphology and structure of the grains and precipitates in the various zones, the following summary generalizes the differing results to create a general overview. Figure 2 below illustrates the grain structures of the various zones.

Figure 2: Typical cross section of FSW displaying the various zones.

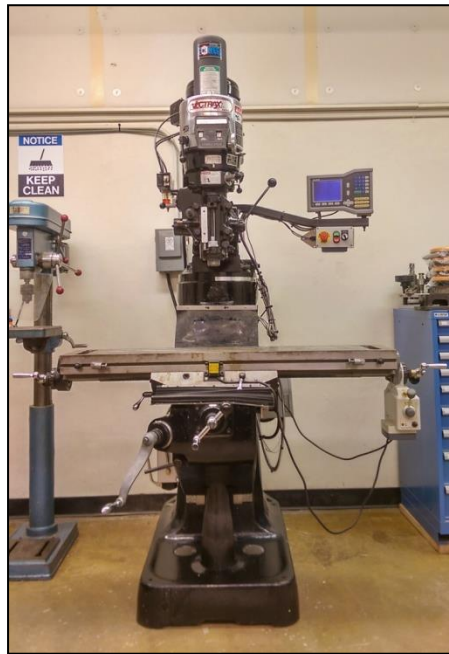
Figure 3: Vectrax CL Series Three Phase Knee Milling Machine Used for FSW.

The Vectrax CL Series Milling Machine in Figure 3 was used to create the FSW of the AA6061 and AA5086 in this study. Furthermore, the FSW in this investigation utilized an 8 mm in diameter and 6.35 mm long welding probe with a shoulder of 25 mm in diameter. The rotational speed was 1000 RPM and the translational speed was 20 mm/min with the probe angles at  $3^\circ$  towards the fed material. The probe was manually driven into the joining materials in the z direction. These parameters were selected to join AA6061 with AA6061, AA5086 with AA5086, and AA6061 with AA5086. Once the two base metals were friction stir welded, the plates were partitioned into smaller test coupons. Figure 4 below displays the topside of the AA6061-AA6061 test coupons after the FSW and partitioning of the coupons and before the flash formation and surface layers were machined off. The coupons exhibit a transversal weld. On some plates, the flash and surface layers were machined off first prior to the section of the specimen into smaller samples.

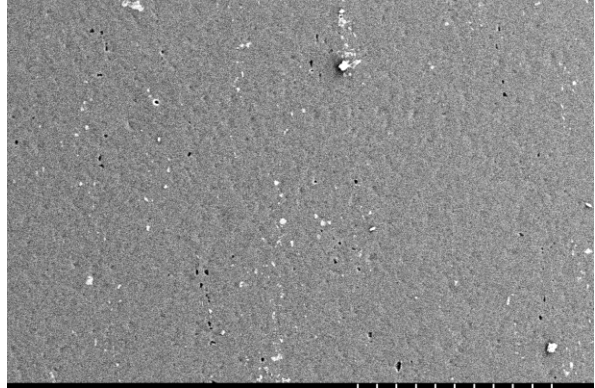
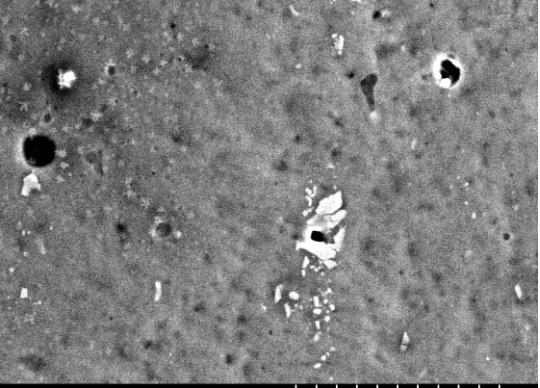
Table 6 below shows the results of the SEM/EDXA of the HAZ on the AA5086 side of the dissimilar weld at two magnifications. Likewise,
