Island Environment and Landscape Responses to 1997 Tropical Cyclones in Fiji¹

JAMES P. TERRY² AND RISHI RAJ³

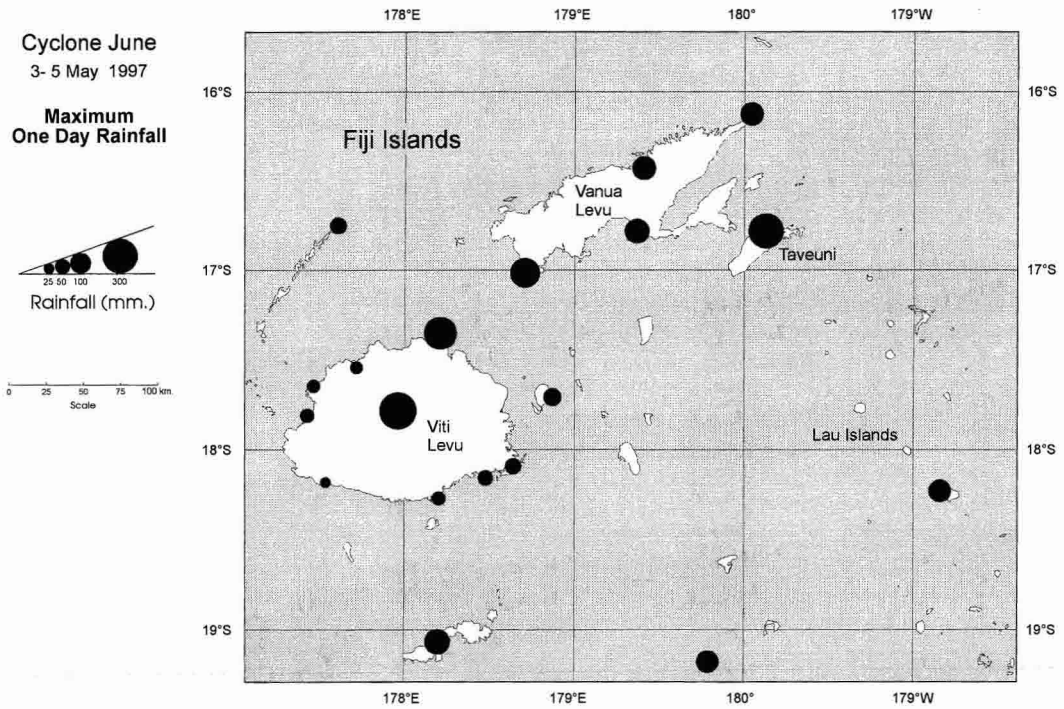
FIGURE 3. Maximum 1-day rainfall produced by Cyclone June across the Fiji Islands.

fall for both cyclones (Figures 2 and 3) reveals that the interior highlands of Viti Levu experienced the greatest deluge twice, owing to orographic lifting effects of the storms' peripheral rain bands. At an elevation of over 760 m, Monasavu weather station in the center of Viti Levu received a torrential 610 mm of rainfall on 7 March during Cyclone Gavin and 341 mm on 4 May during Cyclone June. Associated maximum rainfall intensities, calculated over 10 min from rain gauge chart traces, reached a drenching 152 mm/hr for Gavin and 40 mm/hr for June. Apart from this location, however, the two storms show contrasting patterns in maximum daily rainfall. For Cyclone Gavin it was the northwest coast of Viti Levu that experienced more intense precipitation, whereas for Cyclone June it was Vanua Levu and Taveuni. Because May is usually the beginning of Fiji's dry season, several new extreme rainfall records were established for this month with Cyclone June coming at this time (Table 3). New 1-day extreme rainfall values were set at Rakiraki in north Viti Levu, Matei airport on Taveuni, Monasavu in the highland interior of Viti Levu, and Labasa on the north coast of Vanua Levu (Fiji Meteorological Service 1997e).

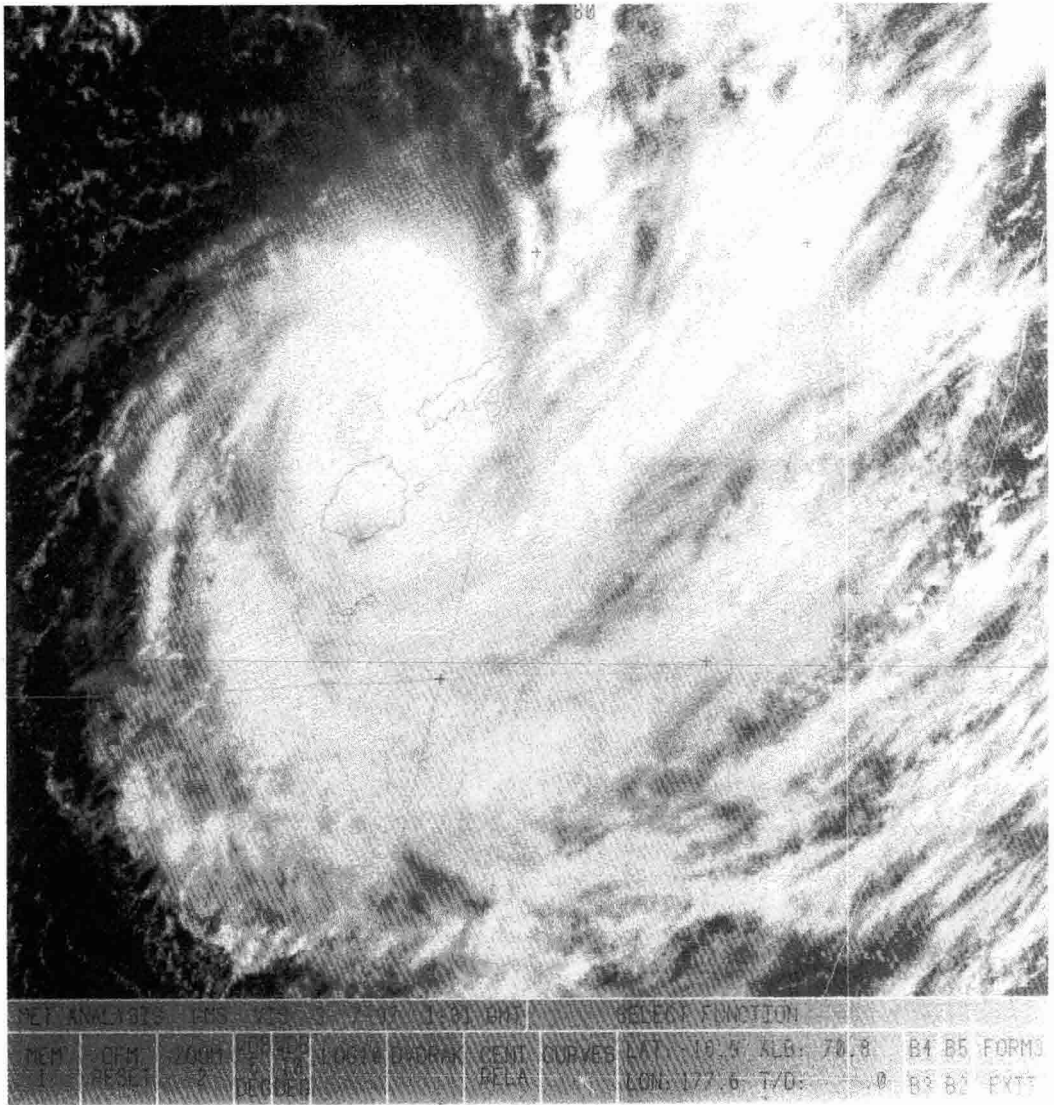
FIGURE 4. Satellite image of Cyclone Gavin, 1400 hours local time, 7 March 1997. Note the well-developed structure and the large cyclone eye, approximately 80 km in diameter, being distorted by land influences of north Viti Levu. Photo courtesy of the Fiji Meteorological Service.

An interesting question is why the largest rainfalls associated with Cyclone June were in the more easterly parts of Fiji compared with Gavin, considering that June's track was farther west and that June was less intense than Gavin. An explanation can best be found by examining the visible satellite images of both systems (Figures 4 and 5). For Cyclone Gavin, the structure of the storm was preserved throughout its traversal of Fiji waters. In contrast, Cyclone June experienced strong vertical shear on 4 and 5 May at the onset of its decay. This meant that upper levels of the storm, and associated cloud-bearing rain, shifted to the east although the cyclone eye remained to the northwest of Viti Levu. Studying the location of the cyclone track alone therefore gives a misleading impression of Cyclone June, because the mass of June's rain-bearing clouds was to the east of the track, giving a more easterly distribution of high-intensity rainfalls.

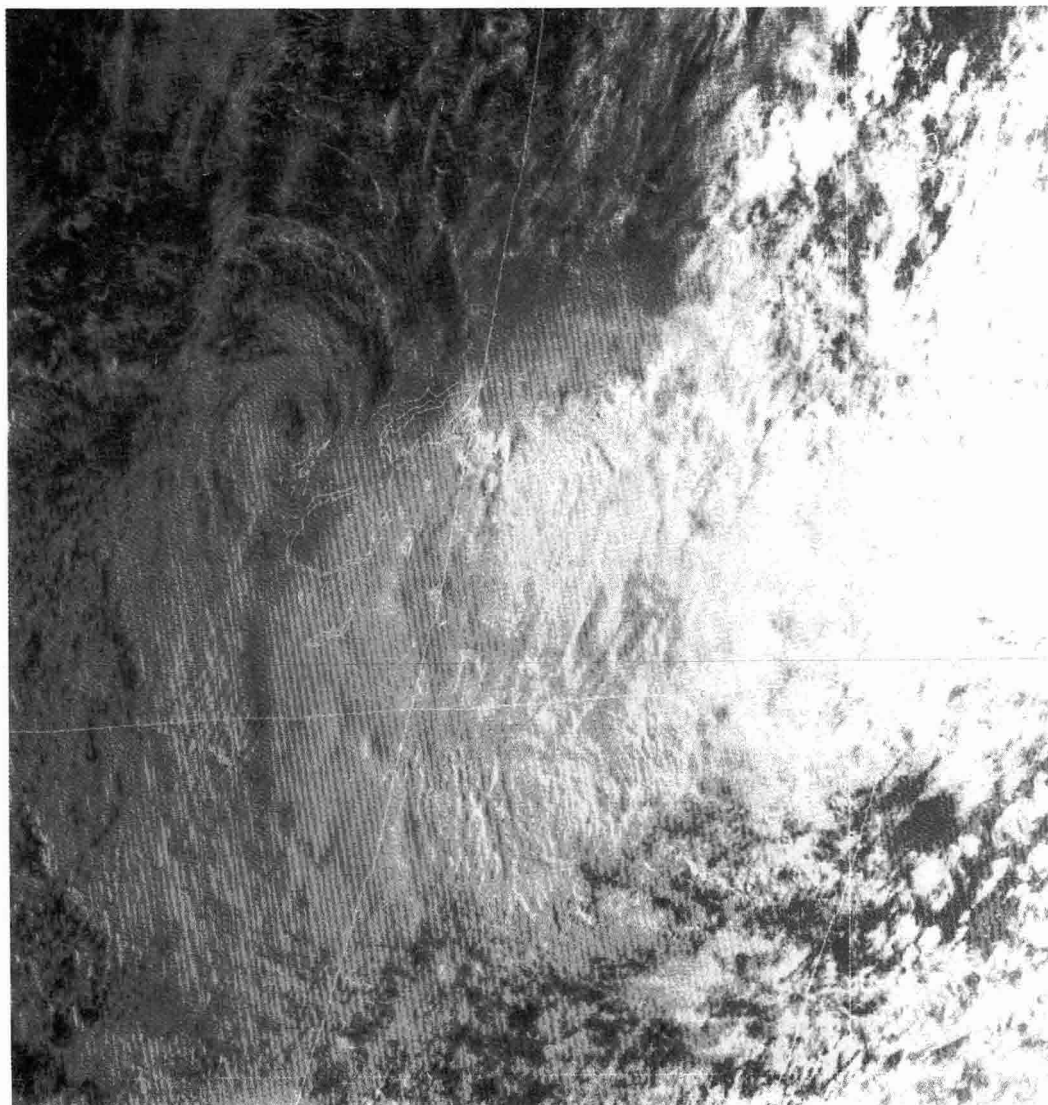
FIGURE 5. Satellite image of Cyclone June, 0800 hours local time, 5 May 1997, showing clearly the exposed low-level circulation, with the upper-level canopy shearing off rapidly to the east. Photo courtesy of the Fiji Meteorological Service.

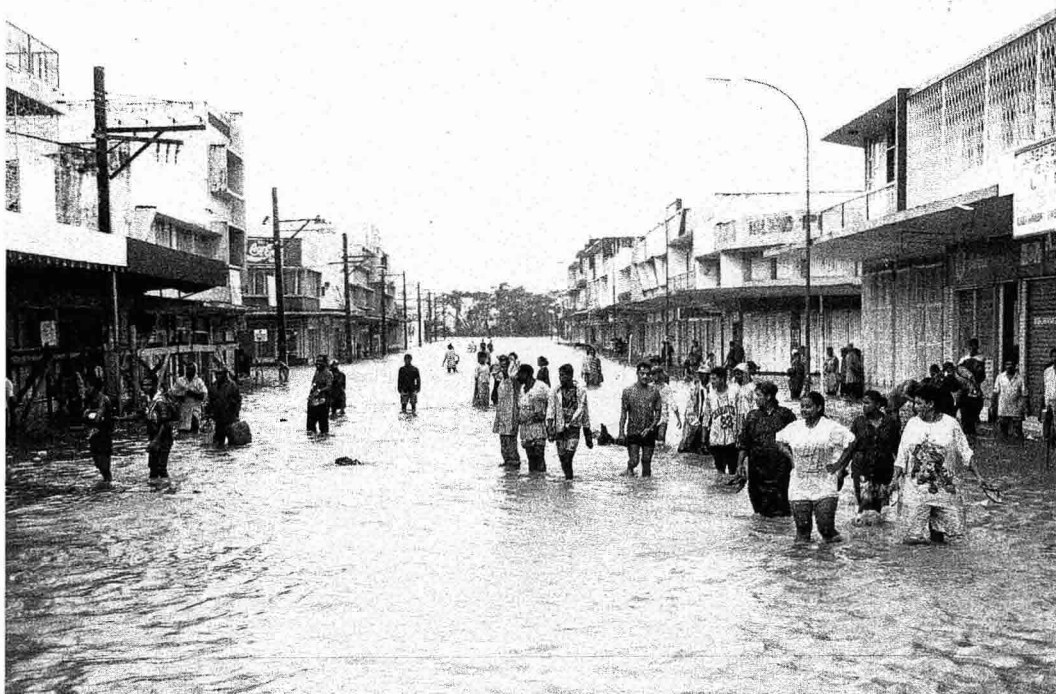
over-bank flood waters reached depths of 1.6 to 1.7 m in the Ba industrial and town areas (Figure 7), causing substantial damage.

FIGURE 7. Flooding in Ba Town after Cyclone Gavin, resulting from over-bank flow of the Ba River and storm surge inundation. Photo courtesy of the *Fiji Times*.

On Viti Levu, storm surge effects were evident along the north coast, causing sea flooding near Rakiraki. At Ba Town, the Ba River first flooded its banks as a result of storm surge around 1530 hours on 7 March (Figure 7), when the eye of the cyclone was in the vicinity of Nadi. It is assumed that the surge traveled upstream, but no records are available to establish the effects and surge levels. A sea level monitoring station at Lautoka wharf, operated by the National Tidal Facility of Flinders University South Australia, recorded a maximum sea level of 2.78 m at 0548 hours on 7 March. This surge is confirmed by a sharp drop in atmospheric pressure at nearby Nadi at the same time.

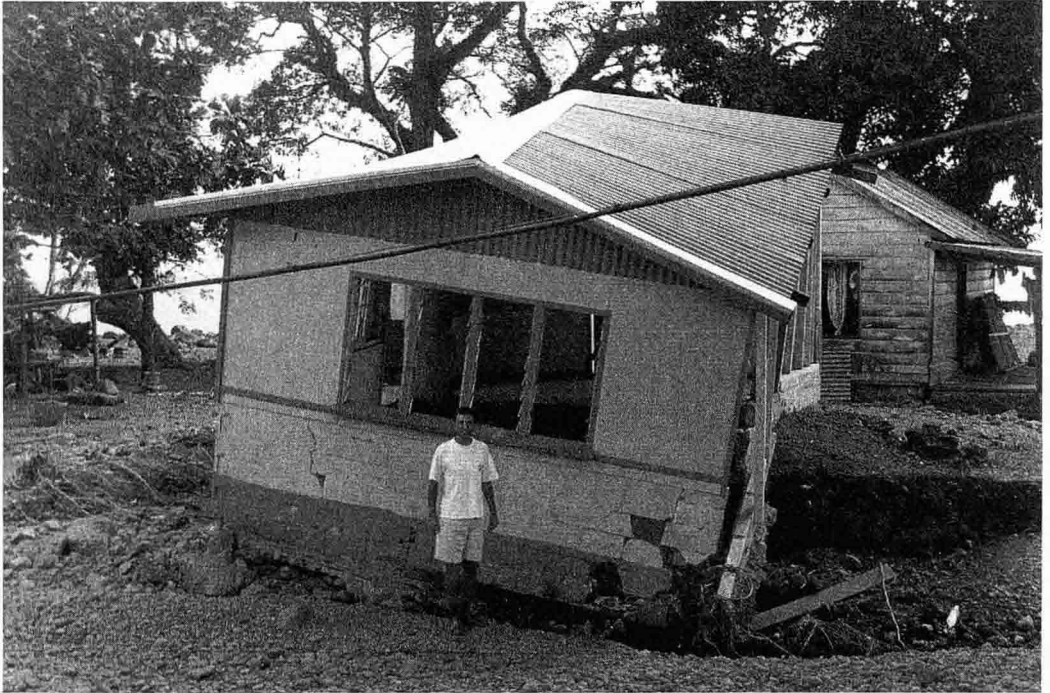
FIGURE 8. Property damage caused by stream floodwaters and erosion by coarse sediments on the island of Taveuni after Cyclone June.

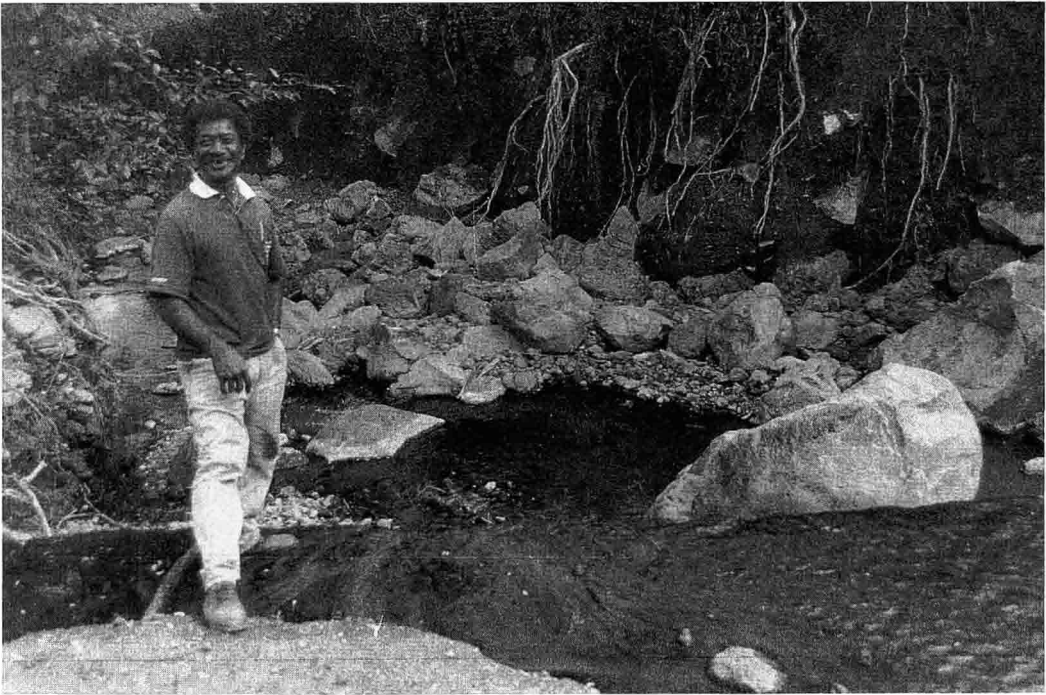
For streams with bouldery channels, cyclone peak flows are a time when the coarsest of bedload sediments undergo downstream transport. Figure 9 shows, for instance, some of the large rocks that were carried down the Somosomo Creek on Taveuni during Cyclone June.

FIGURE 9. Channel erosion and some of the coarse bedload material moved during the flood peak produced by Cyclone June in Somosomo Creek, Taveuni Island.

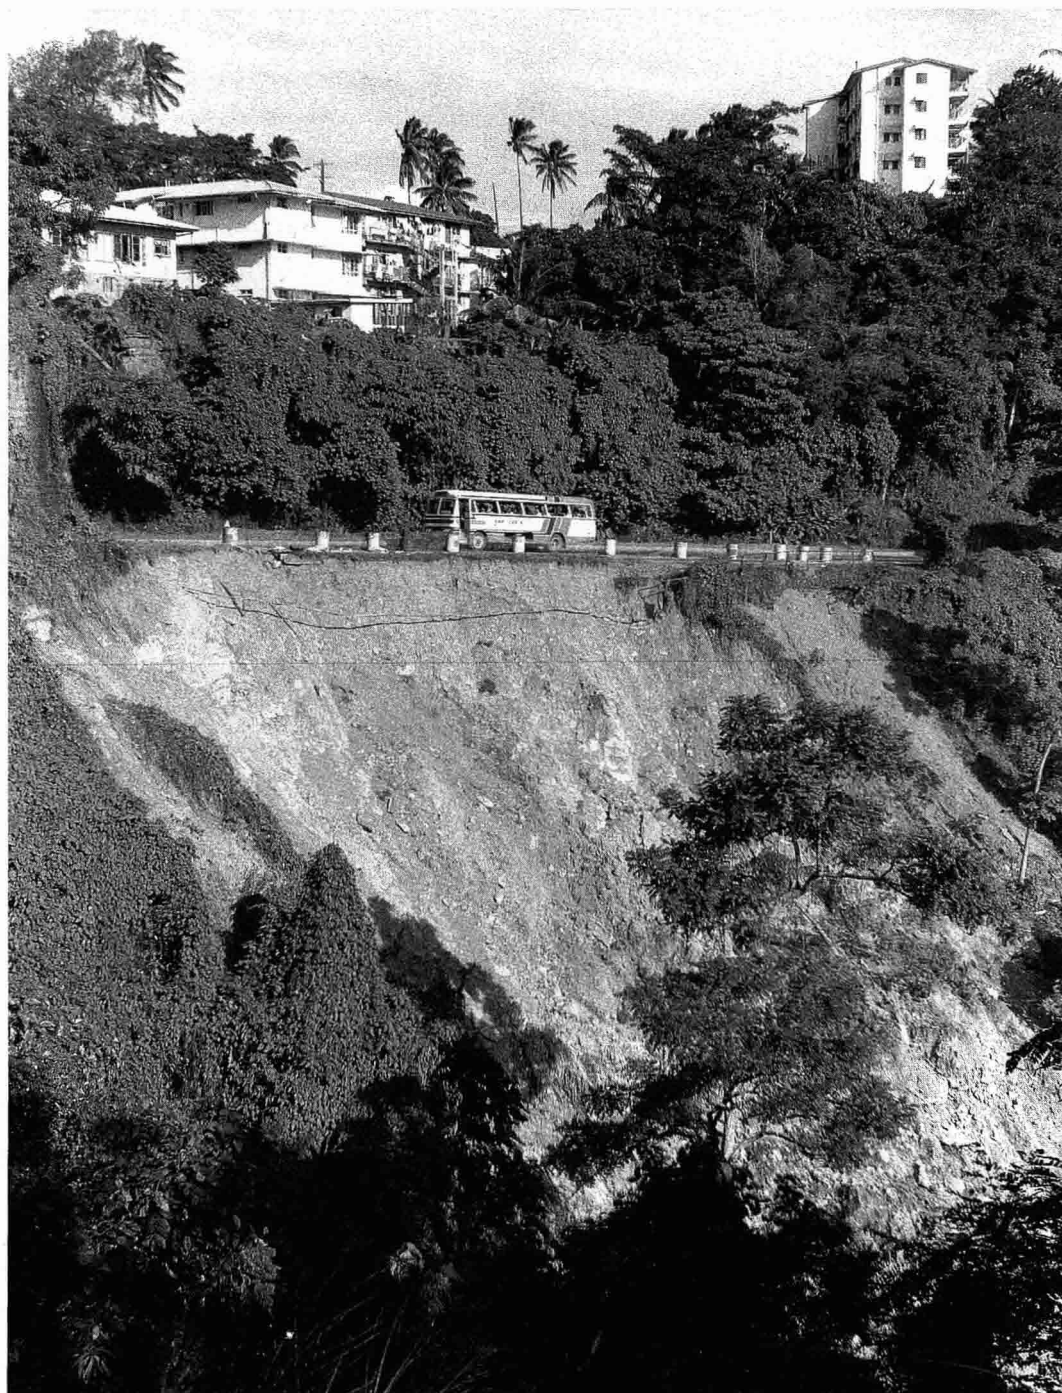
Tropical Cyclone June triggered a "massive landslide" (sic) that buried two homes without casualties on the night of 4 May on Kioa Island off the south coast of Vanua Levu (*Fiji Times*, 6 May 1997), but two people were killed by a landslide in the settlement of Sawani, Viti Levu. Outside Suva City, a shallow translational slide 40 m wide in 1.5 to 2 m of highly weathered "soapstone" (Suva Marl) caused part of a main road to collapse (Figure 10) after several days of heavy rainfall in advance of the main cyclone.

FIGURE 10. A wide, shallow landslide in highly weathered marl along Edinburgh Drive, Suva, triggered by heavy rainfall before Cyclone June. Photo courtesy of the Ministry of Information.

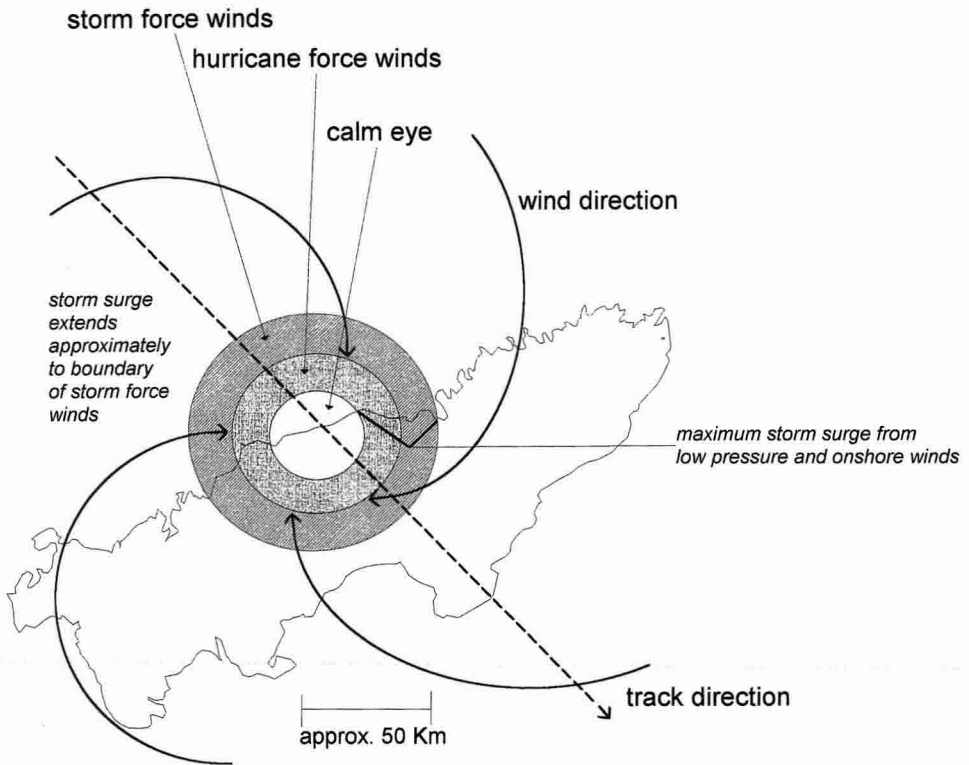
Long island coastlines with many bays and inlets and a gradually sloping seabed are more vulnerable to surge conditions because there is less opportunity for the surge waters to evacuate around the sides of the island (Krishna 1984). In the Southern Hemisphere the full impact of a surge is experienced to the left of the cyclone track in the direction of approach to an island as a result of the violent onshore winds (Figure 11).

FIGURE 11. Island landfall of an idealized tropical cyclone, indicating the section of coastline that suffers maximum storm surge from the combination of low pressure and violent onshore winds (modified from Krishna 1984).

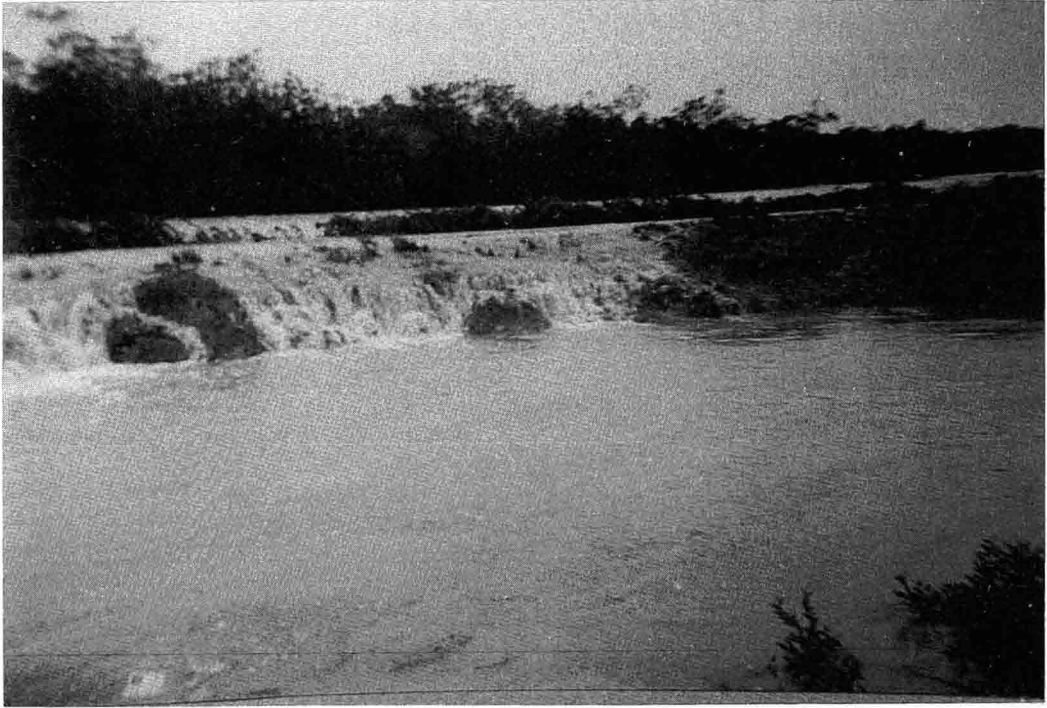
most the total length of the north coast of Vanua Levu was affected, with sea walls breached in 10 places (see Figure 12). Water levels are available for the Labasa River near its estuary in Labasa Town (Figure 13) and are compared with barometric pressure measured at Udu Point, 75 km distant on the northeastern peninsula, and Nabouwalu, lying 90 km away on the southwest end of the island.

FIGURE 12. High seas caused by storm surge associated with Cyclone Gavin spilling over the sea wall at Tabucola on the northern coast of Vanua Levu near Labasa, 1400 hours on 7 March. Photo courtesy of Drainage and Irrigation, Public Works Department.

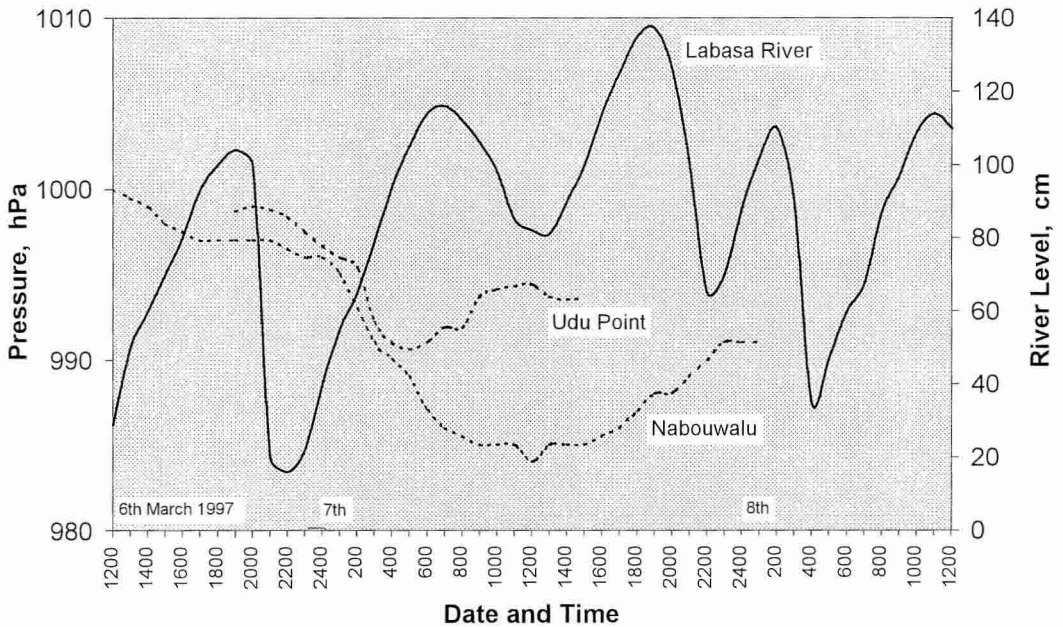
While Cyclone Gavin was approaching Labasa from the north, offshore winds drove water out of the estuary, giving an exceptionally low tide 2 hr before midnight on 6 March. After the eye of the cyclone had passed the river mouth, however, the cyclone winds were directed onshore and hence retarded outflow during low tide the next day at 1400 hours and gave a surge along the river at high tide at 1900 hours, flooding Labasa Town.

FIGURE 13. Water level in the estuary of the Labasa River at Labasa Town and corresponding barometric pressure at Udu Point and Nabouwalu on the northeast and southwestern ends of Vanua Levu (75 km and 90 km distant, respectively) during Cyclone Gavin; maximum storm surge occurred around 1900 hours on 7 March.
