Technical Report 200

**Constructing a Predator Exclusionary Fence to Protect Hawaiian  
Petrels (*Pterodroma sandwichensis*) at Hawai'i Volcanoes National  
Park**

March 2019

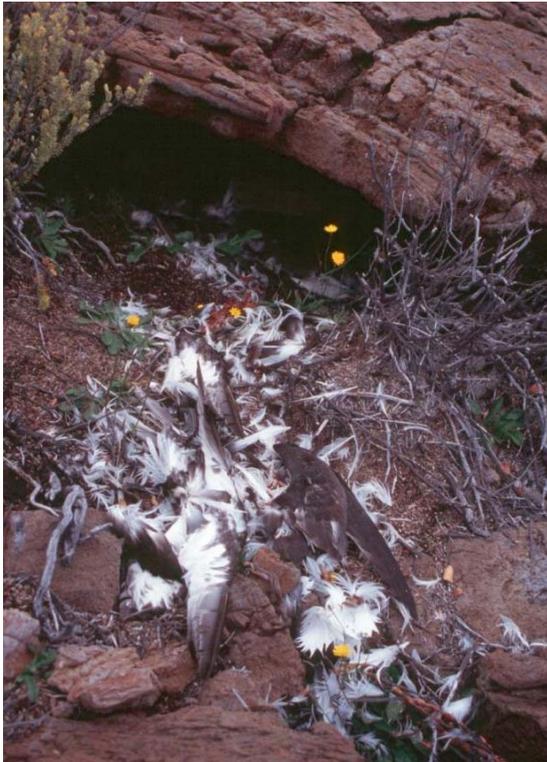
Figure 2 Adult Hawaiian Petrel depredated at burrow by cat

On Hawai'i Island, the subalpine regions of Mauna Loa within Hawai'i Volcanoes National Park (HAVO) harbor the only known surviving Hawaiian Petrel nesting colonies (Figure 1). The primary threat to this species is predation by introduced small mammals. Since their discovery in 1990, these subcolonies have been depredated by feral cats (Hu et al. 2001), and this threat remains the most serious impediment to survival of the park's population (Figure 2). The problem is particularly severe because Hawaiian Petrels have a K-selected life history (late maturity, low annual reproductive output - a single egg clutch - and long lifespan) (Judge 2012), and, while chicks are taken (Figure 3), predation appears to be focused primarily on adult birds (HAVO unpublished data).

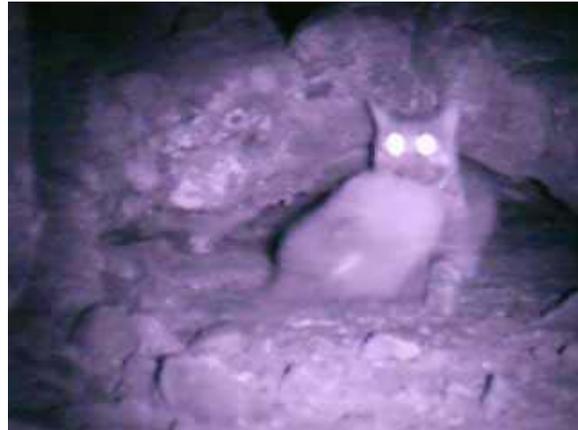
Figure 3 Cat emerges from burrow with Hawaiian Petrel chick

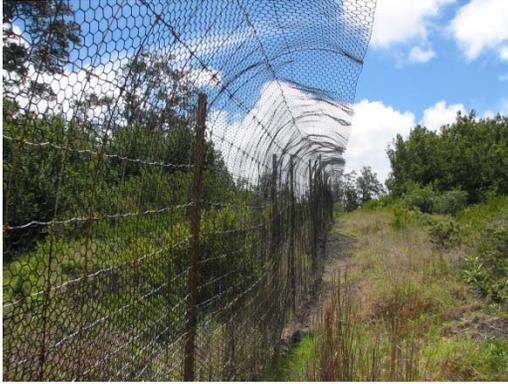
Figure 6 Modified fence design at HAVO

- 1) Two rolls of hog wire were used for the base fence, rather than seven strands of smooth wire, to add stability and strength on the uneven terrain (Figure 6).

- 2) The hog wire was extended up to a 6 foot height then bent out slightly (1-2 eyes) to form a support base for the floppy arc (Figure 6). This reduced the number of smooth wire arc stays required.
- 3) PVC coated hexagonal mesh was used rather than galvanized mesh to increase the longevity of the fence exposed to the park's corrosive volcanic environment (Figure 7).

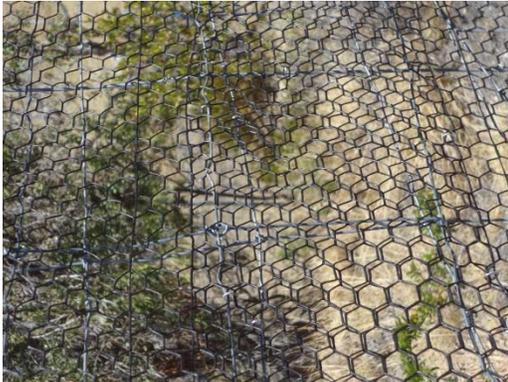
Figure 7 PVC coated hexagonal mesh

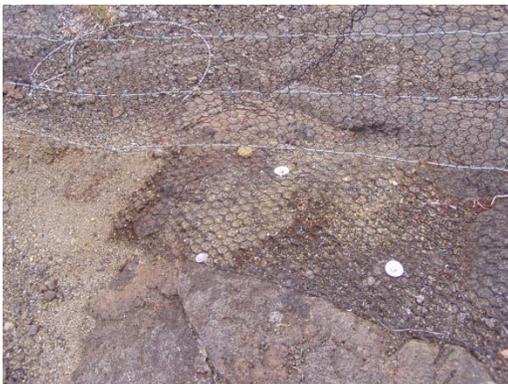
Figure 8 HAVO design modification; skirted affixed to surface

- 4) In areas where the skirting could not be buried, it was affixed directly to the substrate (Figure 8).

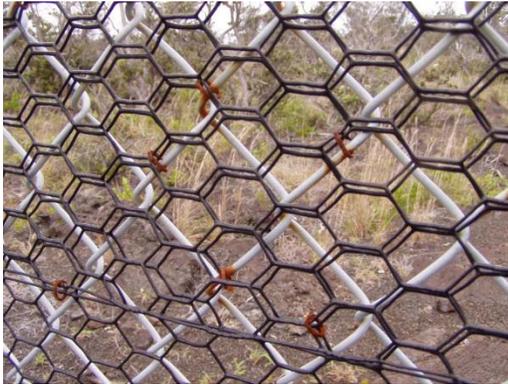
Figure 9 Non-galvanized hog rings after one year

A key lesson learned during this pilot project was to use hog rings with a coating, such as Bezinal or Galfan, to affix the mesh to the hog wire to reduce corrosion at contact points. Initial hog rings were not coated, and required replacement at 1-2 years (Figure 9). Understanding the reactions between different types of metals is key to selecting the best hog rings, anchor wires, arc supports and any other metal items that will be in contact with the hog wire. The park now uses Bezinal coated materials to eliminate corrosive reactions.

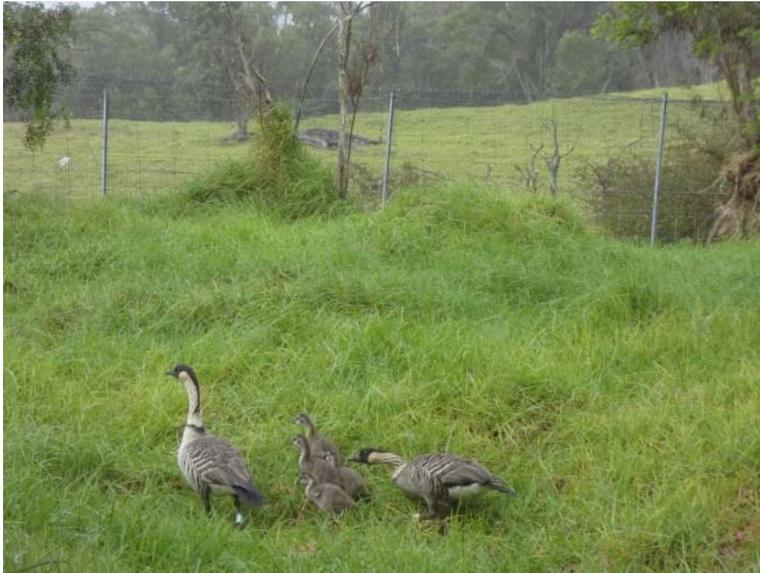
Figure 10 Nēnē family within corrected Ohaikea enclosure

A second fence was constructed in 2012-2013 for the protection of Nēnē due to the success of the 'Āinahou fence (Figure 10). In preparation for the large scale Mauna Loa fence, a cost saving modification was included in this fence design as a trial. The top roll of hog wire was replaced with a custom manufactured product, referred to at the park as “sheep wire”, which has a wider spacing between vertical wires (18-24”) and comes at a significant cost savings. This wire was originally used to increase the height of the park’s existing 4’ fences to 6’ to stop ingress from encroaching sheep. This modification proved unsuccessful as the wider spacing meant the wire was less rigid and therefore did not sustain the weight of the floppy arc (Figure 11). As a result, additional wire arc supports had to be added which required a notable increase in labor and a decrease in floppiness of the arc. It was determined, however, that the sheep wire

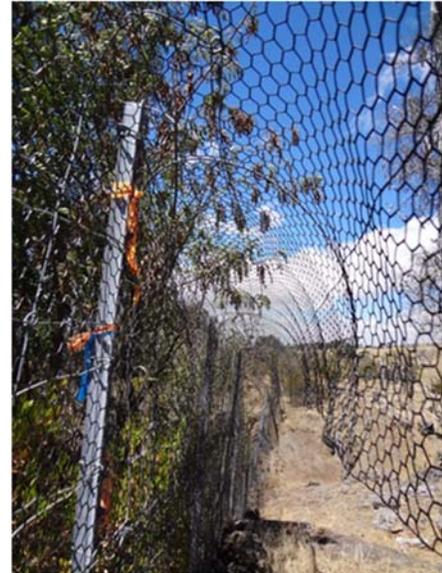
Figure 11 Sheep wire did not support arc

could be used for the lower roll as it was sturdy enough to support the mesh and allowed added flexibility to form fit the lower roll to the undulating landscape.

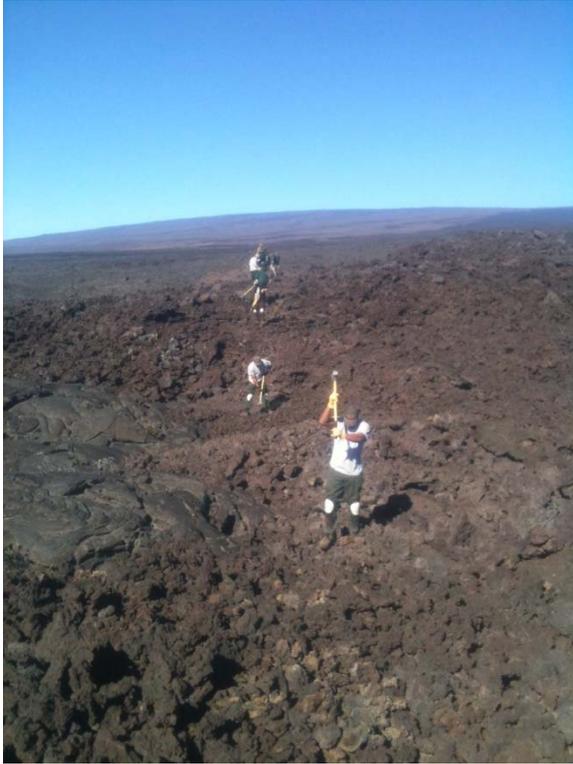
Figure 12 Fence crew pulverizing the route

The majority of the route was across unstable a'a flows. To stabilize the line for construction the a'a had to be pulverized to facilitate walking and post pounding. A crew of 10 spent 7 days preparing a 1.5 x 8,000 meter construction corridor. The crew used sledge hammers to pound the a'a into a workable condition (Figure 12). The first sledge hammers had fiberglass handles however, they were promptly replaced with wooden handles to reduce the excessive vibration associated with the fiberglass. Personal protective equipment for this portion of work included: knee pads, shin guards, protective cups, leather boots, leather gloves, long pants, eye protection.

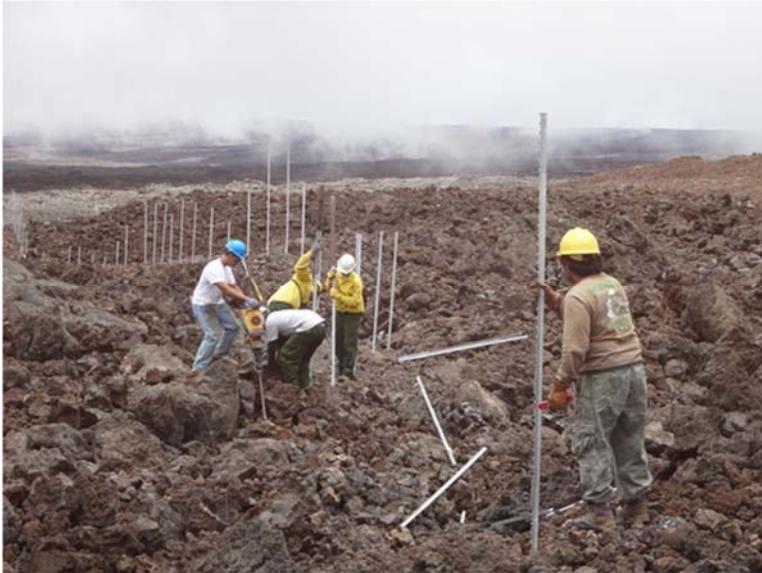
Figure 13 Lining up and setting the posts

Over 3,900 posts were installed along the route using gas drills and post pounders (Figure 13). Crew worked in groups of 5-6 with people assigned to lining up the posts, drilling (Figure 14) and setting and pounding posts rotating assignments throughout the day to avoid fatigue. Personal protective equipment included leather boots, long pants, leather gloves, eye protection and hard hats.

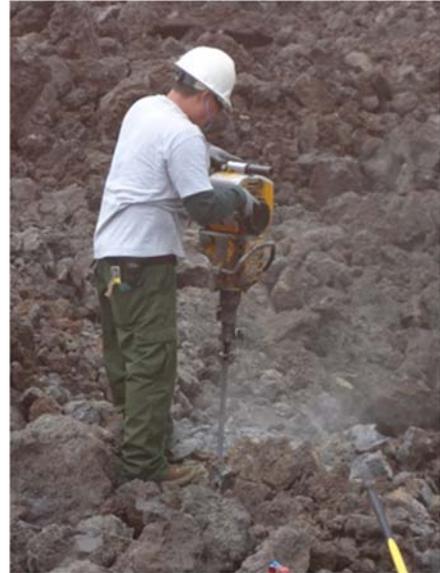
Figure 14 Drilling holes to sink the posts

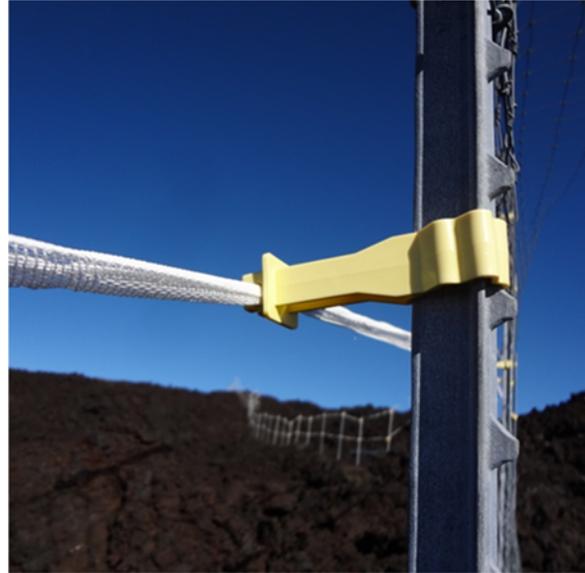
Figure 16 T-post insulator to reduce friction

In an effort to alert birds to the new posts during the upcoming breeding season, and to precondition them to the coming fence, linear white tape was installed upon completion of post installation (Figure 15). Two strands of cool tape (polytape) were attached to each post at the top (6') and midway down (3'), via 3" plastic T-post insulators (Figure 16). The insulators were used to hold the tape away from the mesh to reduce wear from rubbing on the fence. This type of insulator attaches to the back of the T-post and was selected so that the cool tape could be attached in advance of the fencing. Tape was twisted between each insulator to promote movement to increase visibility. Over twisting may result in too much slack; 1-2 twists between insulators is sufficient.

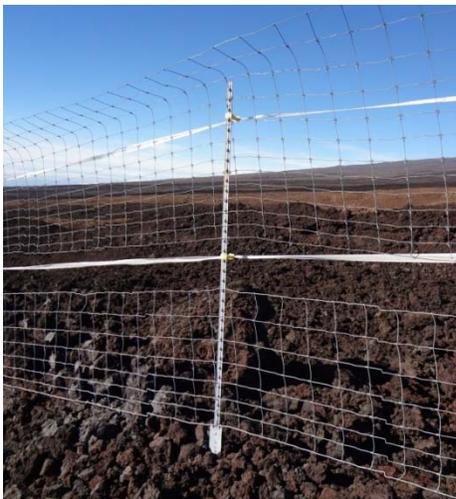
Figure 17 Two heights of hog wire for stability

Hog wire was used as the base for attaching the hex mesh. Two rolls were attached, one above the other, to a height of roughly seven feet (Figure 17). The top foot (roughly) was bent out to form the base of the floppy arc. A gap was left between the two rolls to provide the flexibility to adhere to the ground undulations while allowing for a consistent overhang at the top to provide the base of the arc. The mesh sufficiently covered the gap and was notably overlapped to avert potential breaches. Hog wire was attached to the T-posts using Bezinal coated fence clips. On the a`a sections, the bottom roll of hog wire was not anchored to the substrate; on pāhoehoe sections anchors were installed to stabilize the skirting.

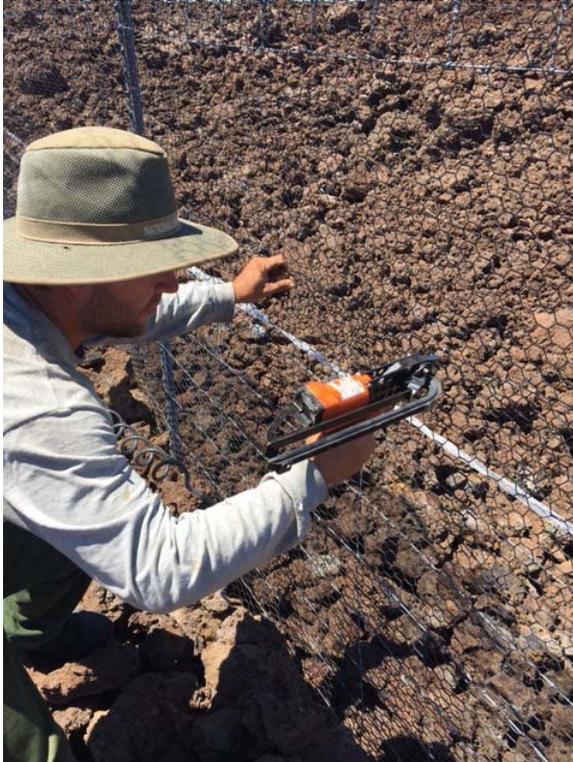
Figure 18 Attaching mesh to hog wire using hog rings

Hexagonal mesh was attached to the hog wire using hog rings. Beznal coated hog rings were applied using both manual and pneumatic tools powered by CO<sub>2</sub> (Figure 18). To keep from tipping, the CO<sub>2</sub> cylinders were secured to the fence at each worksite using a bungee cord (Figure 19). Two heights, 5 foot and 6 foot, were attached one above the other. Mesh was overlapped a minimum of 8 inches and securely attached at multiple levels along the join. The bottom roll was attached leaving 1.5 – 2 feet of mesh along the ground to form the skirt. The upper roll was attached with roughly 2 feet of mesh available at the top to form the arc.

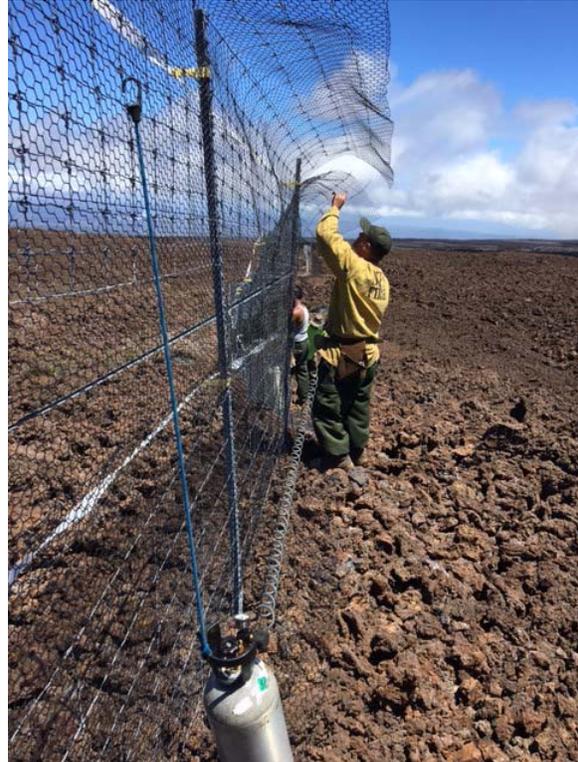
Figure 19 Using the CO<sub>2</sub> powered hog ring tool

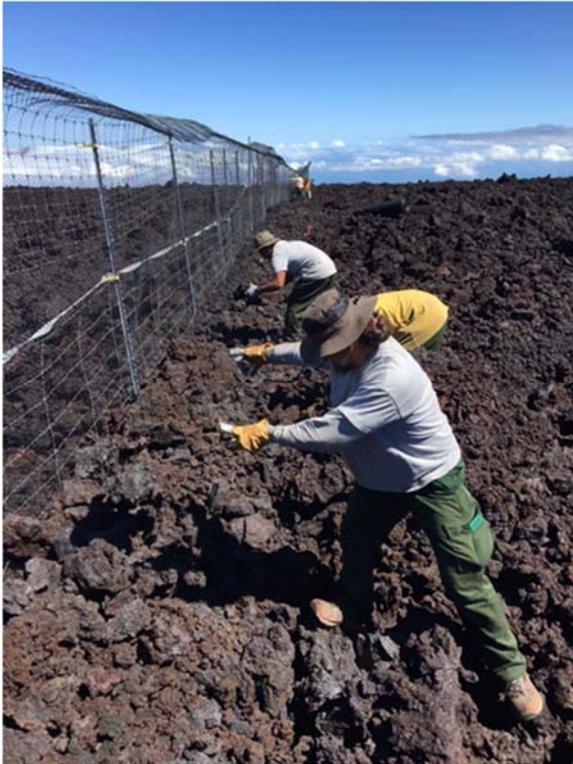
Figure 20 Stacking rocks to secure the mesh skirt

The fence route was largely on rough, a'a lava, however, some segments crossed over varying pāhoehoe flows. The fence crew developed strategies for securing the skirting to the different types of flows to ensure that it provided adequate barrier against predators. On the a'a, the crew removed loose rock and pulverized remaining rock to solidify the spaces underneath the skirt. Then they laid the skirt down, angled outward away from the fence, and covered it with additional pulverized and some heavier pieces of a'a (Figure 20). Care was taken to angle the skirt downward, and to avoid piling rocks too high atop the skirt, and/or out beyond the edge of the top arc, to avoid shortening the overall height of the fence. On the pāhoehoe sections, the skirt was pressed down to conform to the lava and then attached to the surface using a nail gun (Figure 21) using .27 caliber charges (red or yellow, rated 4-5, depending on substrate) and

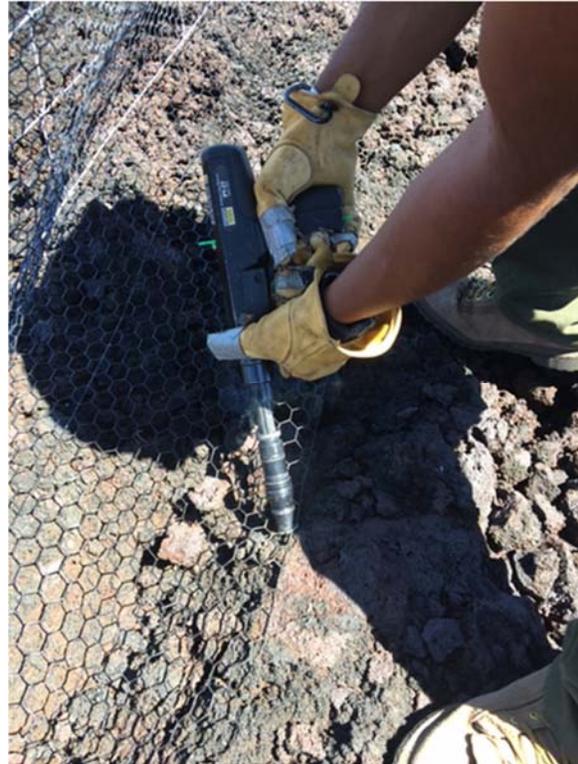
Figure 21 Attaching mesh skirt to surface using nail gun

loaded with 4” nail and 1 1/2” washers. Nails were driven in as needed to ensure the mesh stayed tight to the lava surface.

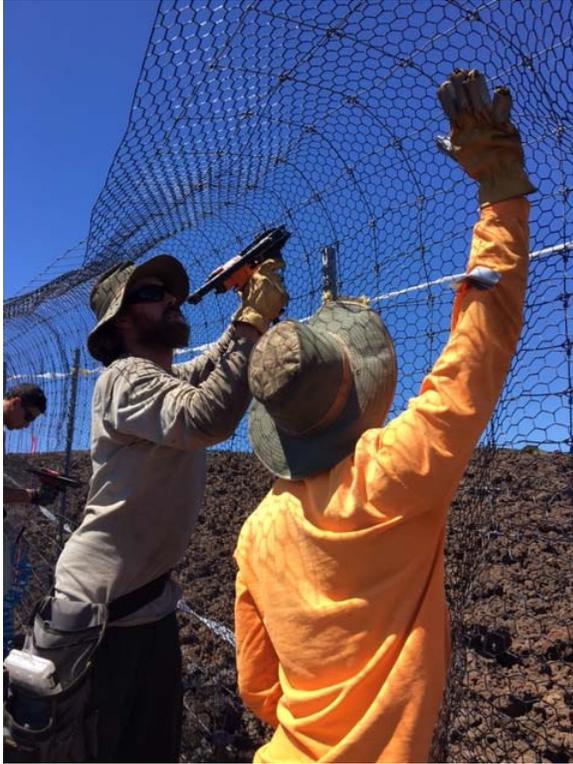
Figure 22 Forming the floppy arc

The top two eyes of hog wire were used to form the base of the floppy arc. The hex mesh was attached to the bent out hog wire using hog rings (Figure 22). A formed arc, made of smooth wire, was inserted as needed to form the outer edge of the arc. It is critical to the design that the arc remains flexible; in the event a cat attempted to jump and grab the arc, it would flex down and discourage the animal from getting a secure hold to climb. The arc should be stable enough to hold its form and maintain the distance from the fence (not droop down) but should remain flexible enough to bend down and spring back up into position when batted at with one's hand (with roughly 6 inches of play). It was difficult to maintain exact heights and arc lengths given the significant undulations of the substrate in this area, therefore, modifications were made as needed. For example, in some areas, more hog wire was available for the arc than needed. In order to maintain the floppy edge, the mesh was only attached to the hog wire at the base, and the outer section was left to hang loose at the edges, below excess hog wire. In other cases, slight bends of the fence line required the splicing in of additional mesh to complete the arc and while maintaining the flexibility (Figure 23).

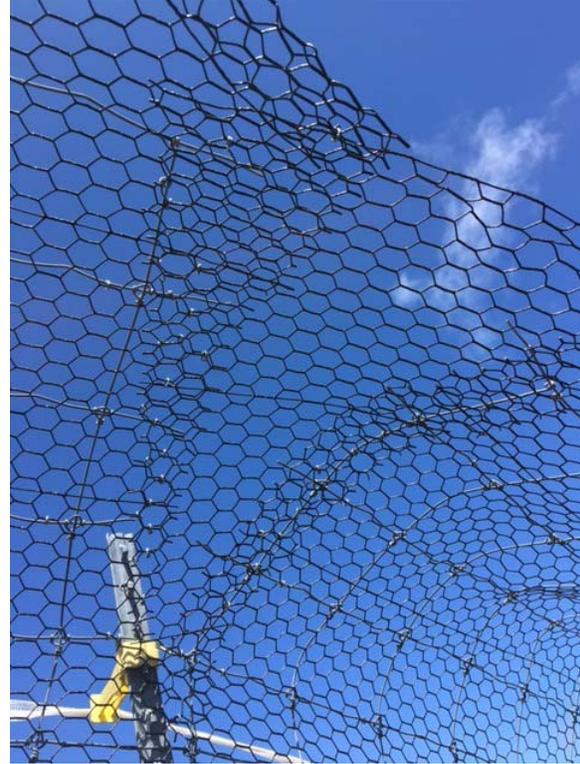
Figure 23 Splicing in mesh as needed

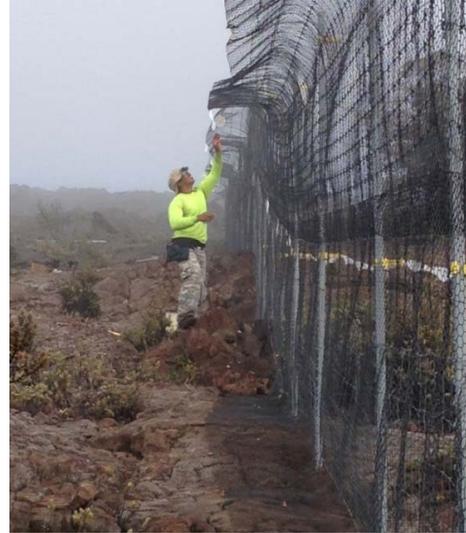
Figure 25 Attaching the deterrents

In addition to the double strands of white linear tape, we attached various commercial bird deterrents to the hoop at roughly 15 meter intervals. Products included the Firefly II, Bird Mark and Fence Flags and included a combination of white, reflective and glow-in-the-dark materials (Figure 24). All devices were installed to allow for flapping movements, as well to increase visibility. Initial methods were modified due to challenges in attachment. The Firefly II came with a stainless steel S-hook that was looped through the mesh and clamped shut with pliers. The S-hook was particularly thick, however, and crimping it tightly was difficult, therefore within the first few years we found several Firefly II deterrents on the ground, likely due to the mesh sliding through the gap in the S-hook. The Bird Mark was attached using a stainless steel O-ring; however, the long overlap was cumbersome and in some cases, the mesh may have been lodged in the overlap of the ring, rather than fed all the way through, resulting in a portion of Bird Marks falling to the ground within the first three years. Currently we are reattaching devices using heavy duty, UV resistant cable ties applied through the mesh to the hog wire to avoid excessive rubbing on the PVC coating of the mesh (Figure 25). Bird strike surveys are conducted along key sections of fence on all monitoring trips and around the entire fence on annual inspections. No bird strike has been detected.

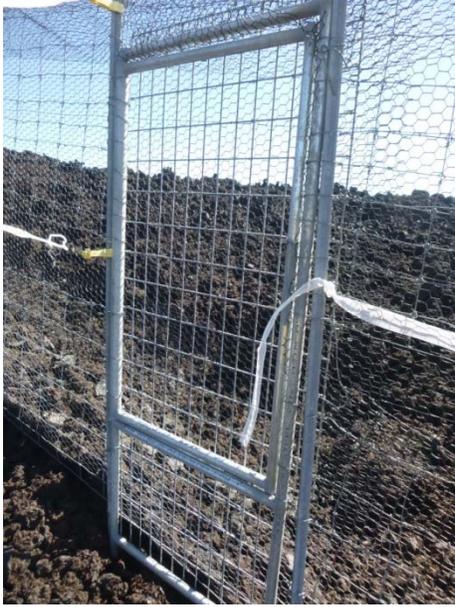
Figure 26 Attaching the gate frame to the T posts

Eight gates were installed at intervals around the perimeter, to allow staff to pass in and out of the fence freely for fence inspections, maintenance and other purposes. Gate locations were determined ahead of construction. During post installation, a set of T posts was placed four feet apart at each of the eight locations to support the gate frames. The hog wire was wrapped onto each of these posts, leaving a gap in the middle. The PVC mesh was attached right across the opening so that the floppy arc and skirt were contiguous. The gates and frames were constructed with galvanized pipe and covered with 2" x 4" hog panels and PVC hex mesh. The frames were installed from behind the existing mesh and secured to the T posts (Figure 26). The gates are two feet wide by four feet high and sit flush within the frames (Figure 27). The bottom of the gates sits 20" above the ground and the top is roughly 6" below the height of the fence so that the upper and lower portions of PVC hex mesh (including the skirt and floppy arc) are contiguous.

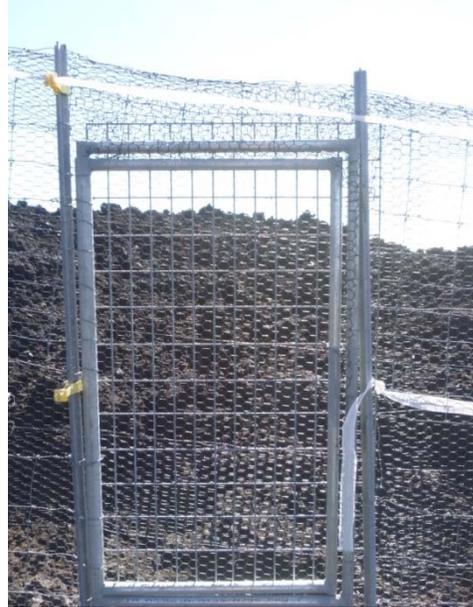
Figure 27 Alternate view of the gate

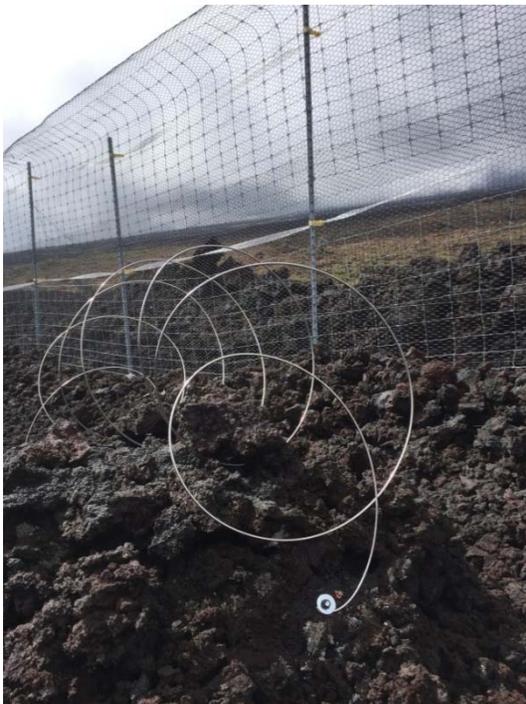
Figure 28 Smooth wire coiled on high spot

While careful routing was implemented at the beginning of the project, not all high spots could be avoided outside of the fence. Upon completion, survey was conducted around the outside of the fence to identify high spots within 8 feet of the perimeter. Once identified, these high spots were either (1) removed by pounding/pulverizing or (2) covered in coiled smooth wire to prevent a cat from using the higher area to launch onto the top of the arc (Figure 28).

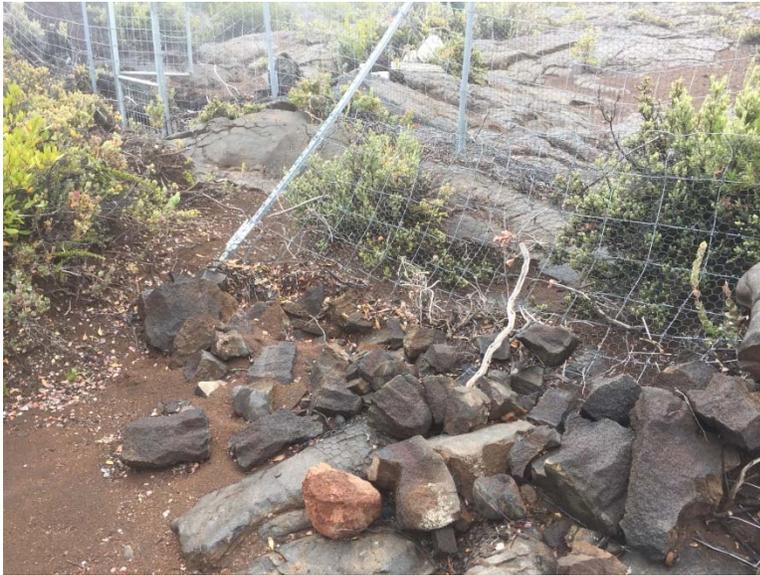
Figure 29 Debris in trap in a wash out area

Key portions of the fence were checked for bird strikes multiple times per season during monitoring and predator control trips; no strikes or evidence thereof were observed. Complete fence inspections were conducted annually; thus far the only required maintenance has been to replace fallen bird deterrent devices and reconnect occasional broken strands of white marking tape. Due to the potential for high amounts of water running through the lower corner of the fence during extreme rain events, this site was checked as needed following major storms. A debris trap that was installed to stop rocks and other items from washing down and piling up against the fence has successfully protected the fence and skirting below from impacts during heavy rain events (Figure 29). The fence remains in good condition at this time (2.5 years after completion, 5.5 years after the start of construction). Routine fence inspection and repair trips will continue annually, at a minimum, and more frequently if potentially damaging situations arise.

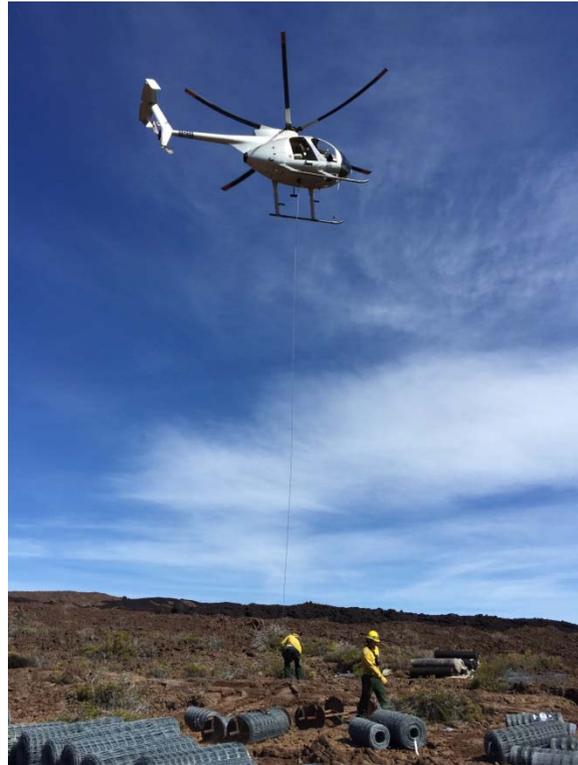
Figure 31 Sling loading fence materials to the site

All personnel, camp gear, materials and field equipment were flown to and from the work site by helicopter. Helicopter operations were conducted at the beginning of each work period to bring in materials and supplies needed for the current phase of construction (Figure 30); additional flights occurred throughout the work period to shuttle work crews and gear in and out and to haul in additional material as needed. Fence materials were delivered via sling load to marked points along the route (Figure 31).

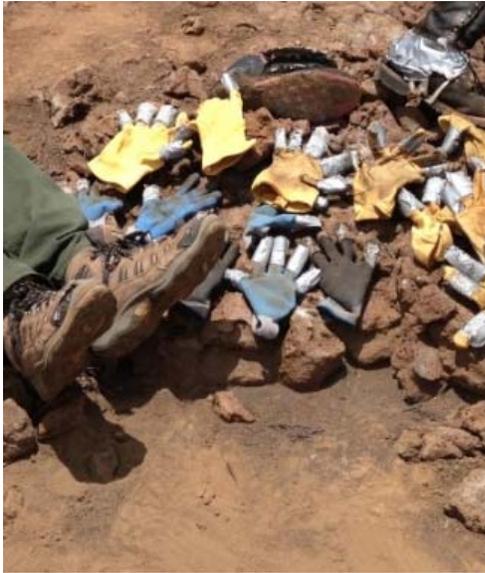
Figure 32 Damaged boots and gloves

It was critical to ensure that crew members had the appropriate equipment and PPE available. Some items, such as gloves and boots, were destroyed quickly in the harsh environment (Figure 32); extra supplies needed to be stored at camp. Very few trees exist in the project area; crew carried umbrellas for shade and took breaks as needed during the heat of the day (Figure 33). Due to the extreme physical challenges of working in this environment, camp trips were scheduled to allow at least one week of alternate work in between trips when possible. These and other safety measures contributed to overall project success.

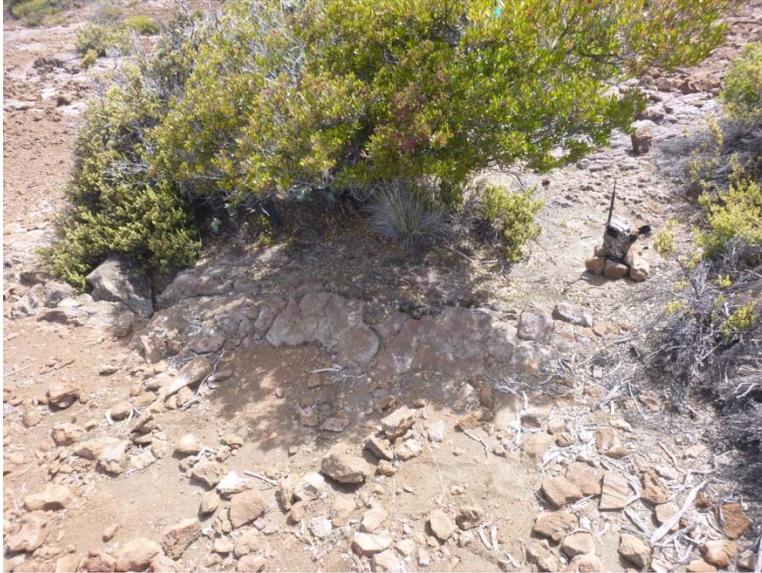
Figure 35 Camera aimed at a nest entrance

Remote cameras (Bushnell Trophy-cams, various models) were used to improve nesting data within the fenced area. Videos provided detailed information on timing of adult visits, emergence of chicks and suggested which nests were either early failures or non-breeders (based on timing of adult activity). Monitoring conducted and refined during the project, both on the ground and using remote cameras, will serve as a baseline to assess the future response of this colony.

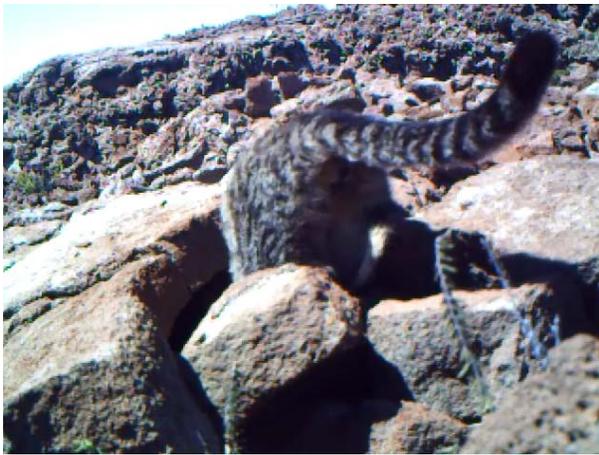
Figure 37 Cat captured on remote camera entering nest

Monitoring occurred two to three times post survey and involved searching for signs of activity that indicated entry or disturbance. Indirect sign of petrel activity included footprints, feathers, smell, natal down and droppings. Direct signs of disturbance included adult or chick carcasses, eggs, or associated scents. Due to the inaccessibility of most chambers, direct sightings of eggs or live birds were extremely rare and therefore not typically available to indicate nesting activity. In addition to assessing on-the-ground cues, game cameras were used at a subset of nests for all or a portion of each nesting season. Cameras were directed at nest site entrances (Figure 37) to monitor adult and chick activity (Figure 38) and the presence of predators at nest sites.
