HAWAII DEEP WATER CABLE PROGRAM

PHASE II-D

ABRASION-CORROSION STUDIES

AUGUST 1988

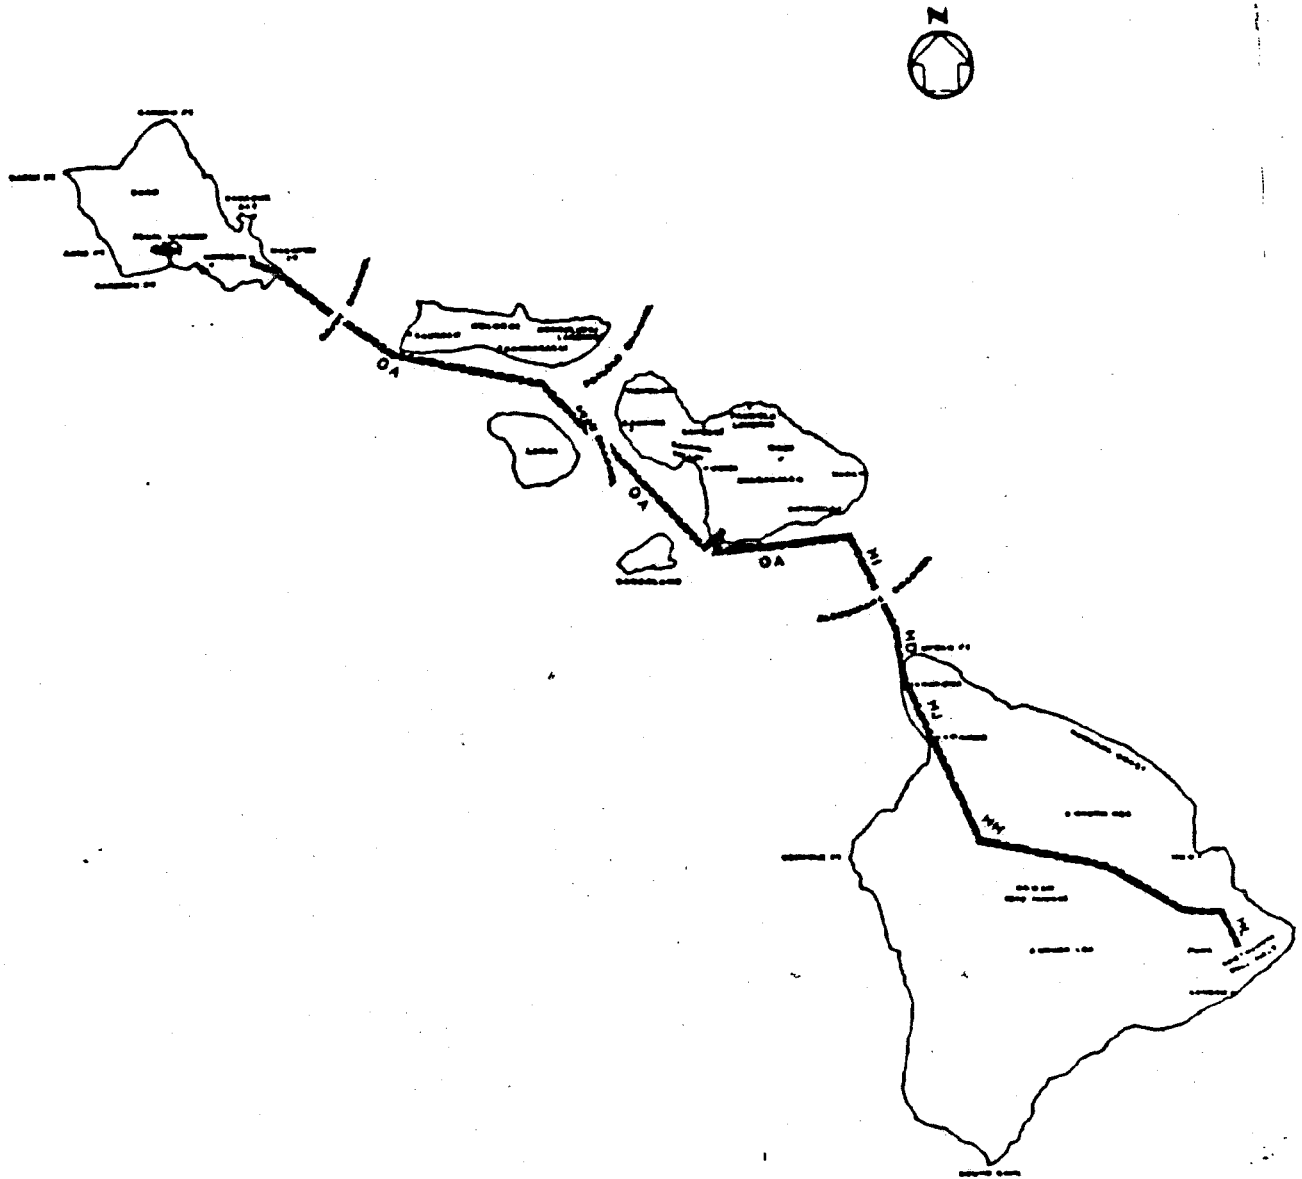
Fig. 1 One of the possible cable routes (1).

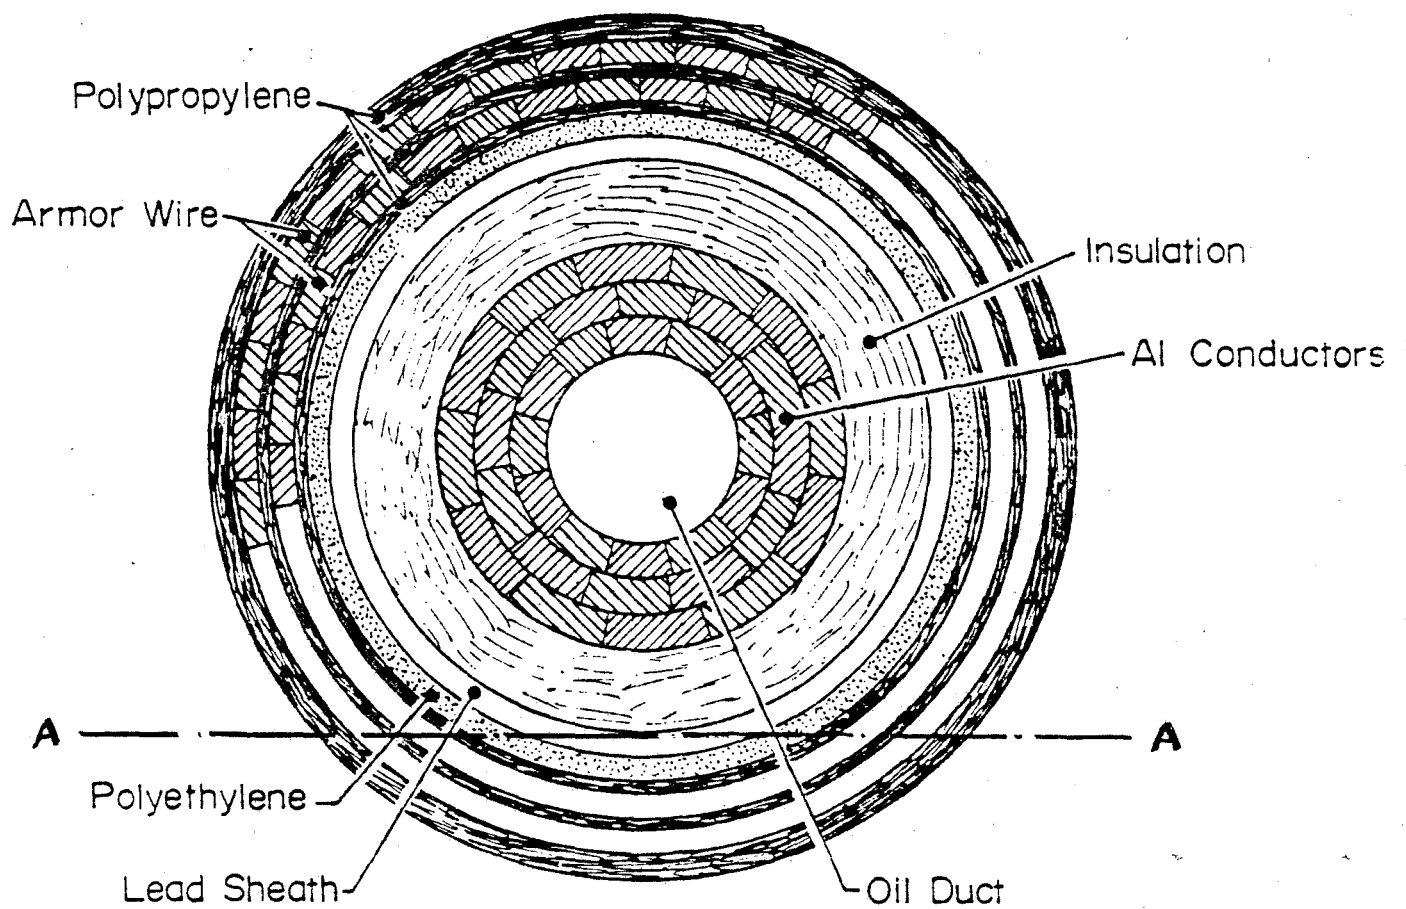
Fig. 2 Cross section of the final cable design. Only the major components are indicated.

The selected final design is shown in Fig. 2. The materials selection was based on many factors but a major one was the strength to weight ratio, in order to make cable laying feasible at the depths encountered.

- 1) due to water infiltration when the damage penetrates the lead sheath, indicated by line A-A in Fig. 2, or
- 2) due to mechanical overload (fracture) after significant corrosion and abrasion has taken place, possibly with stresses accentuated while a deep water section of the cable is being retrieved for repair of other damage.

It would appear that condition (1) above is the more commonly expected of the two. It will be used as the tentative failure criterion in this study. For illustration the level of requisite damage is indicated by the line in Fig. 2.

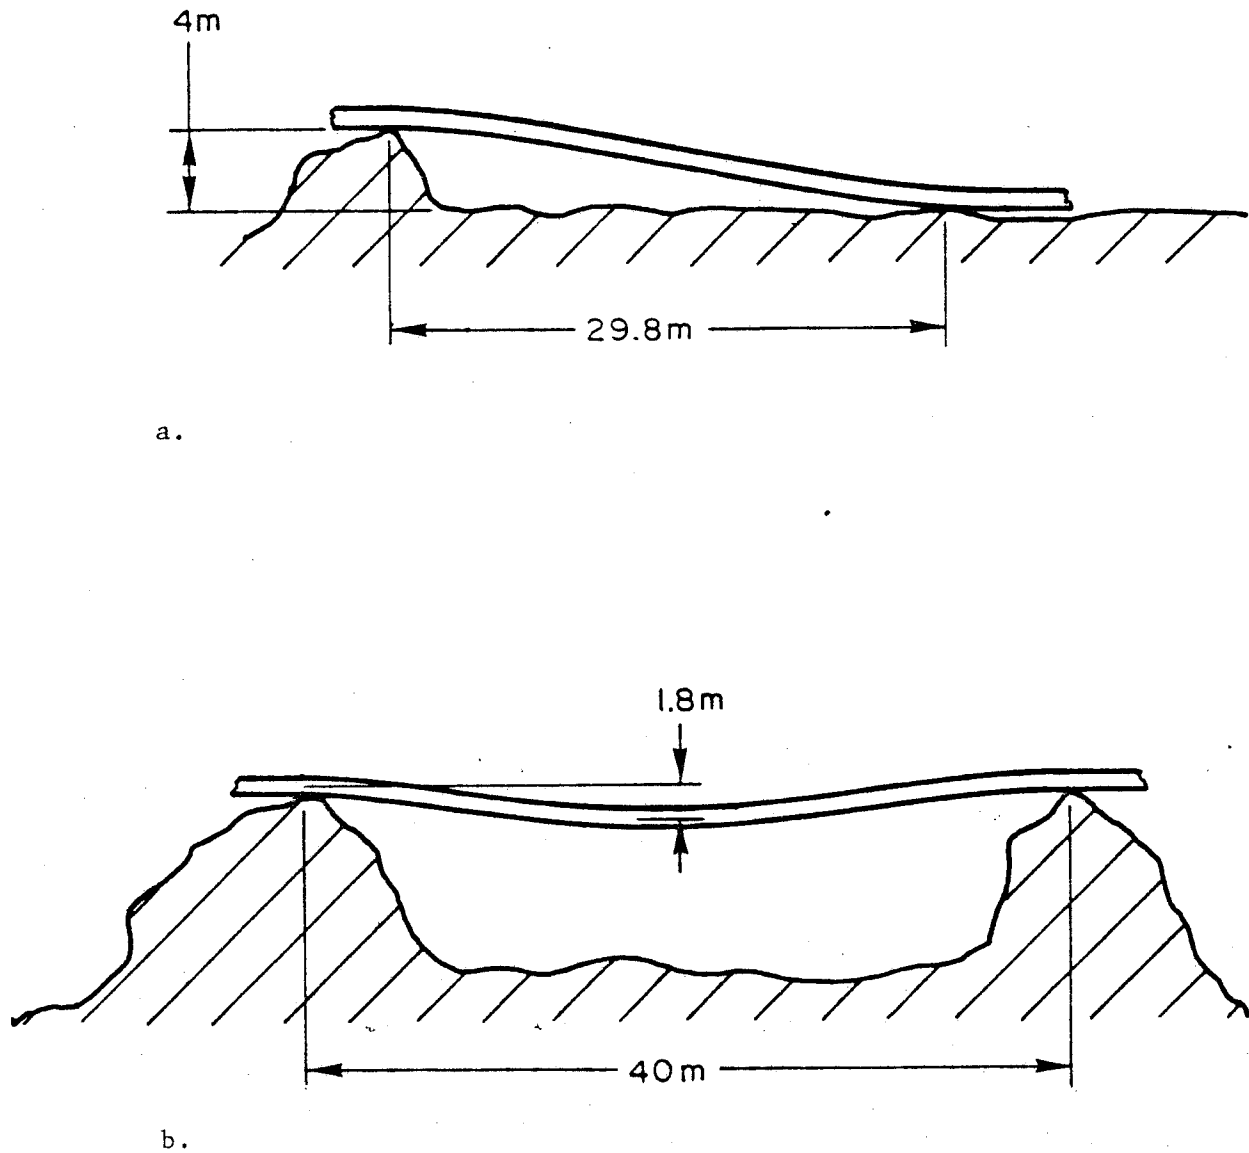
Fig. 4 Sketch of upper-limit conditions for which abrasion becomes a potential failure mechanism. a) The cable will fail due to tension fracture of the sheath if it is deployed over an outcrop which is $> 4\text{m}$ above surroundings⁽³⁾. The corresponding minimum span length is 29.8 m . b) The cable will fail in 30 years or less by fatigue of the sheath due to tidal current forces if the free span length is $> 40\text{ m}$ ⁽³⁾.

outcrop which is more than 4 m high (Fig. 4a). And it will fail in fatigue due to tidal forces in 30 years or less if the span length exceeds 40 m (Fig. 4b). We have used these conditions as the upper limits for the case of failure due to abrasion.

For the calculations the same values as in (3) were used for bottom tension (3000 kg) and flexural modulus ($500 \text{ kg} \cdot \text{m}^2$, measured for the Vancouver and Messina cables). The vertical force on a span is 27 kg/m (the cable's weight in water) and the horizontal force is due to drag from the tidal currents. Using again the values from (3) this force varies from zero to an average maximum of 7 kg/m. Force balance between these two forces means that the cable can swing an angle of $\tan^{-1} (7/27) = 14.5^\circ$. For the condition shown in Fig. 4b the maximum excursion is at the midpoint and it amounts to 0.47m.

At the support points for the span in Fig. 4b the vertical force is $20 \times 27 \text{ kg} = 540 \text{ kg}$. The average max. horizontal force is $20 \times 7 = 140 \text{ kg}$. Thus, for a coefficient of friction between cable and rock of less than $140/540 = 0.26$, the cable will slide at the supports. This value is quite low for abrasive situations, where values of 0.6 - 0.8 are common. Thus, unless

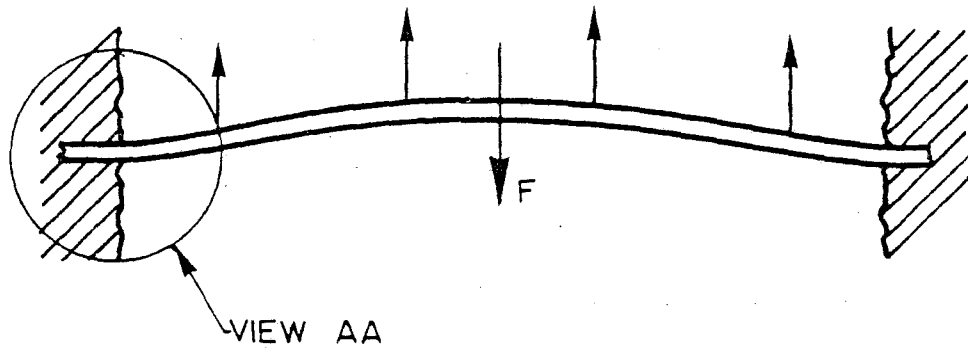
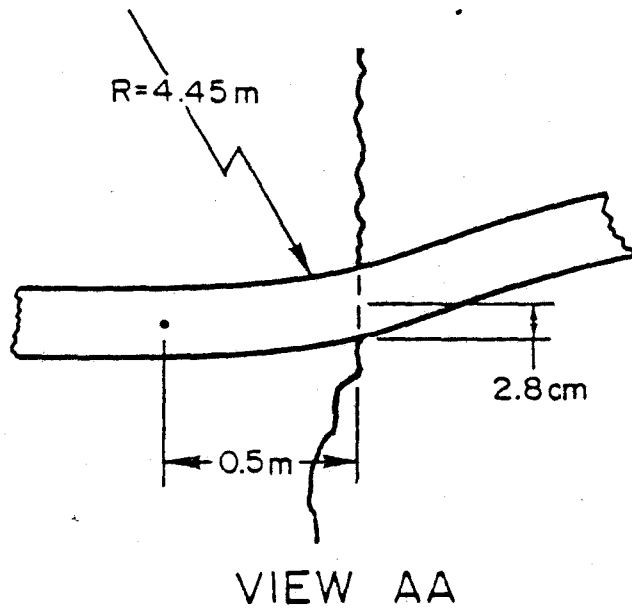
Fig. 5 Top view of catenary exposed to tidal current drag; excursion at mid-point, balance between tidal current drag and possible friction against rock; possible excursion at support point.

Some minor sliding could be expected at these points, however. This could occur if there is contact for some distance from the major support point, see Fig. 5b. In the horizontal plane the radius of curvature at the support joint is about 4.45 m for a drag of 7 kg/m. If the contact zone is, say, 0.5 m long, the excursion at the end of that zone is then 2.8 cm.

If abrasion takes place at a mid point of a span, then the excursion at that point depends on the contact load and the coefficient of friction, see Fig. 5a. The friction force at midpoint will counteract movement of the cable in the horizontal plane due to tidal drag. To obtain a rough estimate of the excursion as a function of the friction force the latter has been distributed on the middle 30 m of the 40 m catenary. The drag then is $(7 - F/30)$ kg/m, where F is the friction force. The excursion at mid point then becomes

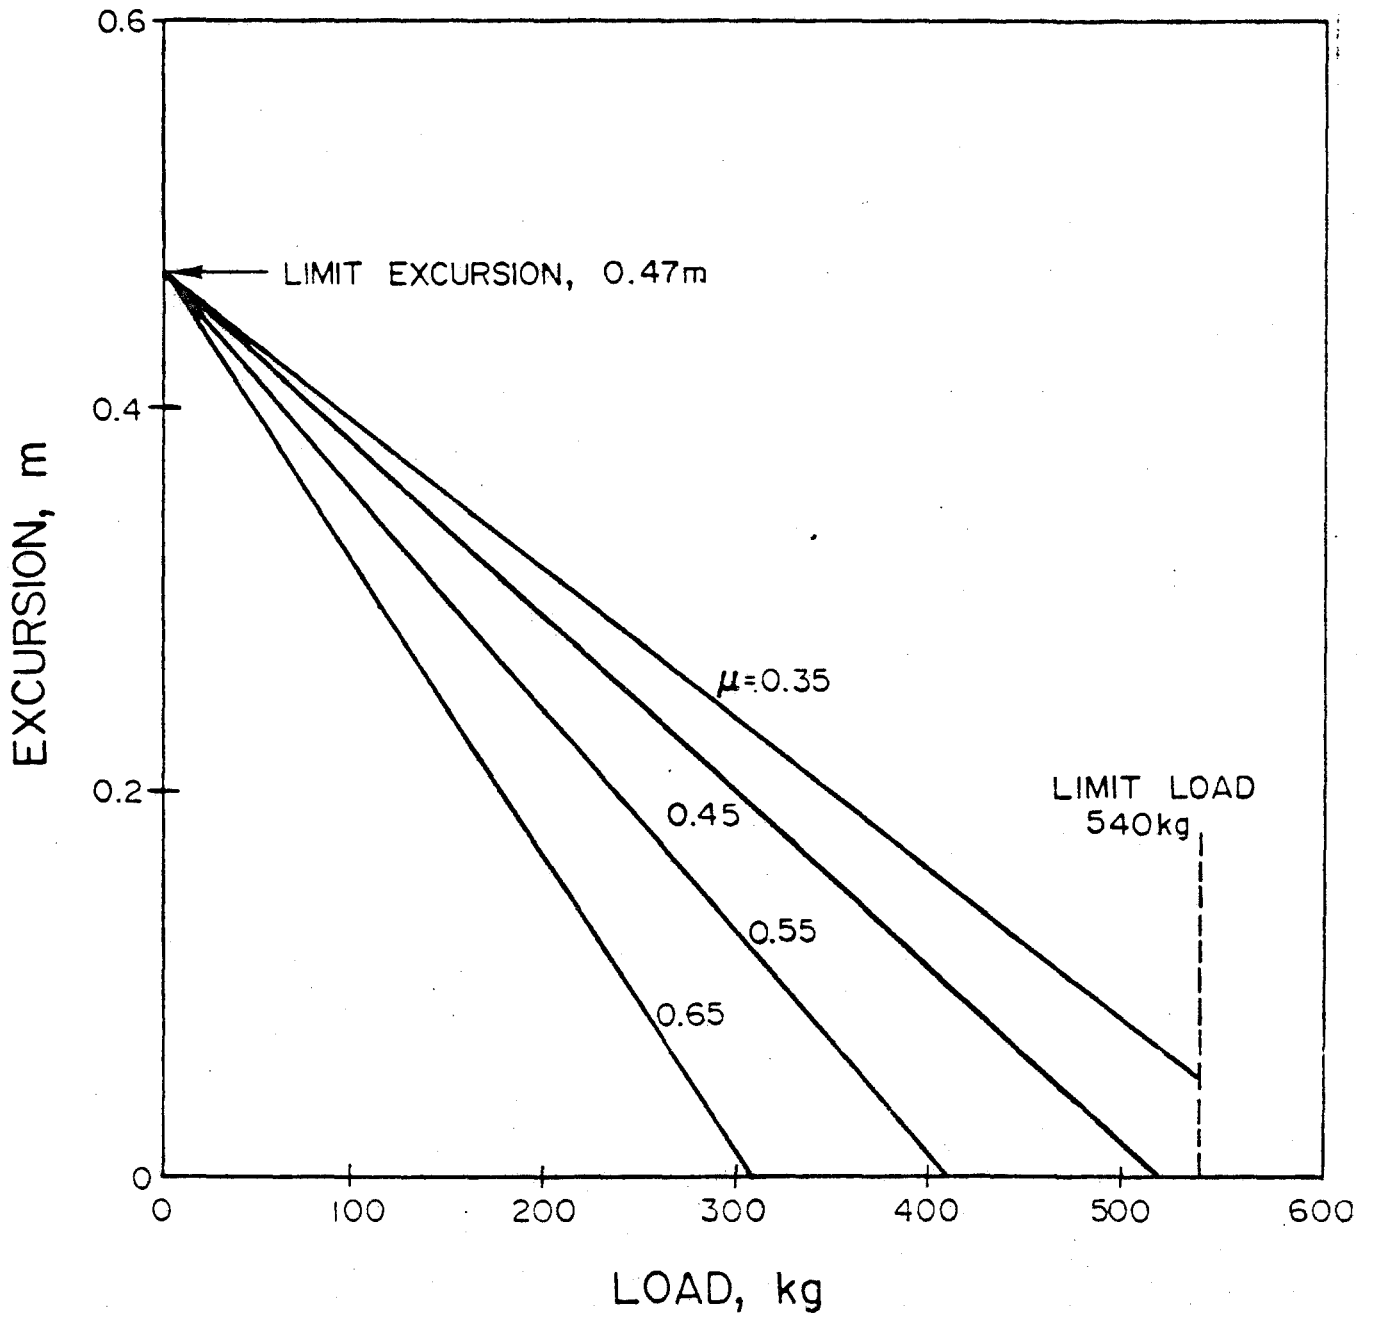
Fig. 6 Estimated mid-point excursions for various levels of contact load and friction coefficient.

It is realized that this approach is only a rough estimate. It should be sufficient to evaluate the possible abrasive conditions in a worst-case scenario. The calculated excursion-load relations for selected values of μ

are shown in Fig. 6. Quite similar results, but slightly lower, are expected for the case shown in Fig. 4a, where the free span equivalent is about 30 m in length.

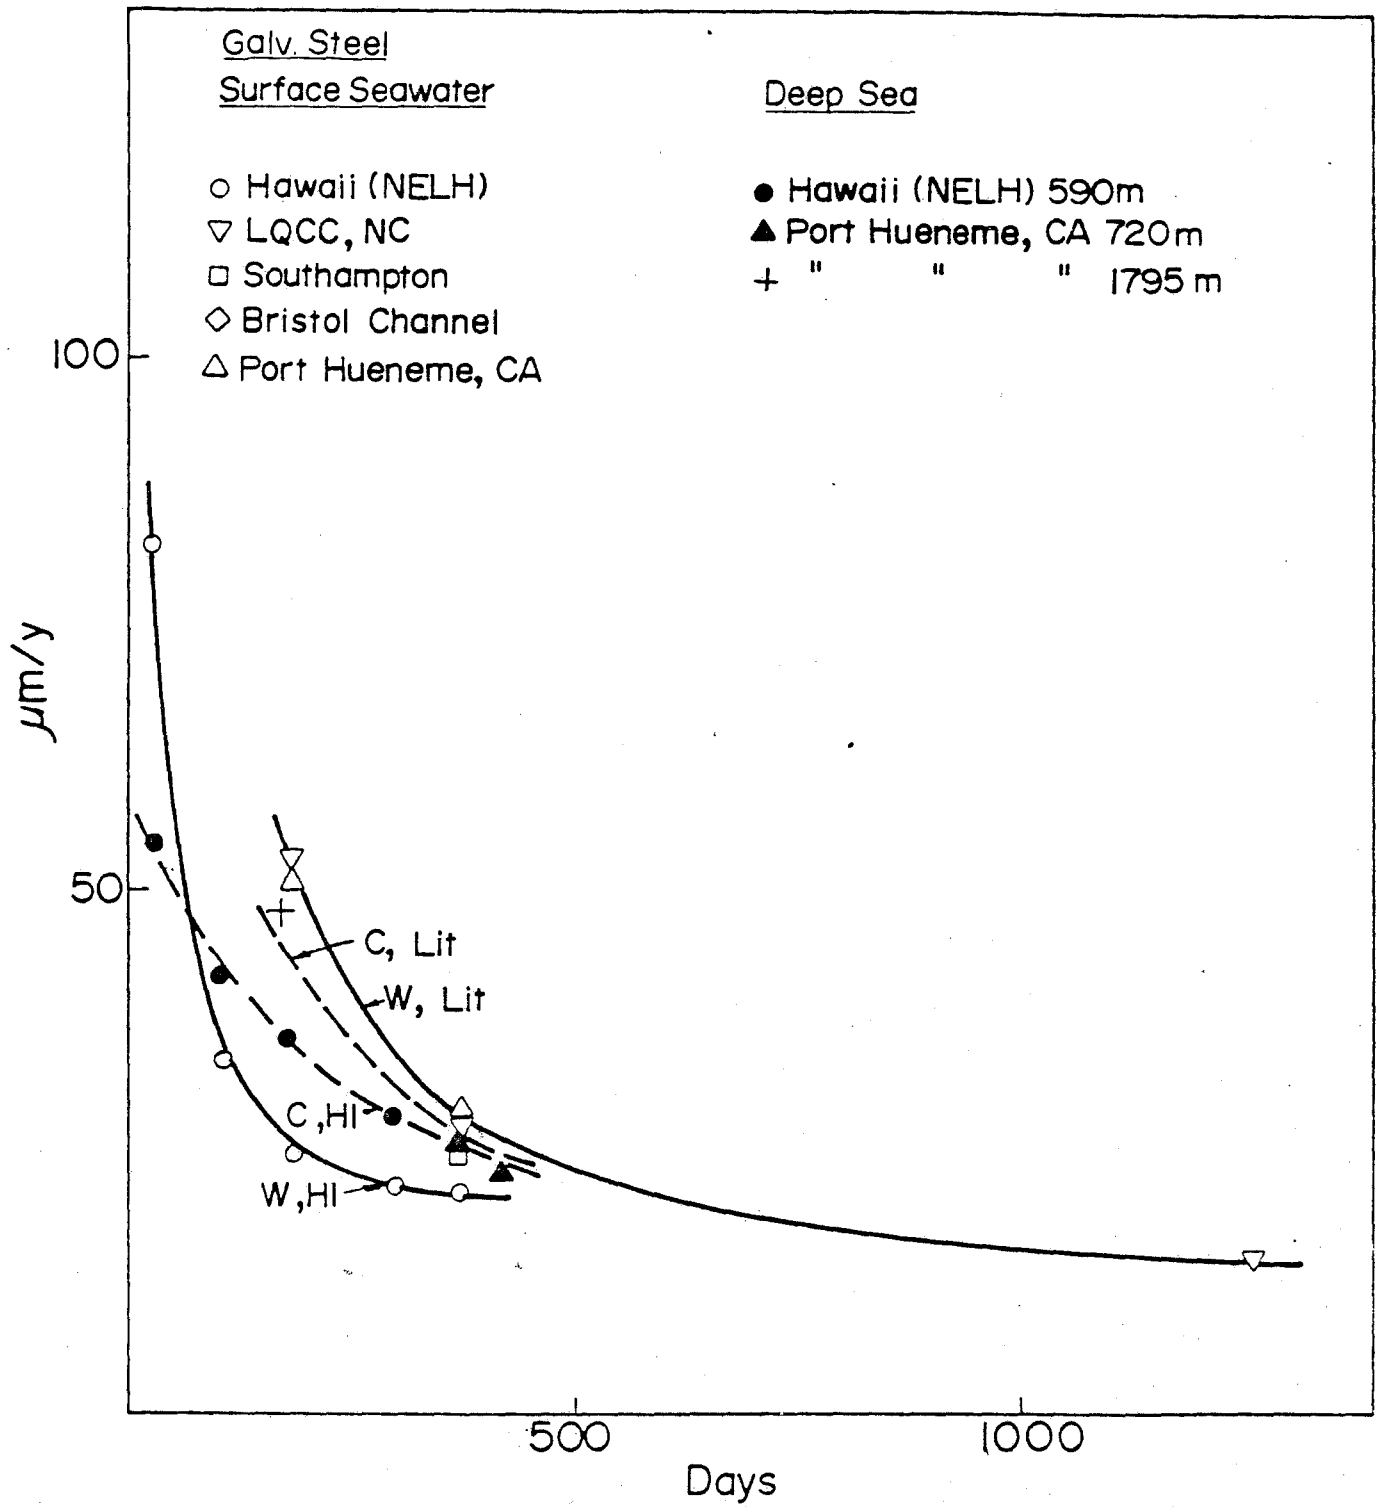
Fig. 7 Comparison of linear corrosion rate data from NELH with literature data.

Comparison with literature data is shown in Fig. 7. The limited deep ocean data indicate that a long term rate of around 20 $\mu\text{m}/\text{y}$ (micrometers per year) is established after two years. The surface water data from Hawaii showed lower rates in the beginning than did other waters around the world, possibly because of the high pH. After about two years, however, a universal rate of about 15-20 μm seems to become established.

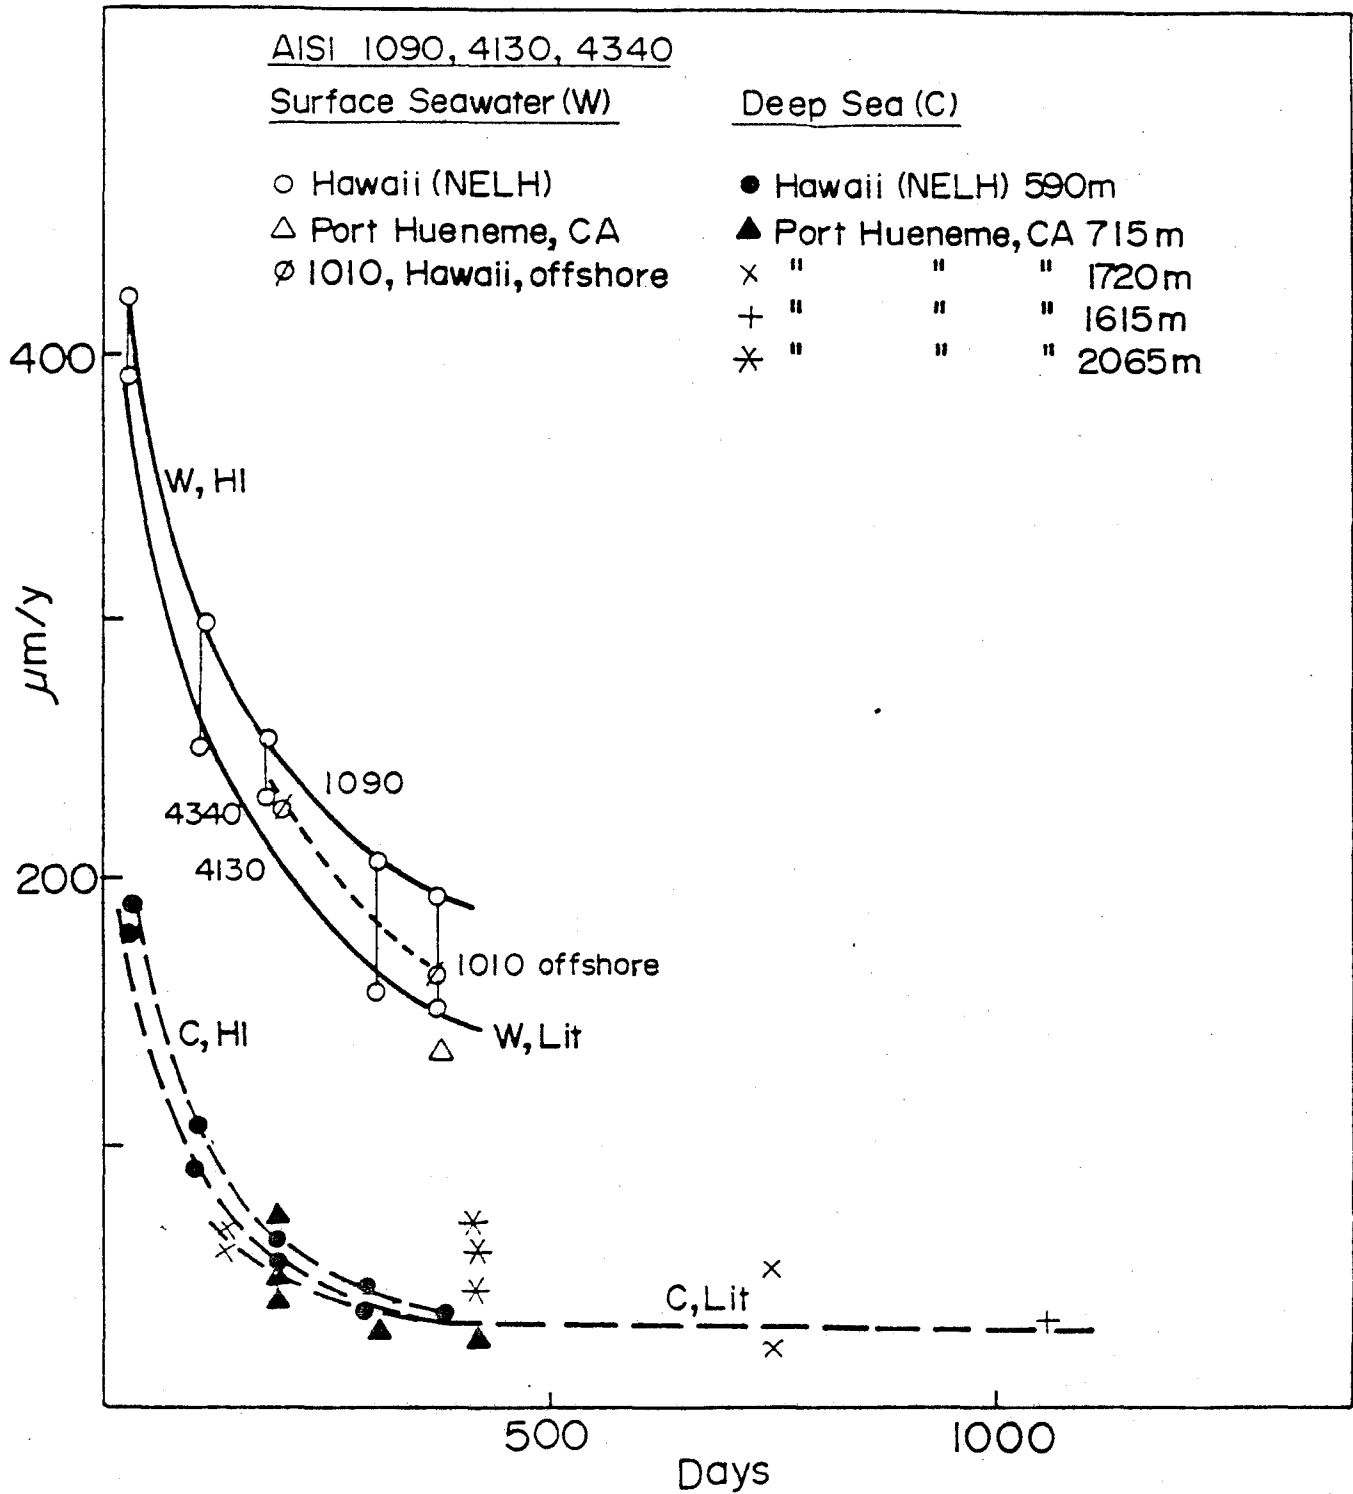
Fig. 8 Comparison of linear corrosion rate data from NELH for steels AISI 1090, 4130 and 4340 with data from Port Hueneme.

in the cold. Comparison with literature data is shown in Fig. 8. This graph also includes data for low alloy steels AISI 4130 and 4340 from the troughs at NELH, as well as data for AISI 1010 tested offshore at NELH in a round-robin ASTM test series. The cold water data coincide with the Port Hueneme deep ocean test results and show that a long-range corrosion rate of 20-40 $\mu\text{m}/\text{y}$ becomes established after about one year.

For the warm water the data do not allow confident estimation of long-term rates. It would appear that a rate of around 130 $\mu\text{m}/\text{y}$ is established after 3 years. Comparison with results for low carbon steels suggests that the rate may drop to about 50-75 $\mu\text{m}/\text{y}$ after 4-5 years.

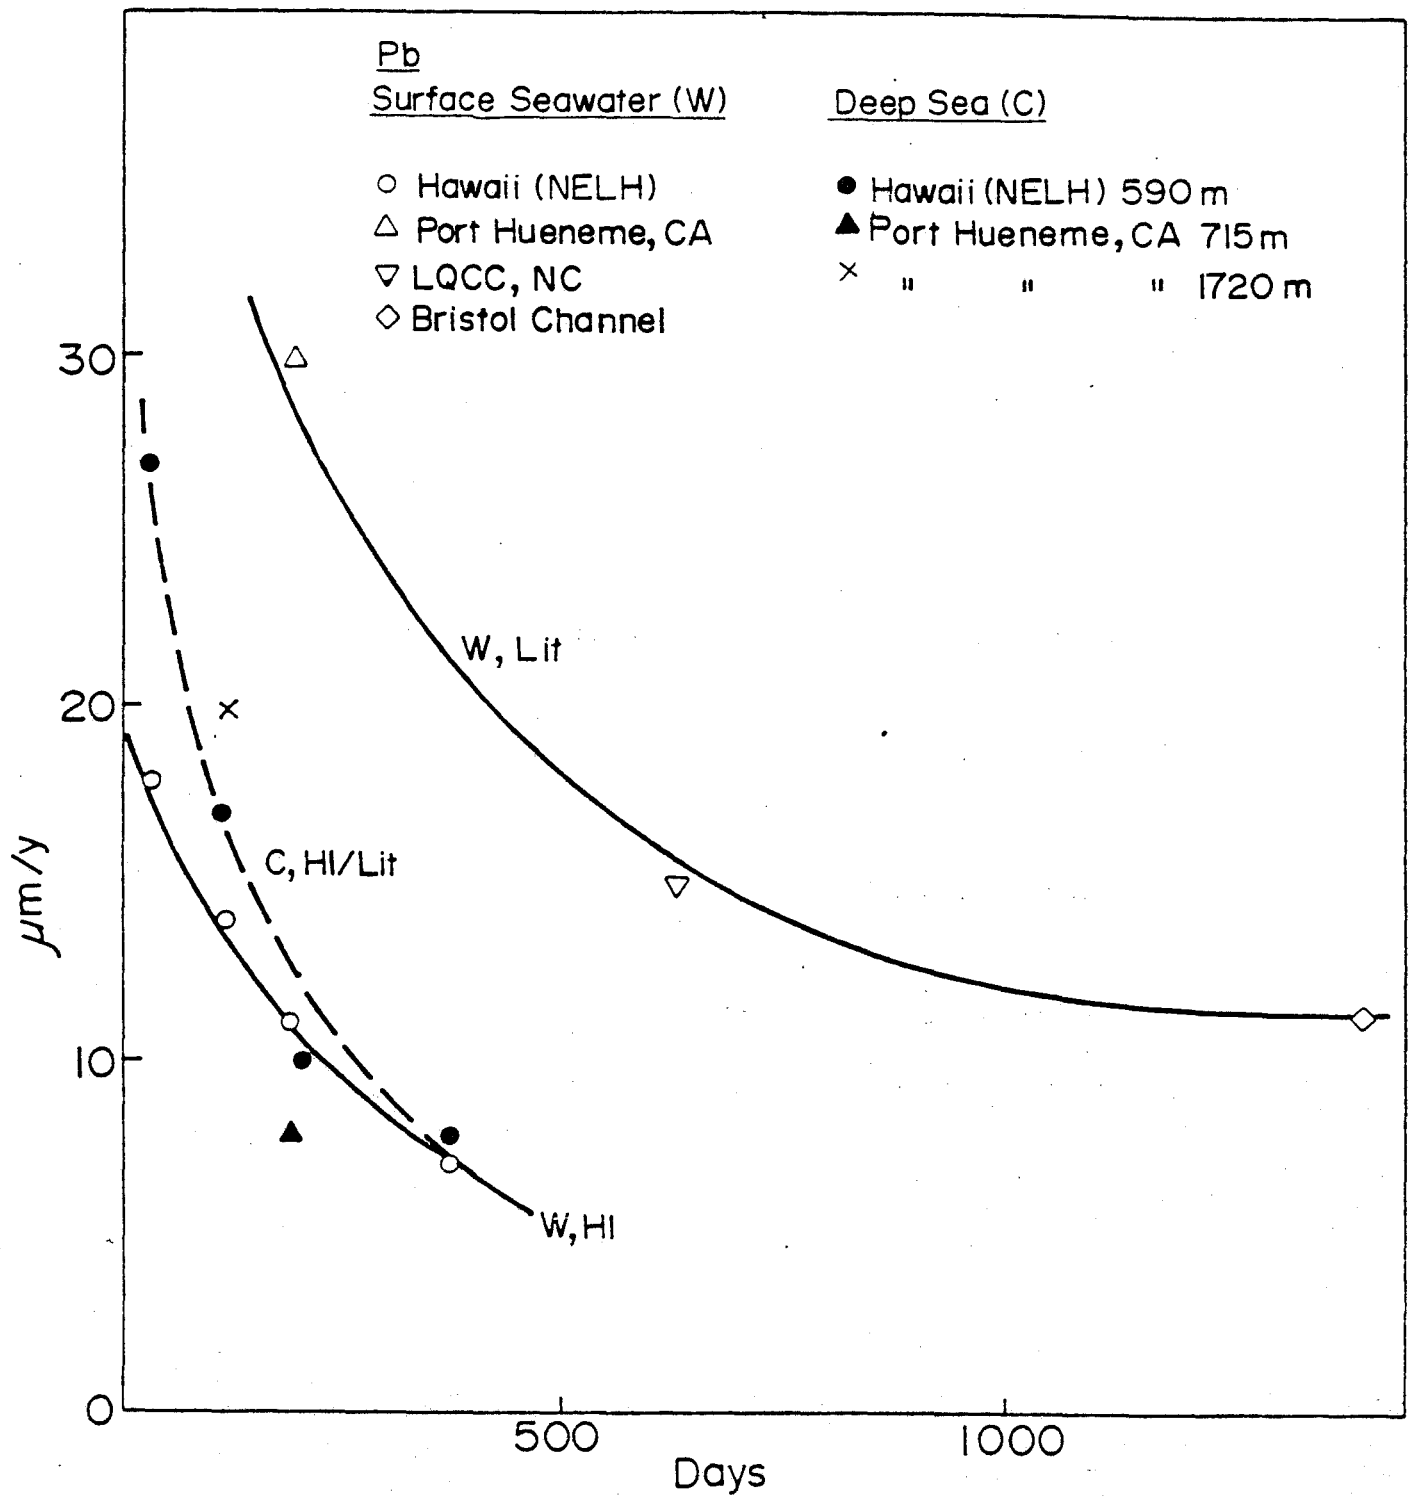
Fig. 9 Comparison of linear corrosion rate data from NELH for lead with literature data.

A comparison with literature data is shown in Fig. 9. The cold water data from Hawaii essentially coincide with the deep sea results from Port Hueneme, while the Hawaiian surface water rates are considerably lower than rates reported from other sites. It appears that a long-term rate of 2-4 $\mu\text{m}/\text{y}$ is established in both Hawaiian waters after about 3 years. The same rate is obtained for the Port Hueneme deepsea exposures, while surface seawaters around the world establish a rate of 10-13 $\mu\text{m}/\text{y}$ after 4 years. It has been suggested⁽⁸⁾ that the low rate found in Hawaiian surface seawater is primarily due to its greater pH (lead corrosion is accelerated at lower pH-values) and possibly also due to the low water flow rates used in the tests.

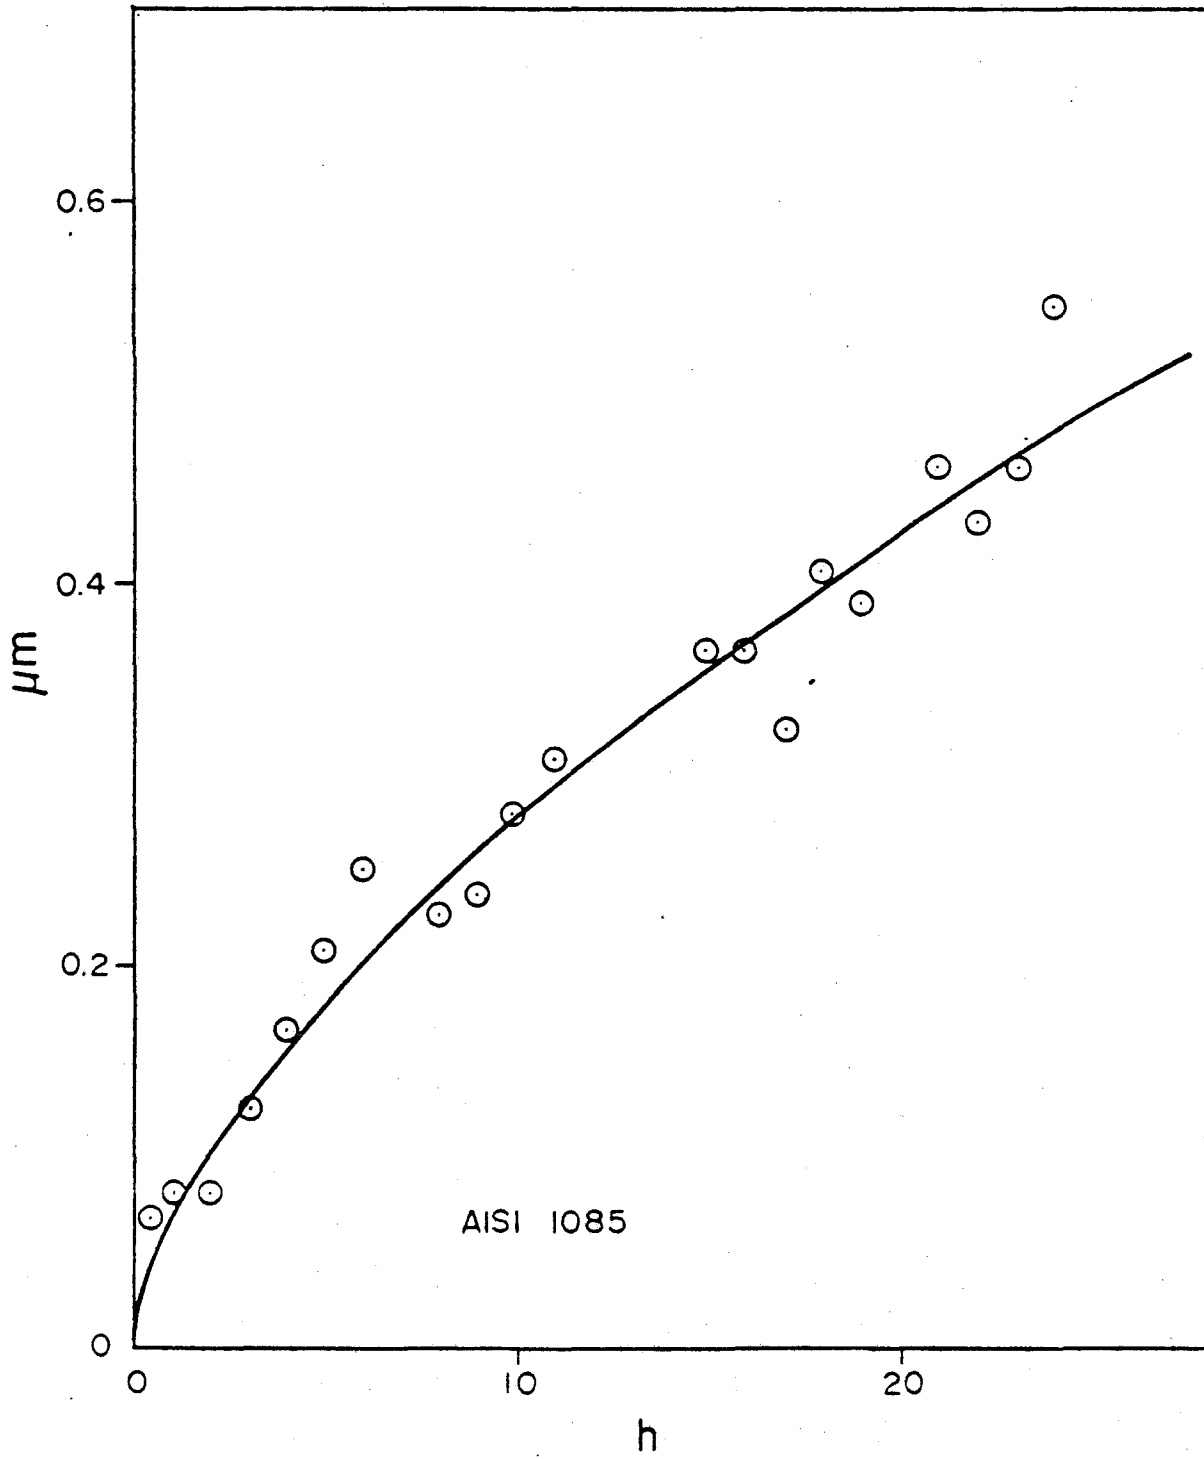
Fig. 10 Corrosion loss for armor wire exposed in stagnant seawater for short periods of time.

Tests in the Laboratory: Twenty samples of armor wire, 34 mm long, were stripped of coating by immersion in HCl and subsequently exposed in stagnant seawater at room temperature. Weight loss was determined for exposure period of 0.5 to 24 h. The calculated average thickness loss is plotted in Fig. 10. The 24 h value corresponds to an annual rate of 175 $\mu\text{m}/\text{y}$, which, in view of other data, seems reasonable for the early stage of attack. The one-hour corrosion is about 0.07 μm , which corresponds to an annual rate of 613 $\mu\text{m}/\text{y}$. The actual one-hour corrosion determined here is substantially lower than the value obtained from back extrapolation of equation (6) which was derived from longer-term tests of AISI 1090. That value is 0.40 μm (vs. 0.07 μm). The difference is probably primarily due to uncertainties in the extrapolation from 1-10 month data to a 1 hour exposure time and only secondarily due to the small differences in exposure conditions.

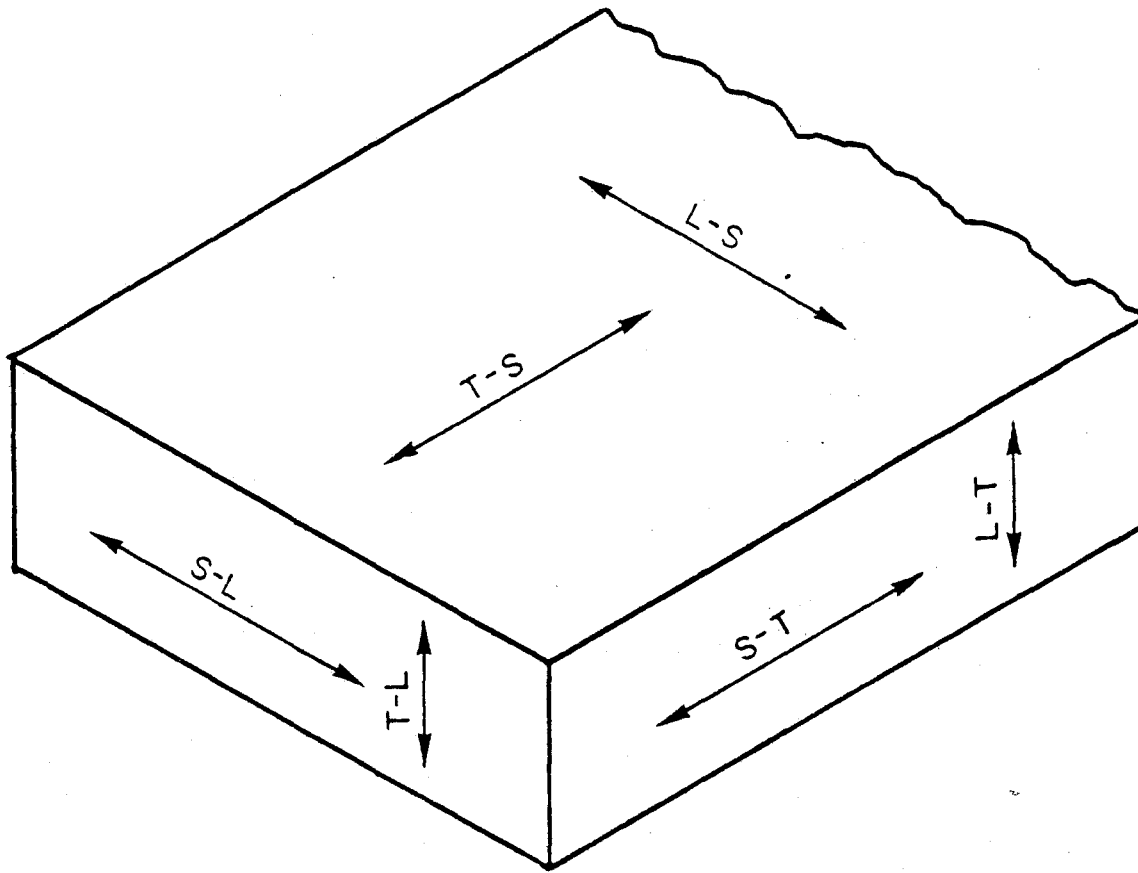
Fig. 11 Notations used to indicate sliding direction.

In order to determine the possible effects of wire orientation on abrasive wear rates scoping tests were carried out using 120 grit silicon carbide abrasive paper, which has a mean grit size of 120 micrometers. Since the armor wire has rectangular cross section and is heavily cold drawn the mechanical properties may vary with direction. There are six possible orientations of interest, as shown in Figure 11. The ASTM notation system for fracture mechanics has been adapted for use here. The arrows indicate direction of sliding, i.e., direction of the abrasion grooves.

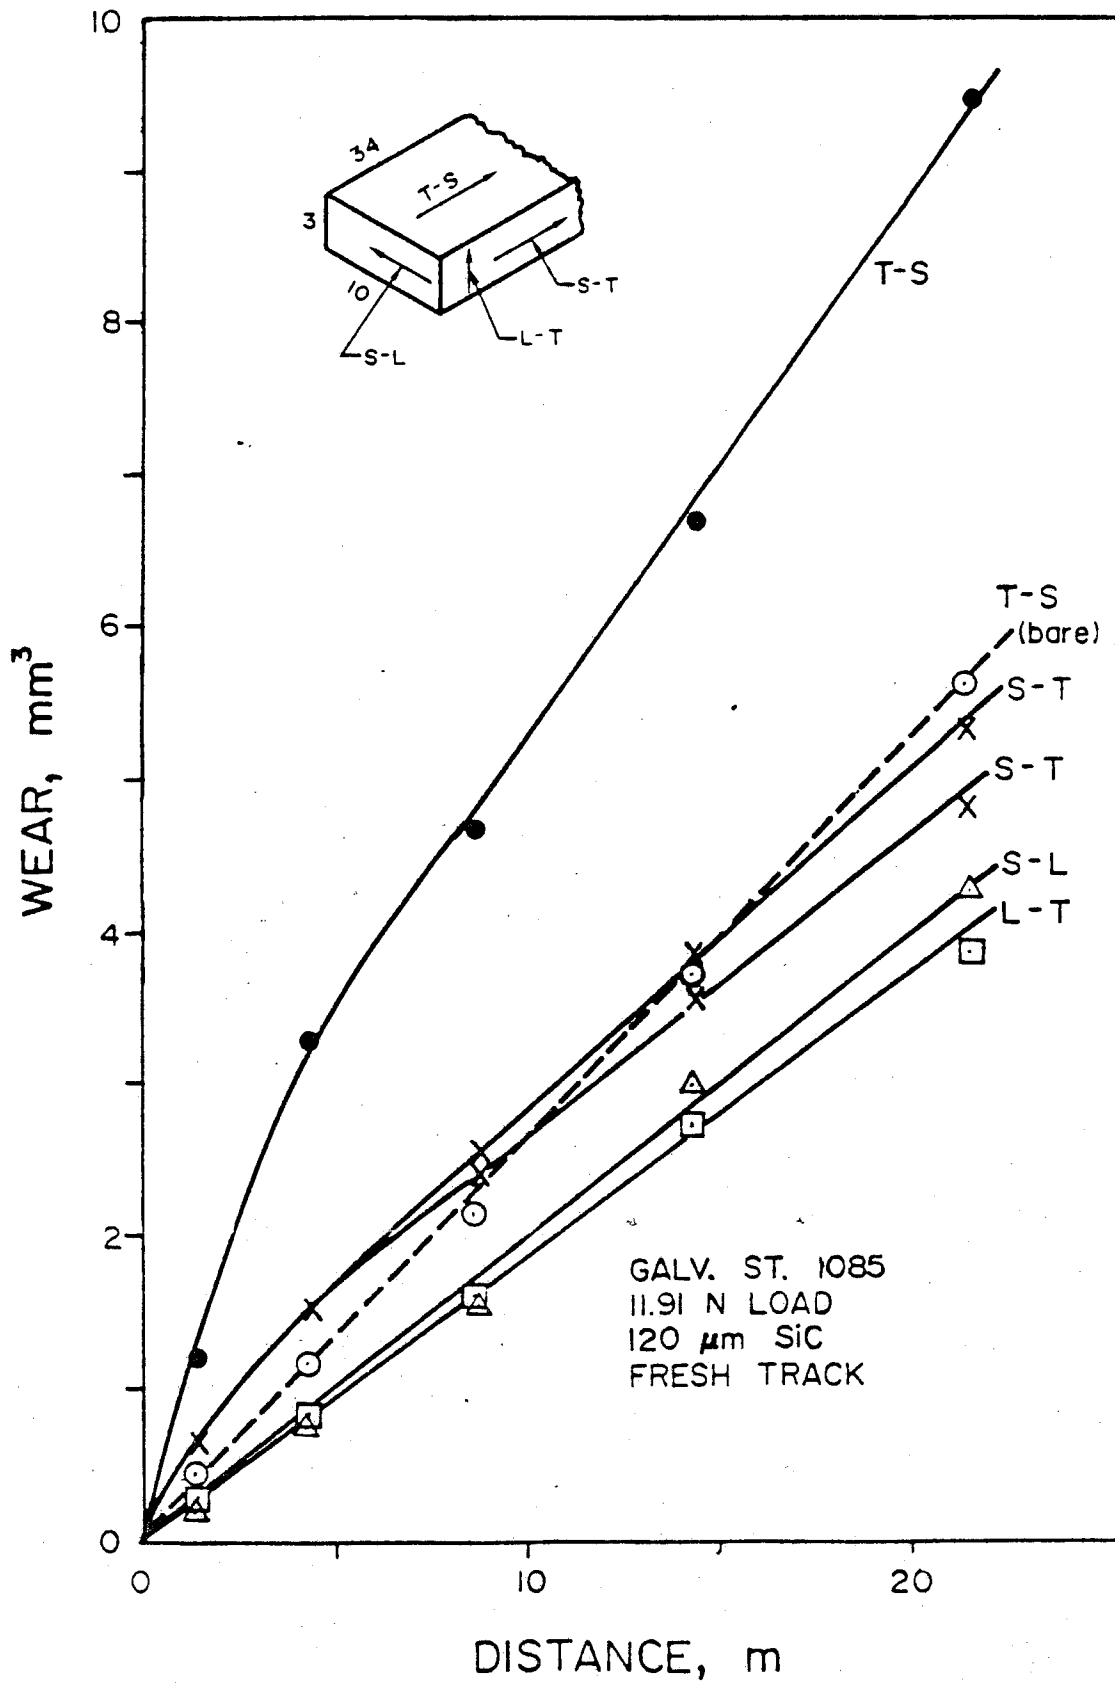
Fig. 12 Wear-distance curves for tests on fresh tracks of SiC paper for various sliding directions.

Tests with Fresh Tracks: These tests were conducted with galvanized samples, except for one test with a bare sample (zinc removed). The results are plotted in Figure 12.

The coefficient of friction stayed essentially constant for each test and only the average values have been plotted. These range between 0.59 and 0.72, showing no clear correlation with specimen direction being abraded. An overall value of 0.66 appears to be reasonable, and is consistent with common literature values.

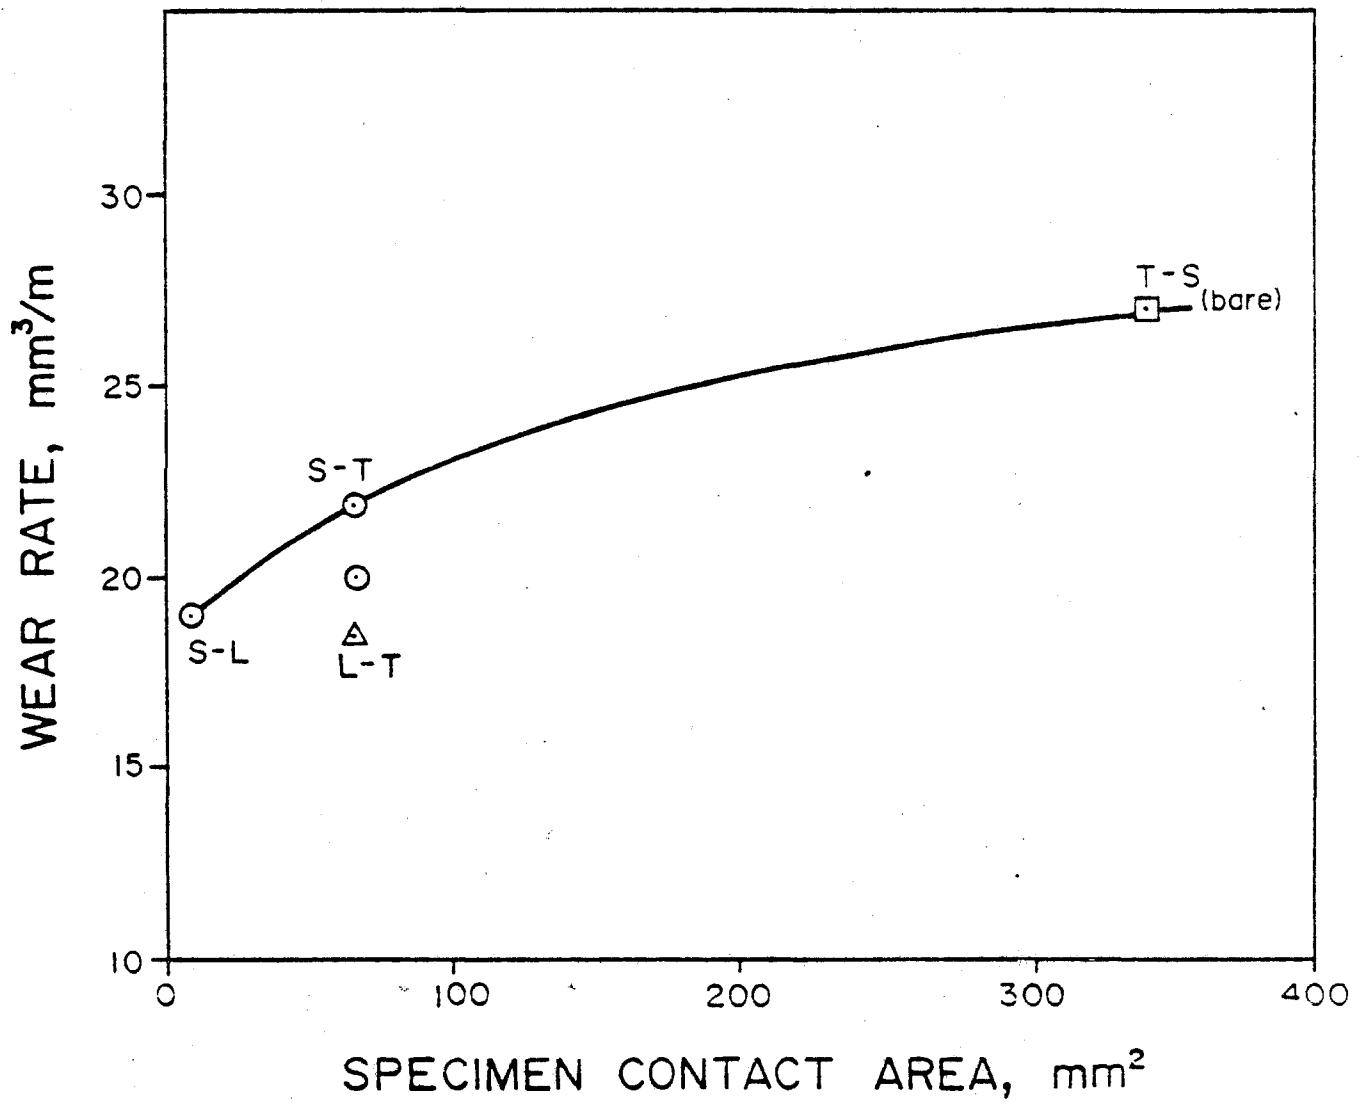
Fig. 14 Wear rate vs. contact area for abrasion by SiC paper.
