HAWAII DEEP WATER CABLE PROGRAM

PHASE II-D

ABRASION-CORROSION STUDIES

AUGUST 1988

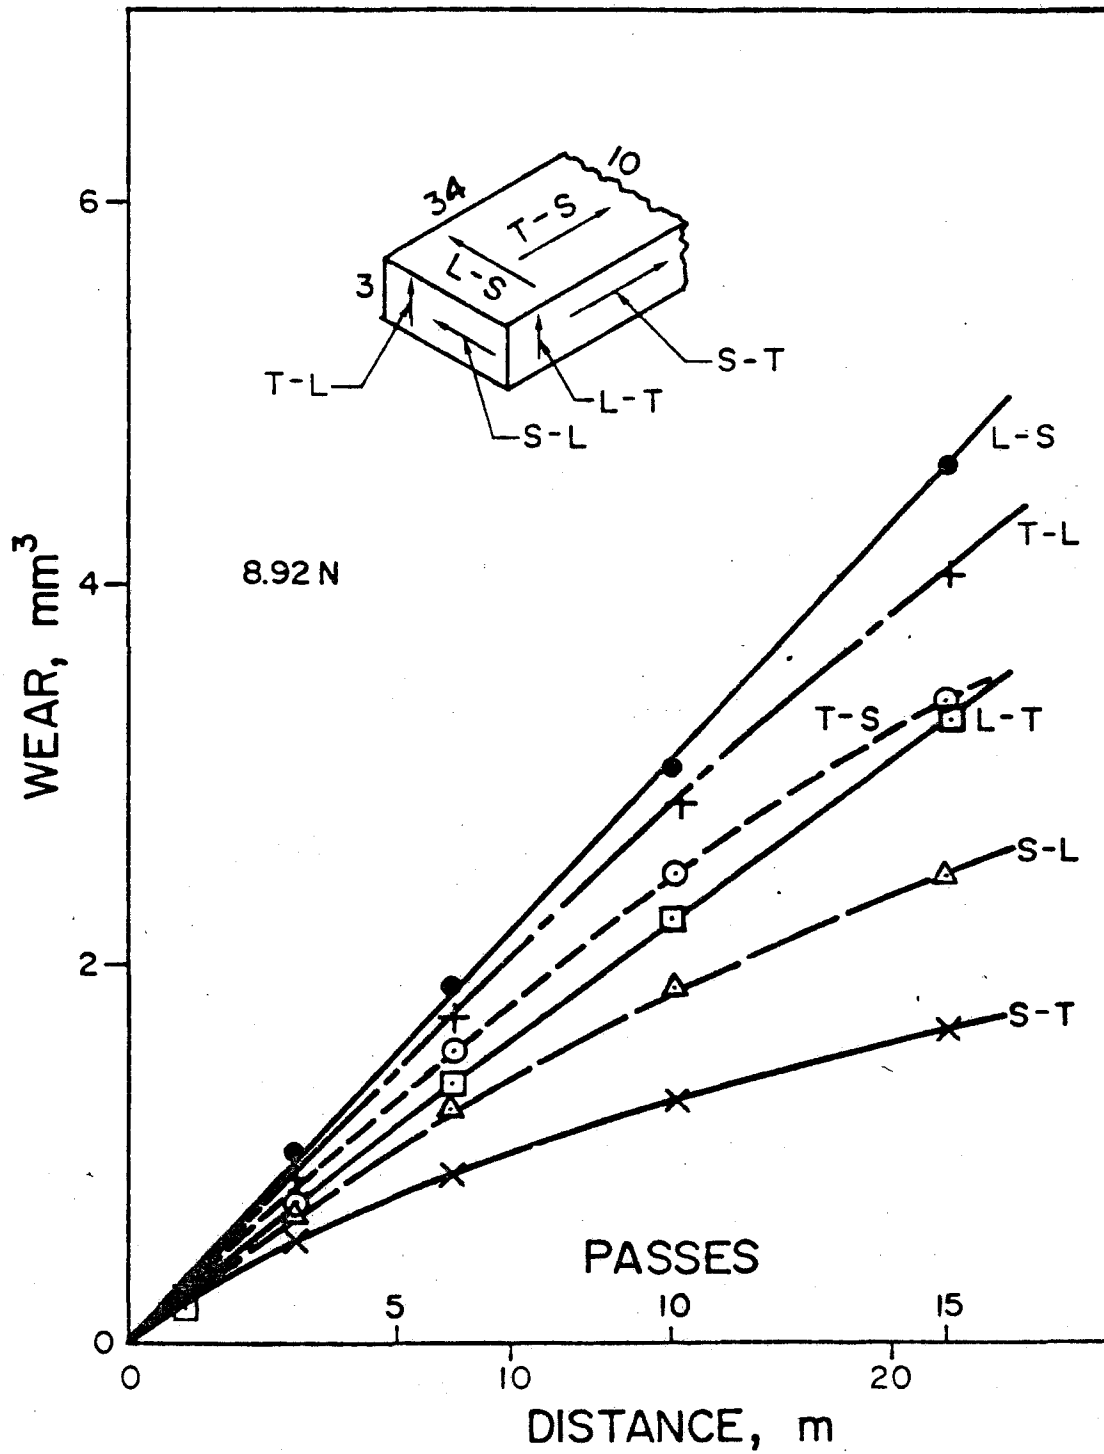
Fig. 15 Wear vs. distance of sliding in same track on SiC paper for different sample orientations.

The wear data are plotted in Figs. 15 and 16. The results show a rather complicated interdependence of contact pressure, distance, and specimen length in the direction of sliding. Much of this behavior is due to wear of the abrasives. The data show no indication that the wire material's resistance to abrasion is in any way dependent on orientation.

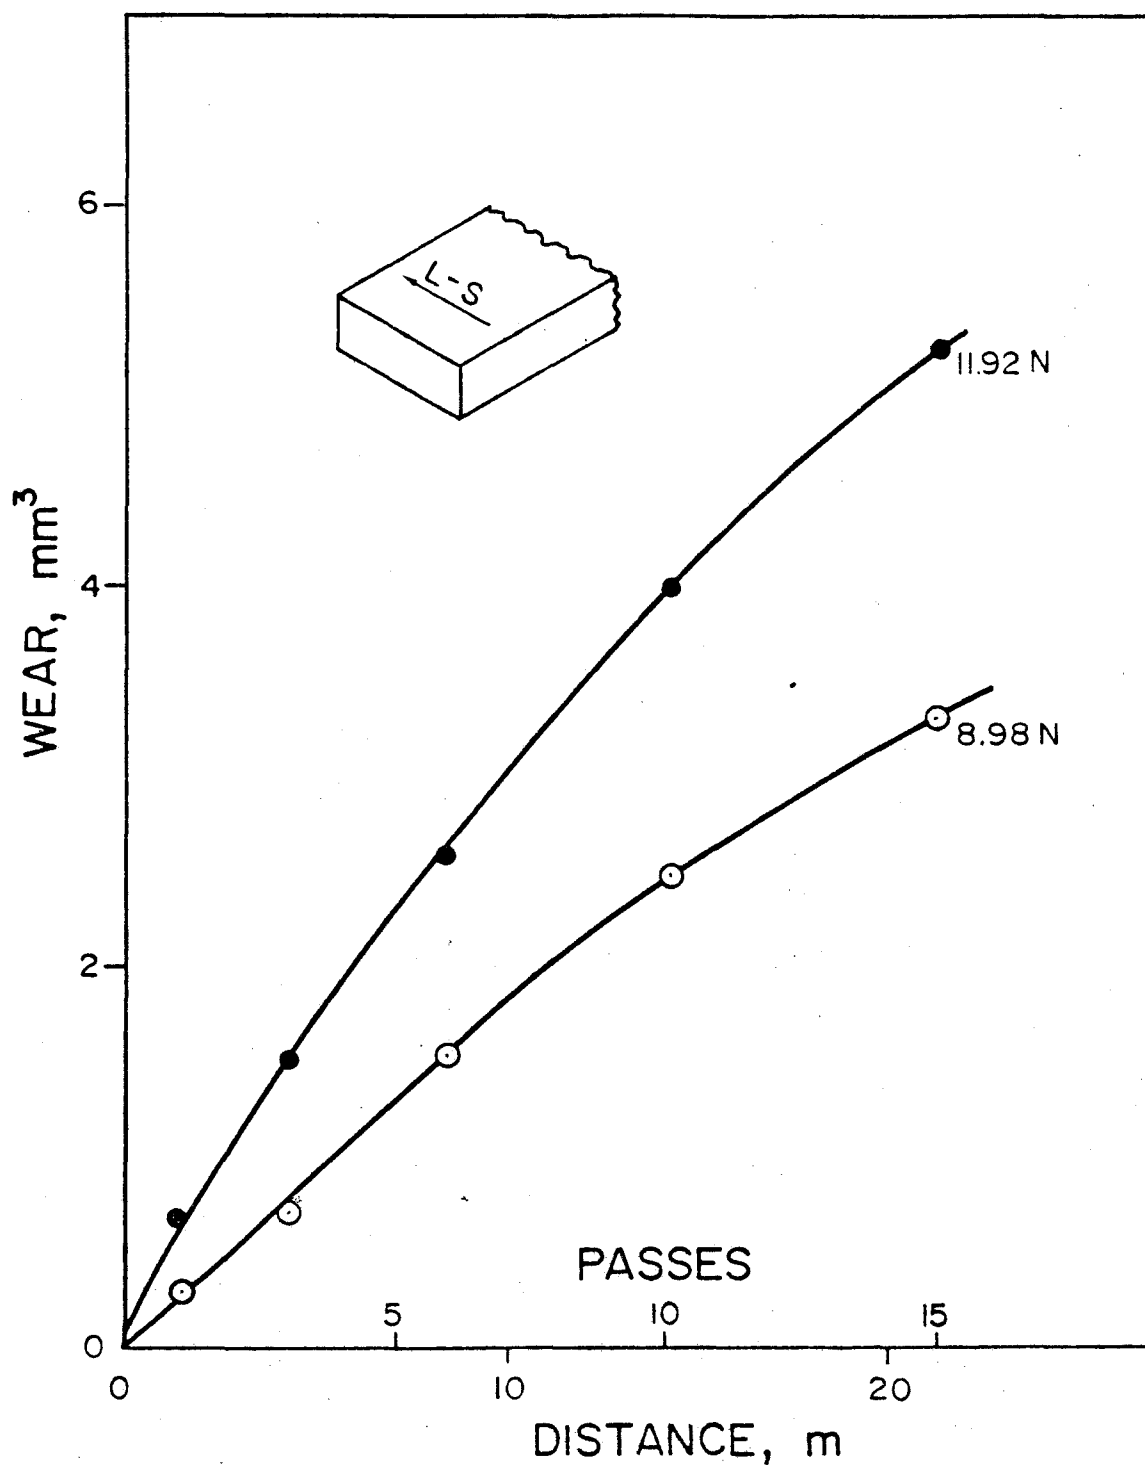
Fig. 16 Wear vs. distance of sliding in same track on SiC paper for two different loads.

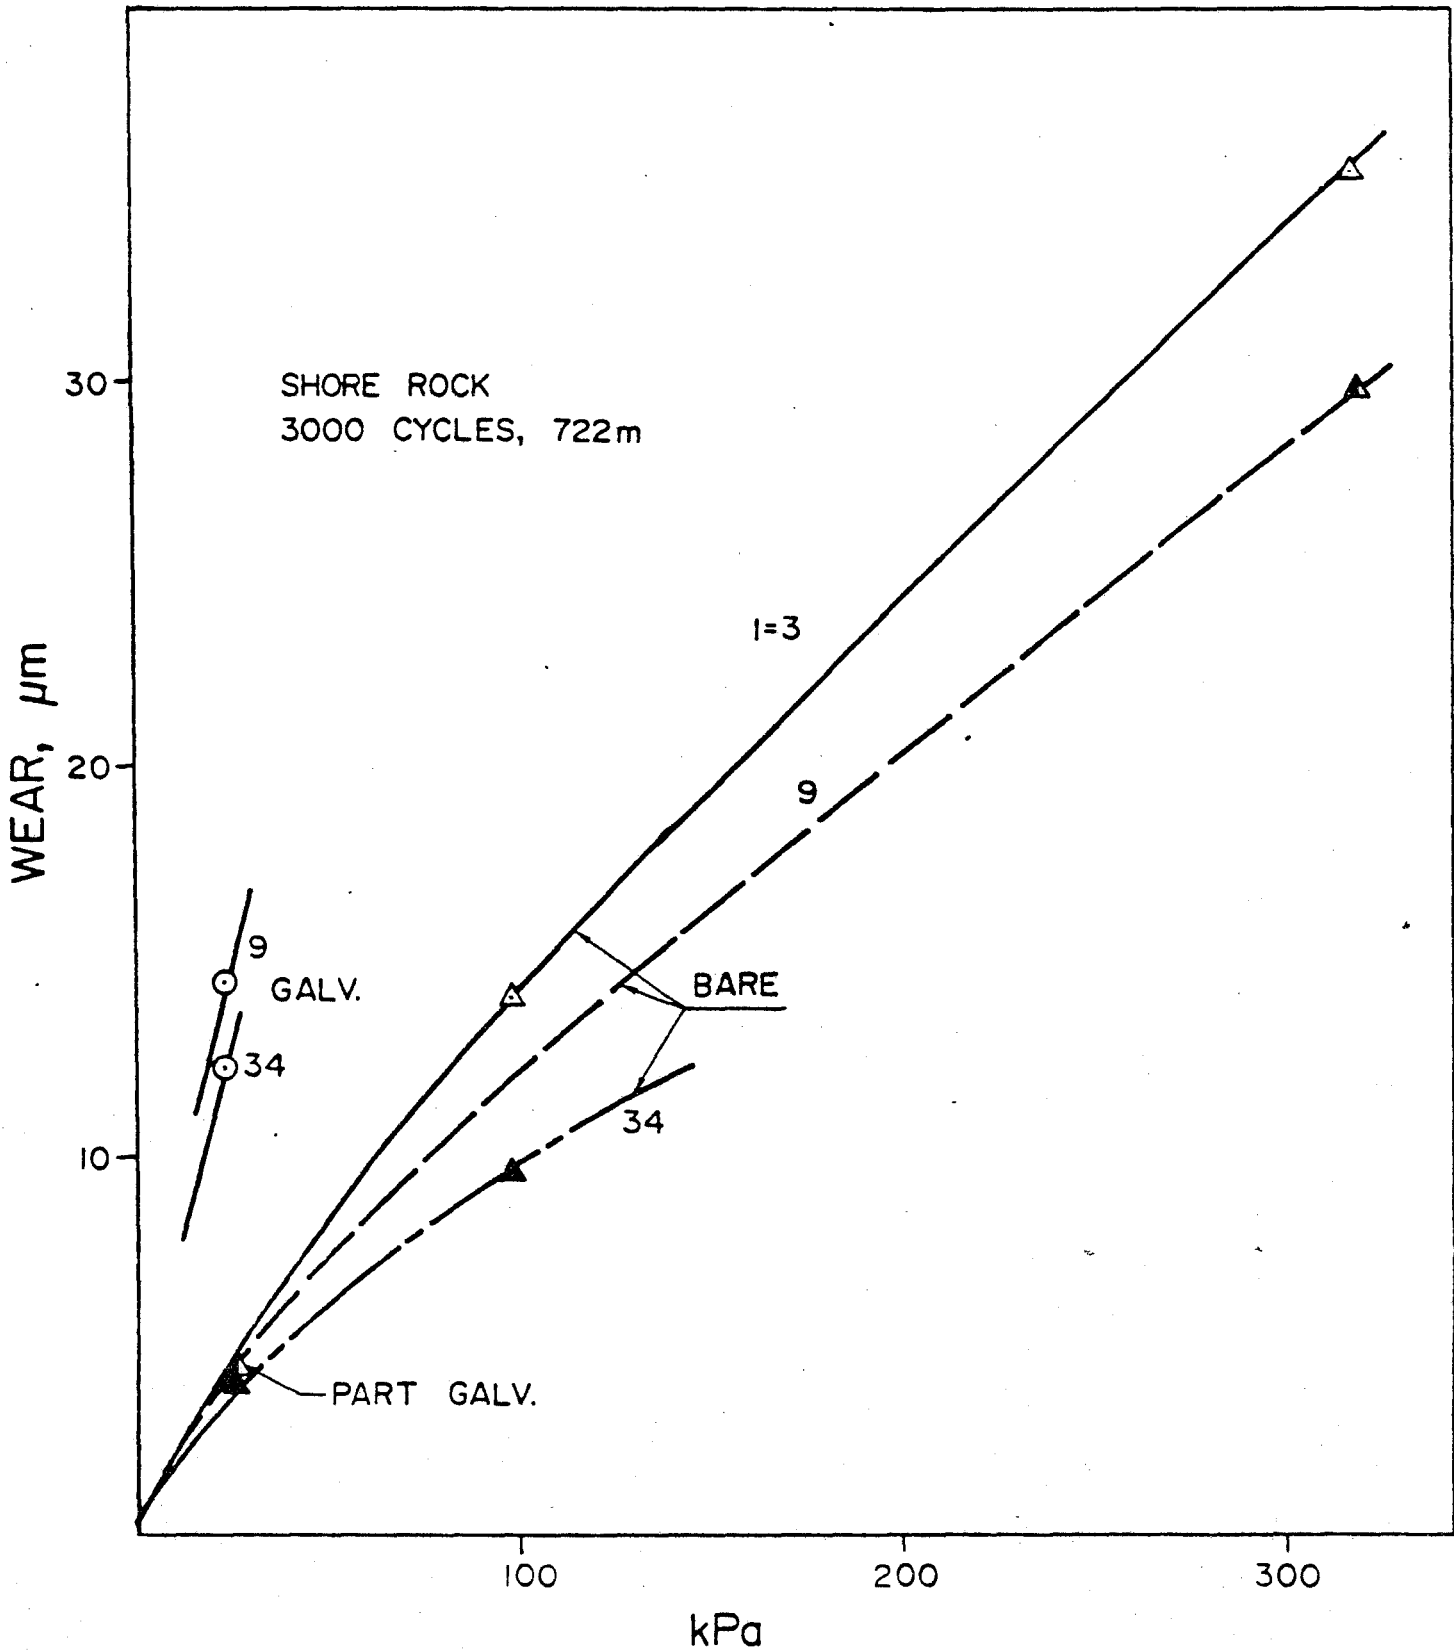
Fig. 17 Wear as thickness lost after 3,000 cycles or 722 m vs. contact pressure for different values of l , the specimen length in the direction of sliding.

The data show some interesting trends when plotted in terms of wear as thickness of material removed as a function of contact pressure, for various values of specimen length in the direction of sliding. See Fig. 17 for low pressure levels and Fig. 18 for the high pressure range. Fig. 19 illustrates the effect of sliding distance at high pressure on the wear. The results show the following:

- shore rock is about 25% more abrasive than channel rock,
- wear increases almost linearly with distance, after an initial running-in period,
- wear increases with contact pressure, somewhat less than linearly,
- wear decreases as the specimen length is increased for the same contact pressure,
- typical wear loss at 2.7 MPa contact pressure for 3000 cycles or 720 m sliding are 220 and 140 μm vs. shore and channel rocks, respectively, and,
- coefficients of friction fall in the range 0.4 to 0.5, concentrated around 0.45.

Results are shown in Fig. 22. Comparison with Fig. 17 shows that the slurry gives a wear rate which is about 3 times faster than abrasion by the solid rock face.

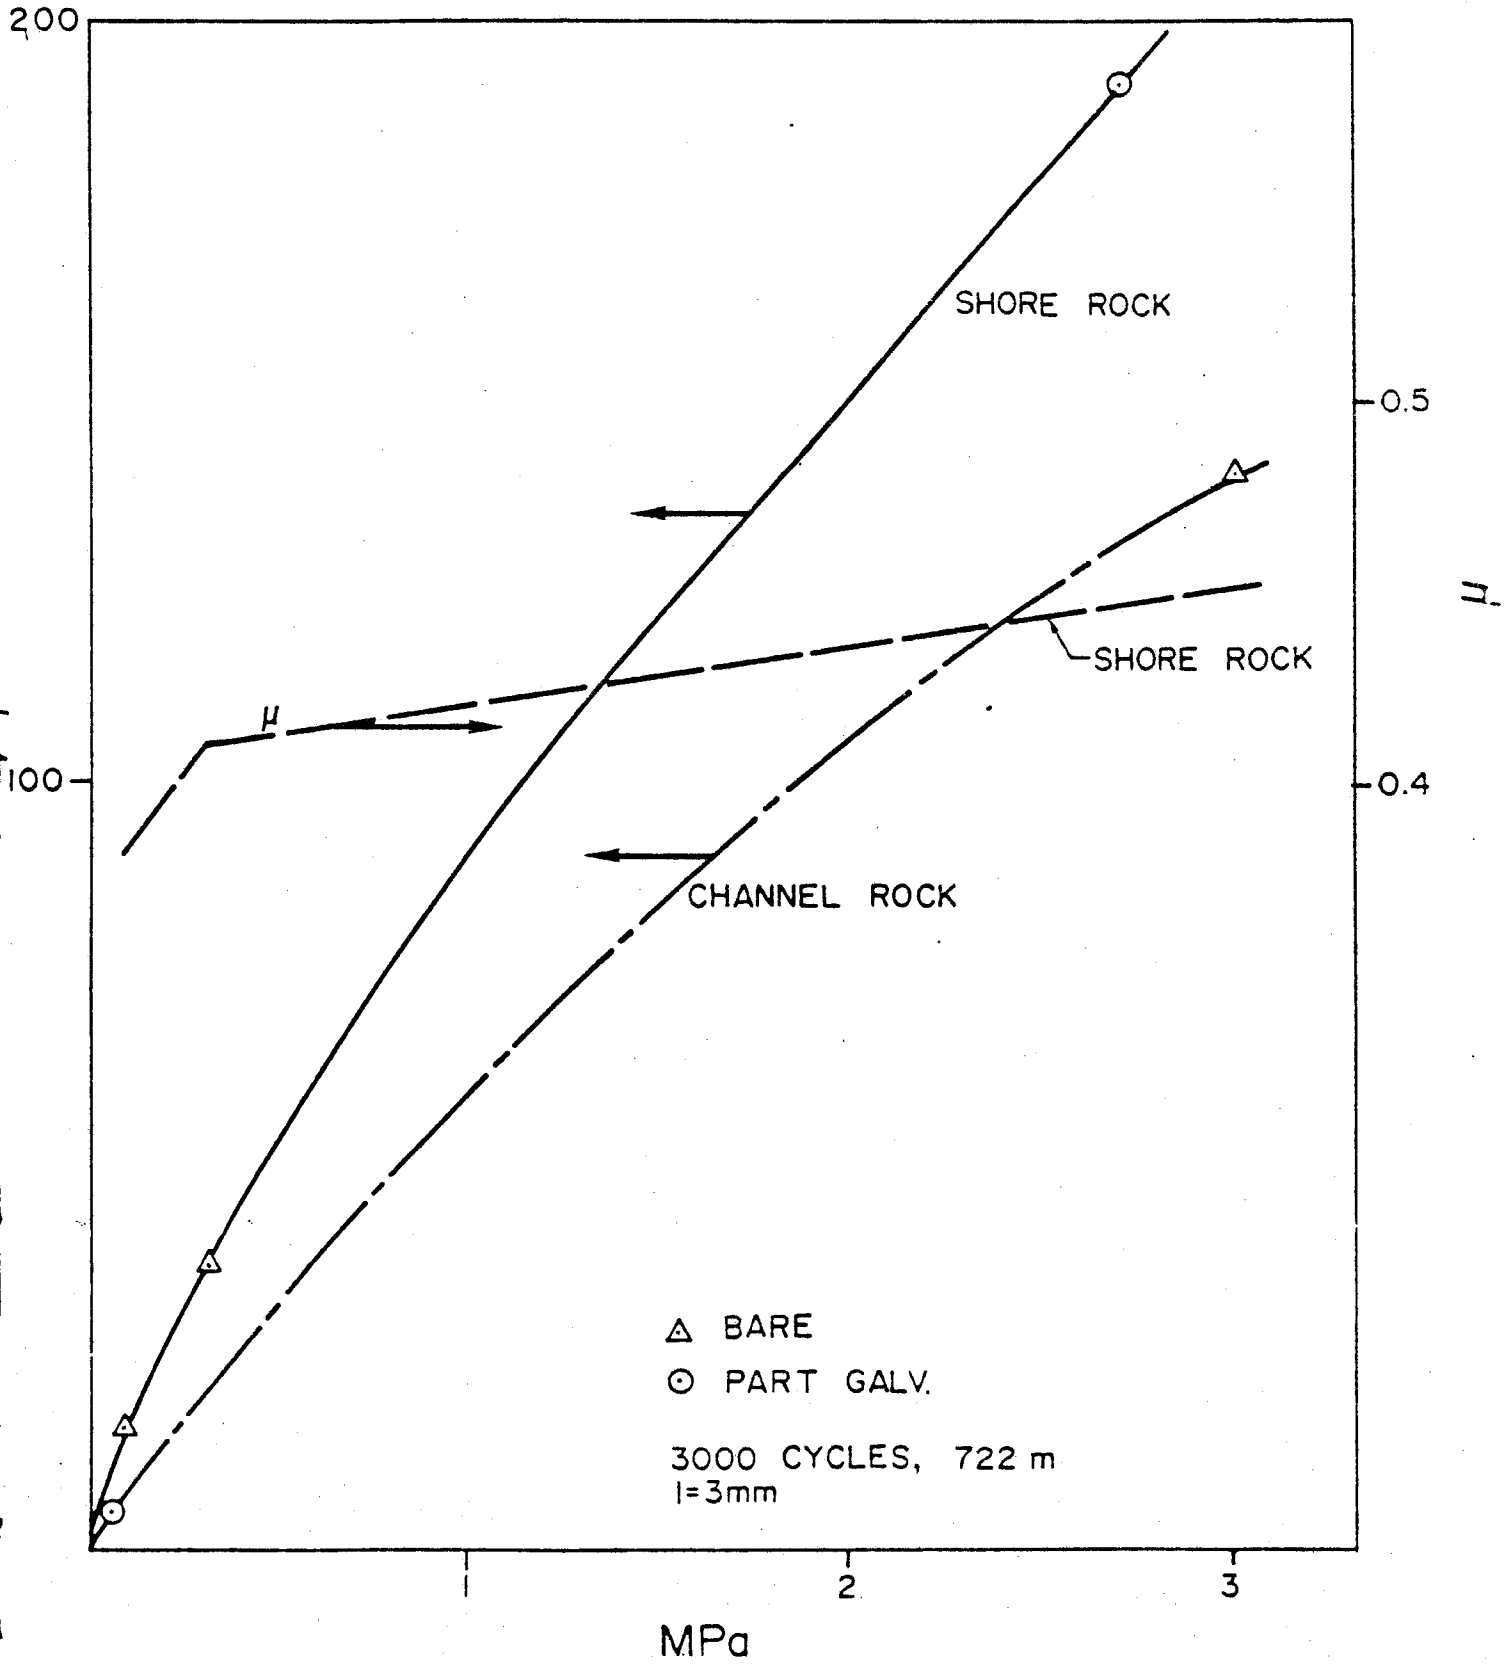
Fig. 18 Wear and coefficient of friction vs. contact pressure.

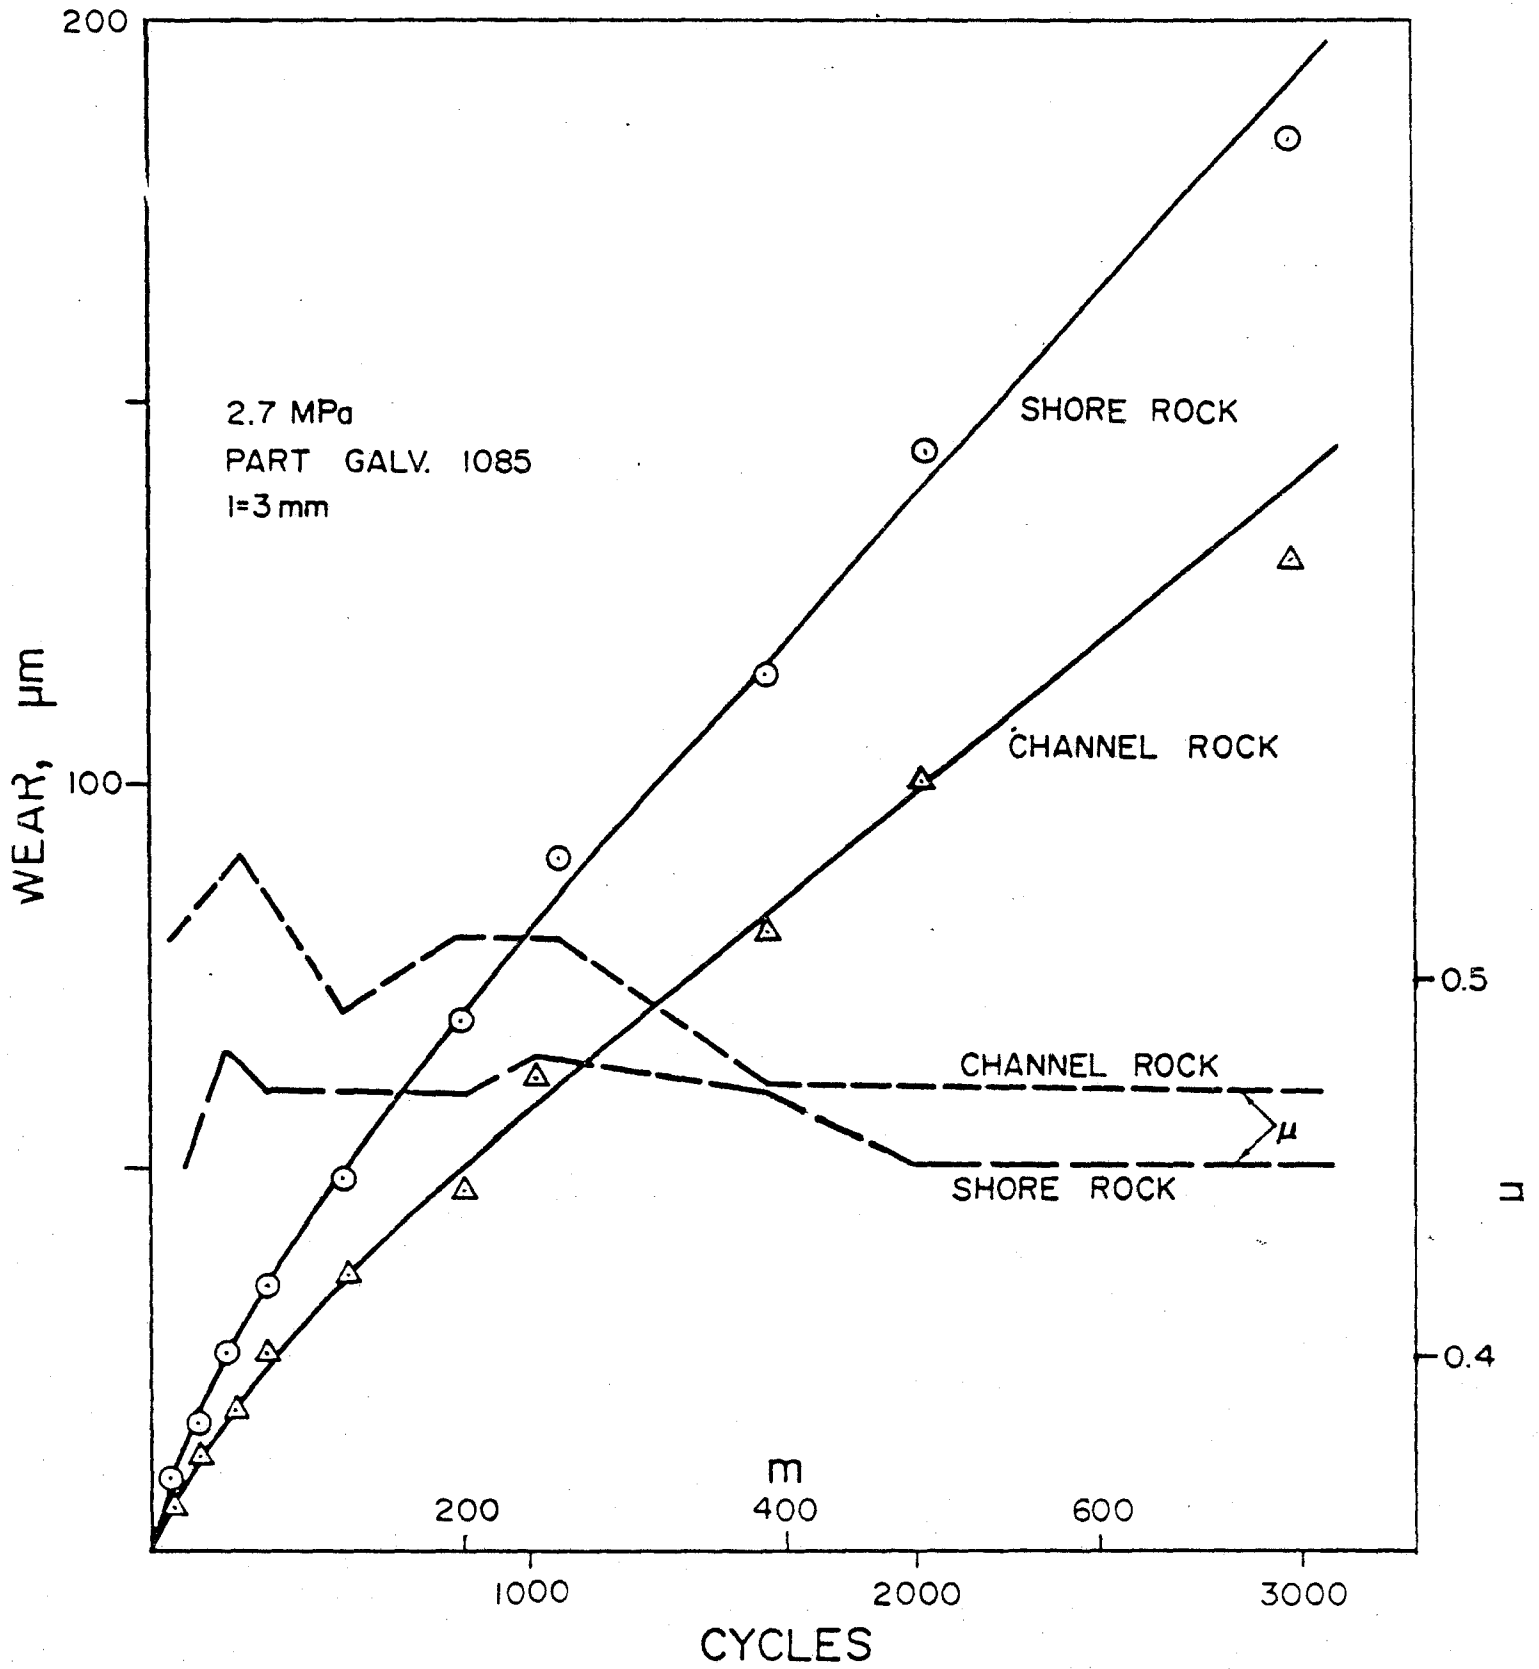
Fig. 19 Wear and coefficient of friction vs. sliding distance.

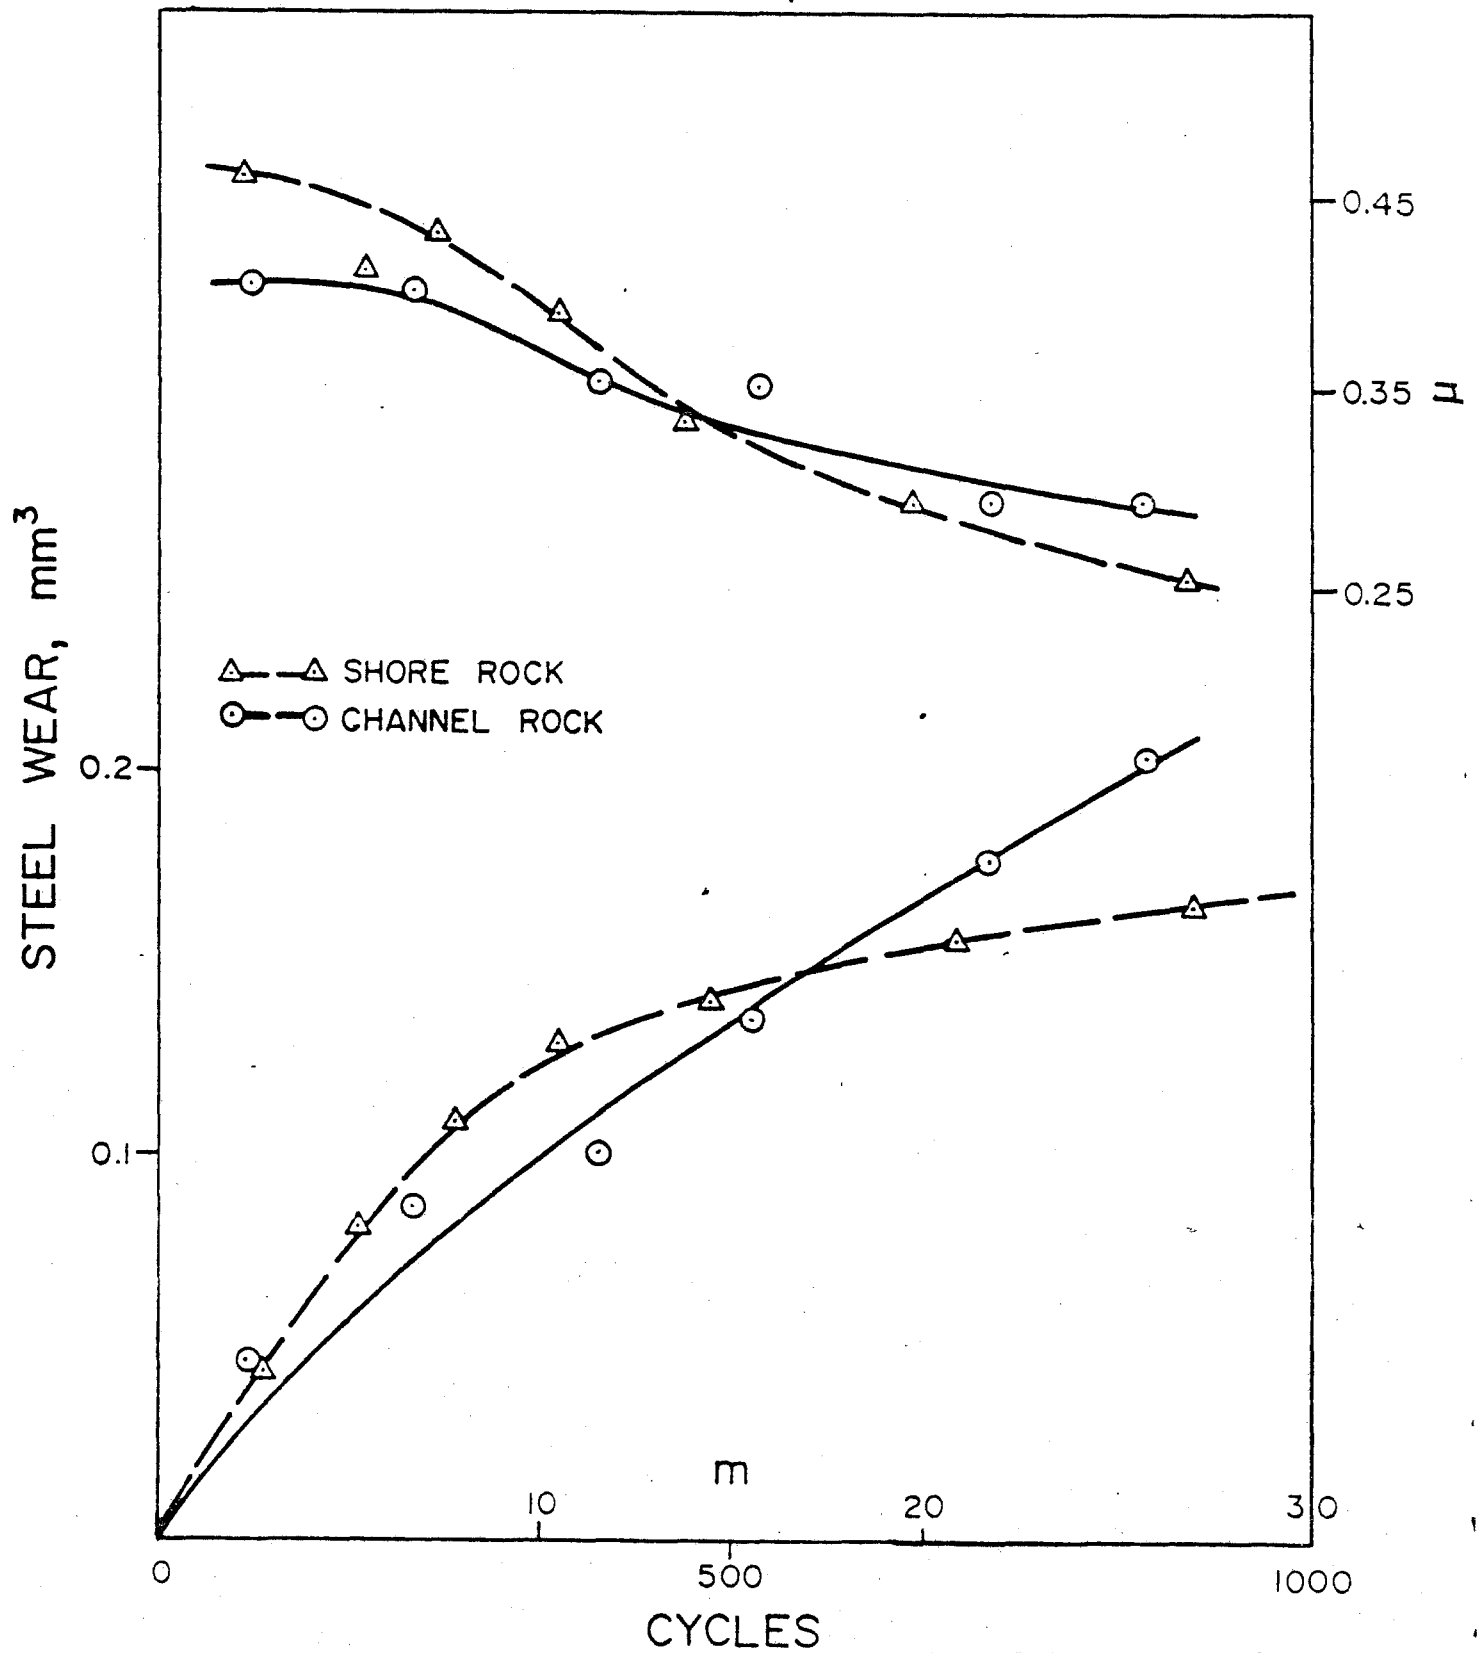
Fig. 20 Wear of bare armor wire abraded in the L-S direction against a 90° edge of rock under 46.4 N load.

In order to obtain some information on the behavior of the armor wire-rock system under high contact stresses some tests were run with armor wires pressed against 90° angle edges of rock. These tests were run dry, with stroke lengths of 0.05 m. Weight loss of both rock and steel was determined.

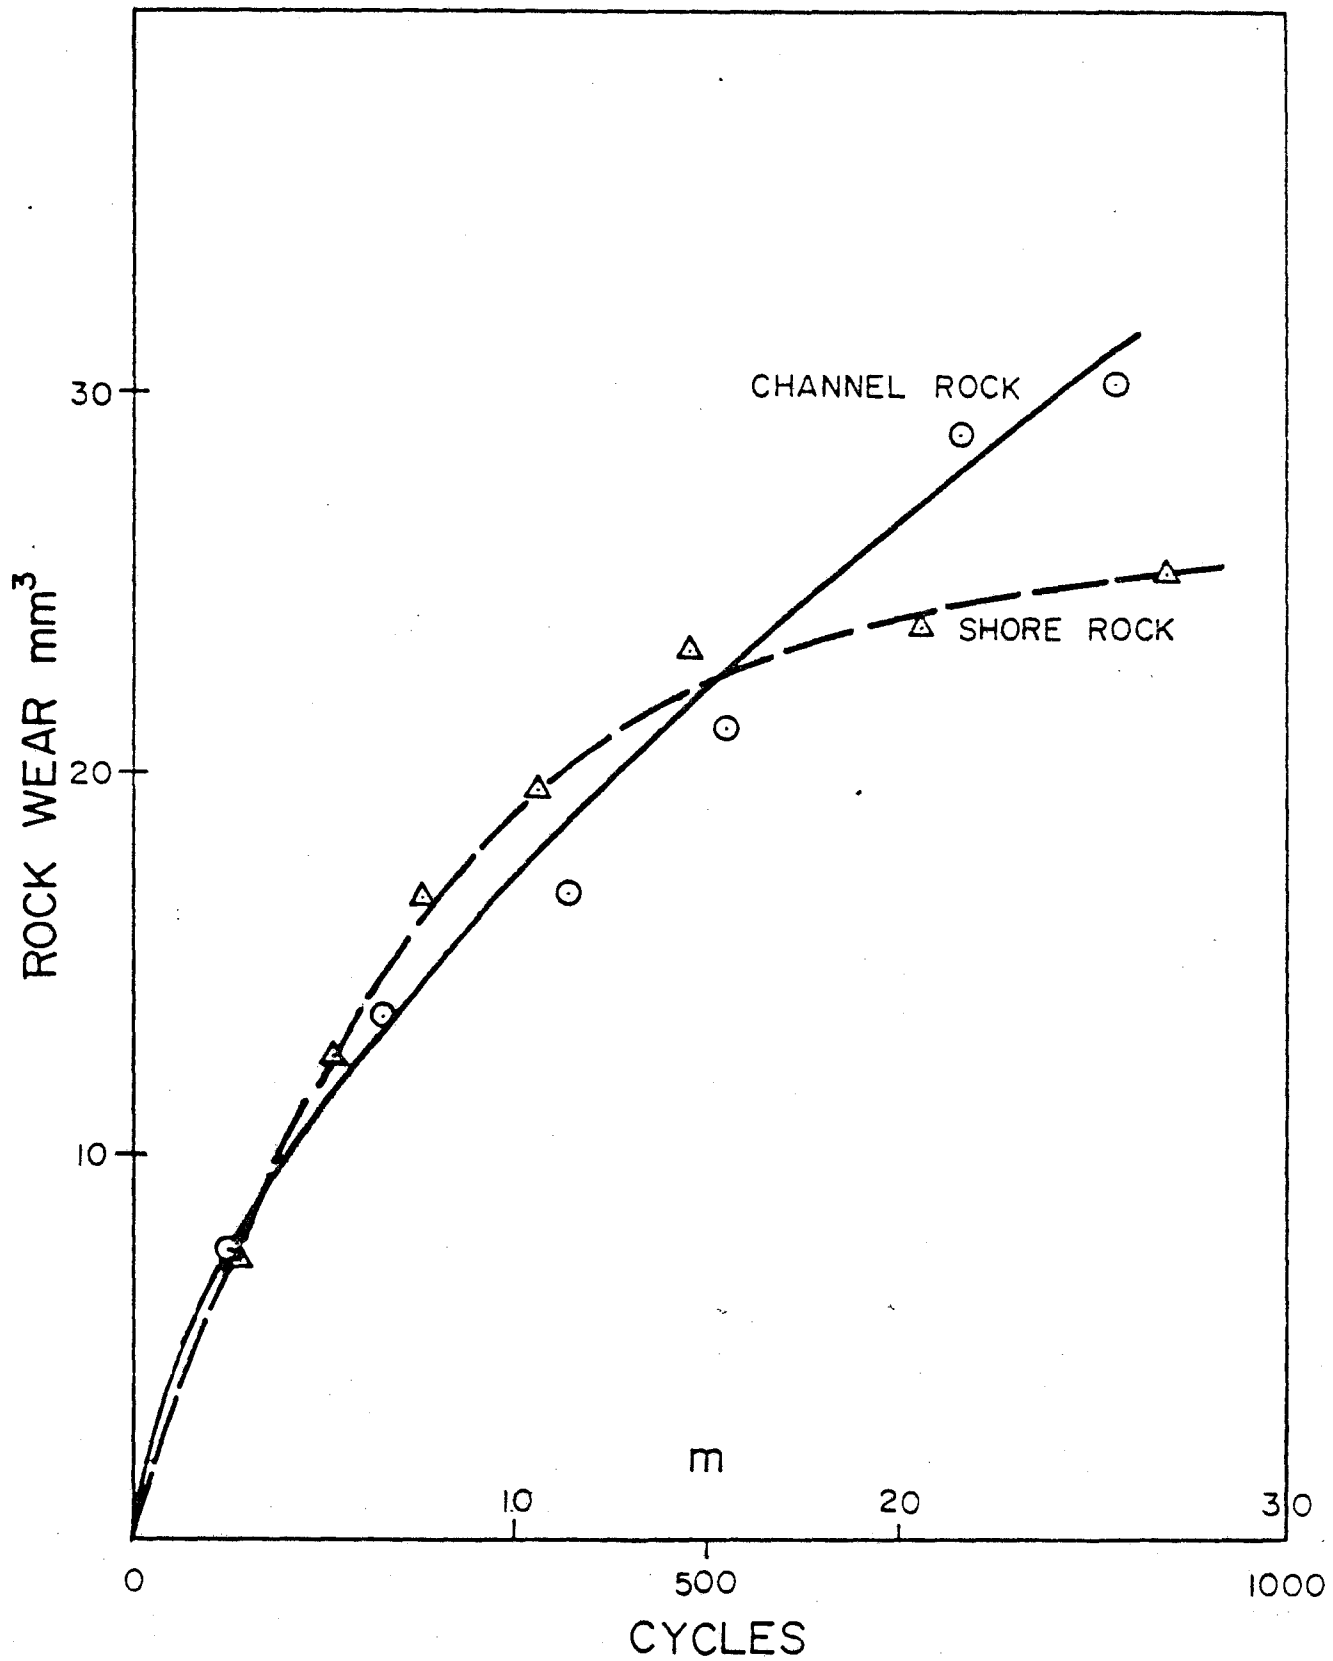
Fig. 21 Wear of rock under same conditions as in Fig. 20.

The results are shown in Figs. 20 and 21. There is little difference in the rate of wear caused by the two different rocks. For extended testing the channel rock both causes more steel wear and itself wears more than the shore rock. The friction values, which were measured at intervals under a reduced load of 5N, declined from 0.4-0.45 to 0.25-0.3 during the course of the test. At the end of about 800 cycles or 25 m of sliding the rock had worn to a width of about 0.8 mm, such that the contact pressure was about 3.1-3.6 MPa, which is near the top of the range used in the seawater tests described above. At that point, the wear of the steel amounted to a depth of around 25-30 μm , and the wear rates were 0.45 $\mu\text{m}/\text{m}$ against the channel rock and 0.2 $\mu\text{m}/\text{m}$ against the shore rock. These values are in the general range found in the previous tests, where at 3MPa and 722 m sliding the wear rates were 0.2 and 0.25 $\mu\text{m}/\text{m}$ against channel and shore rocks, respectively.

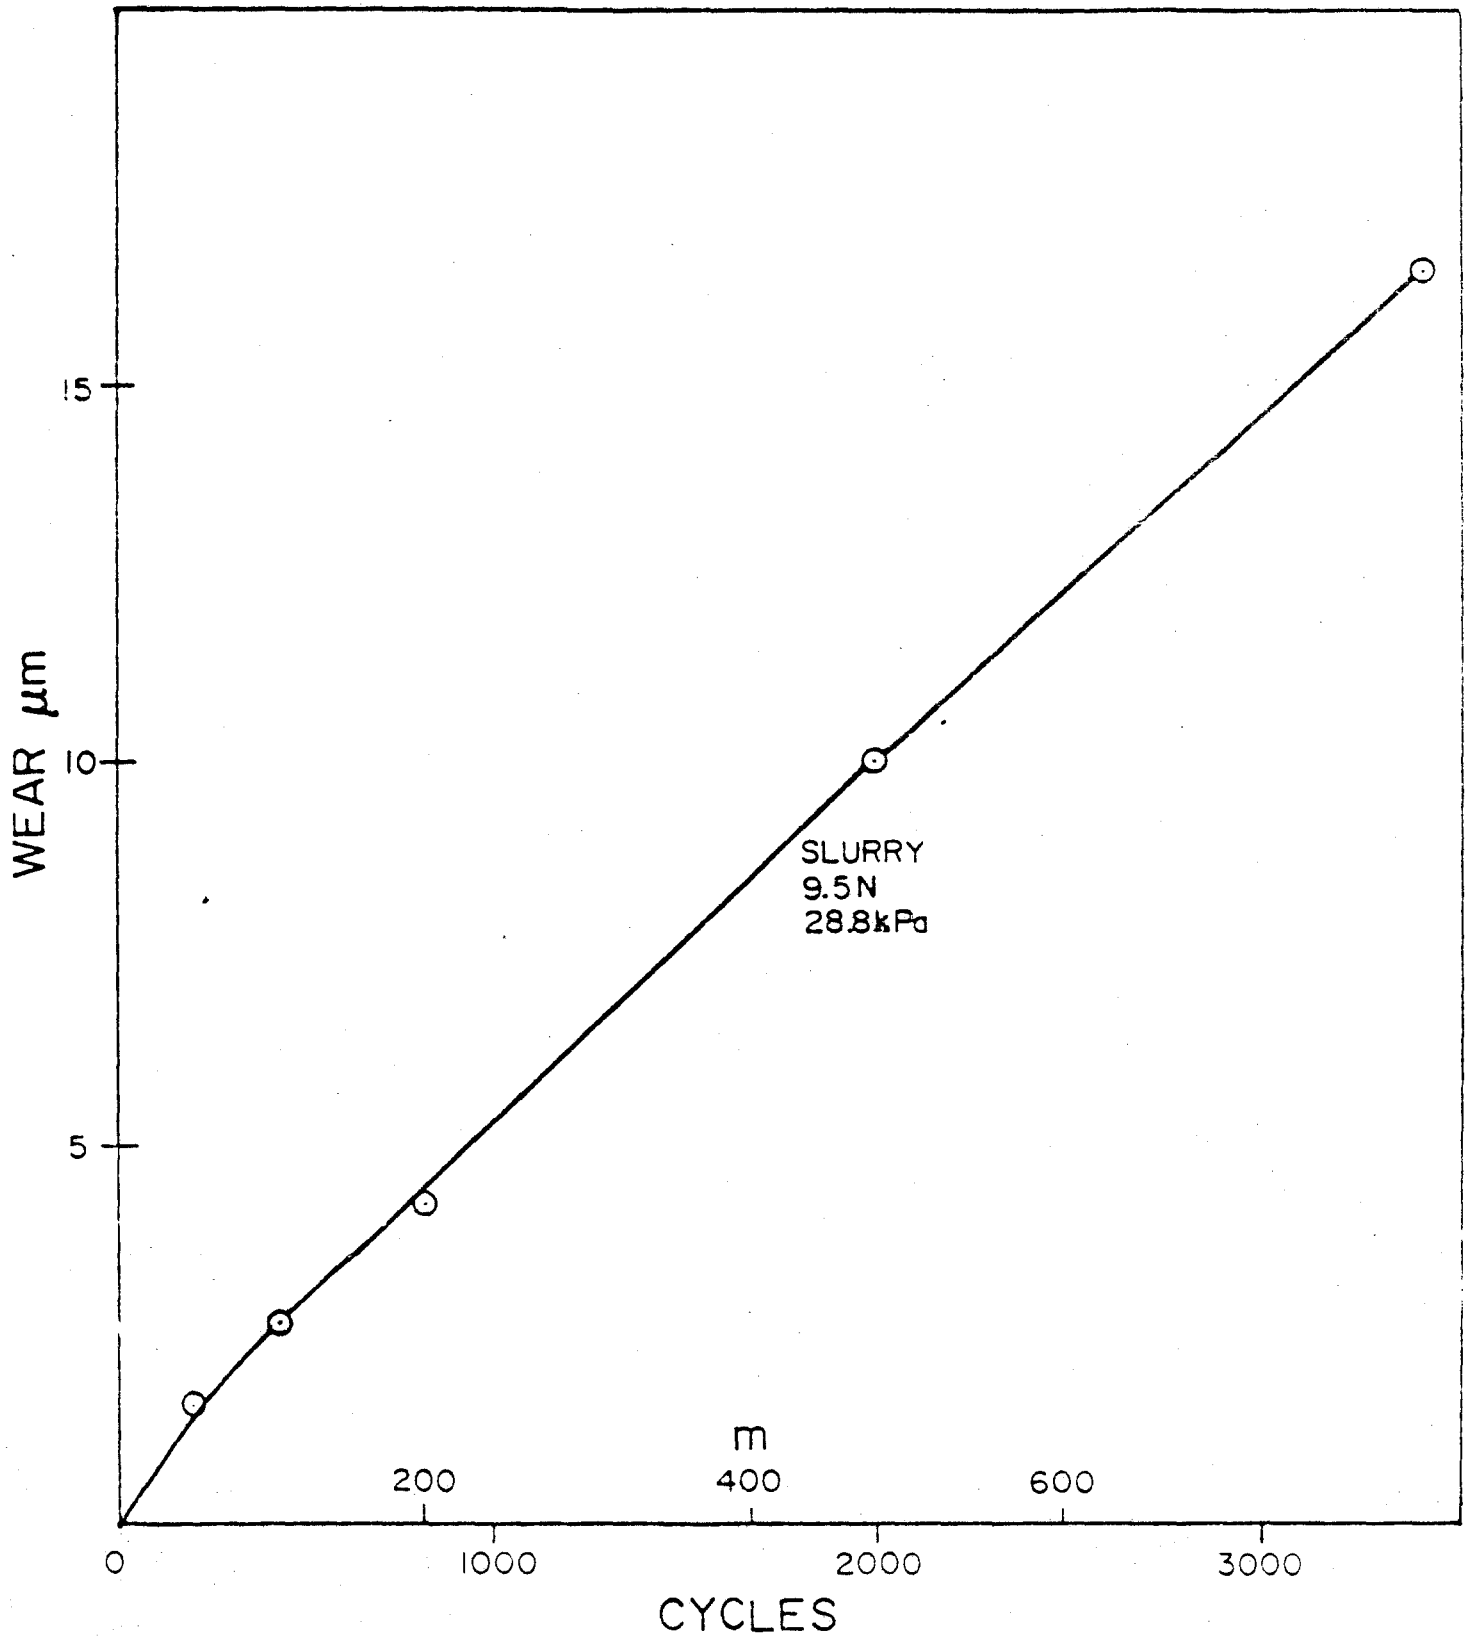
Fig. 22 Slurry abrasion of bare wire in the L-S direction at 28.8 kPa pressure.

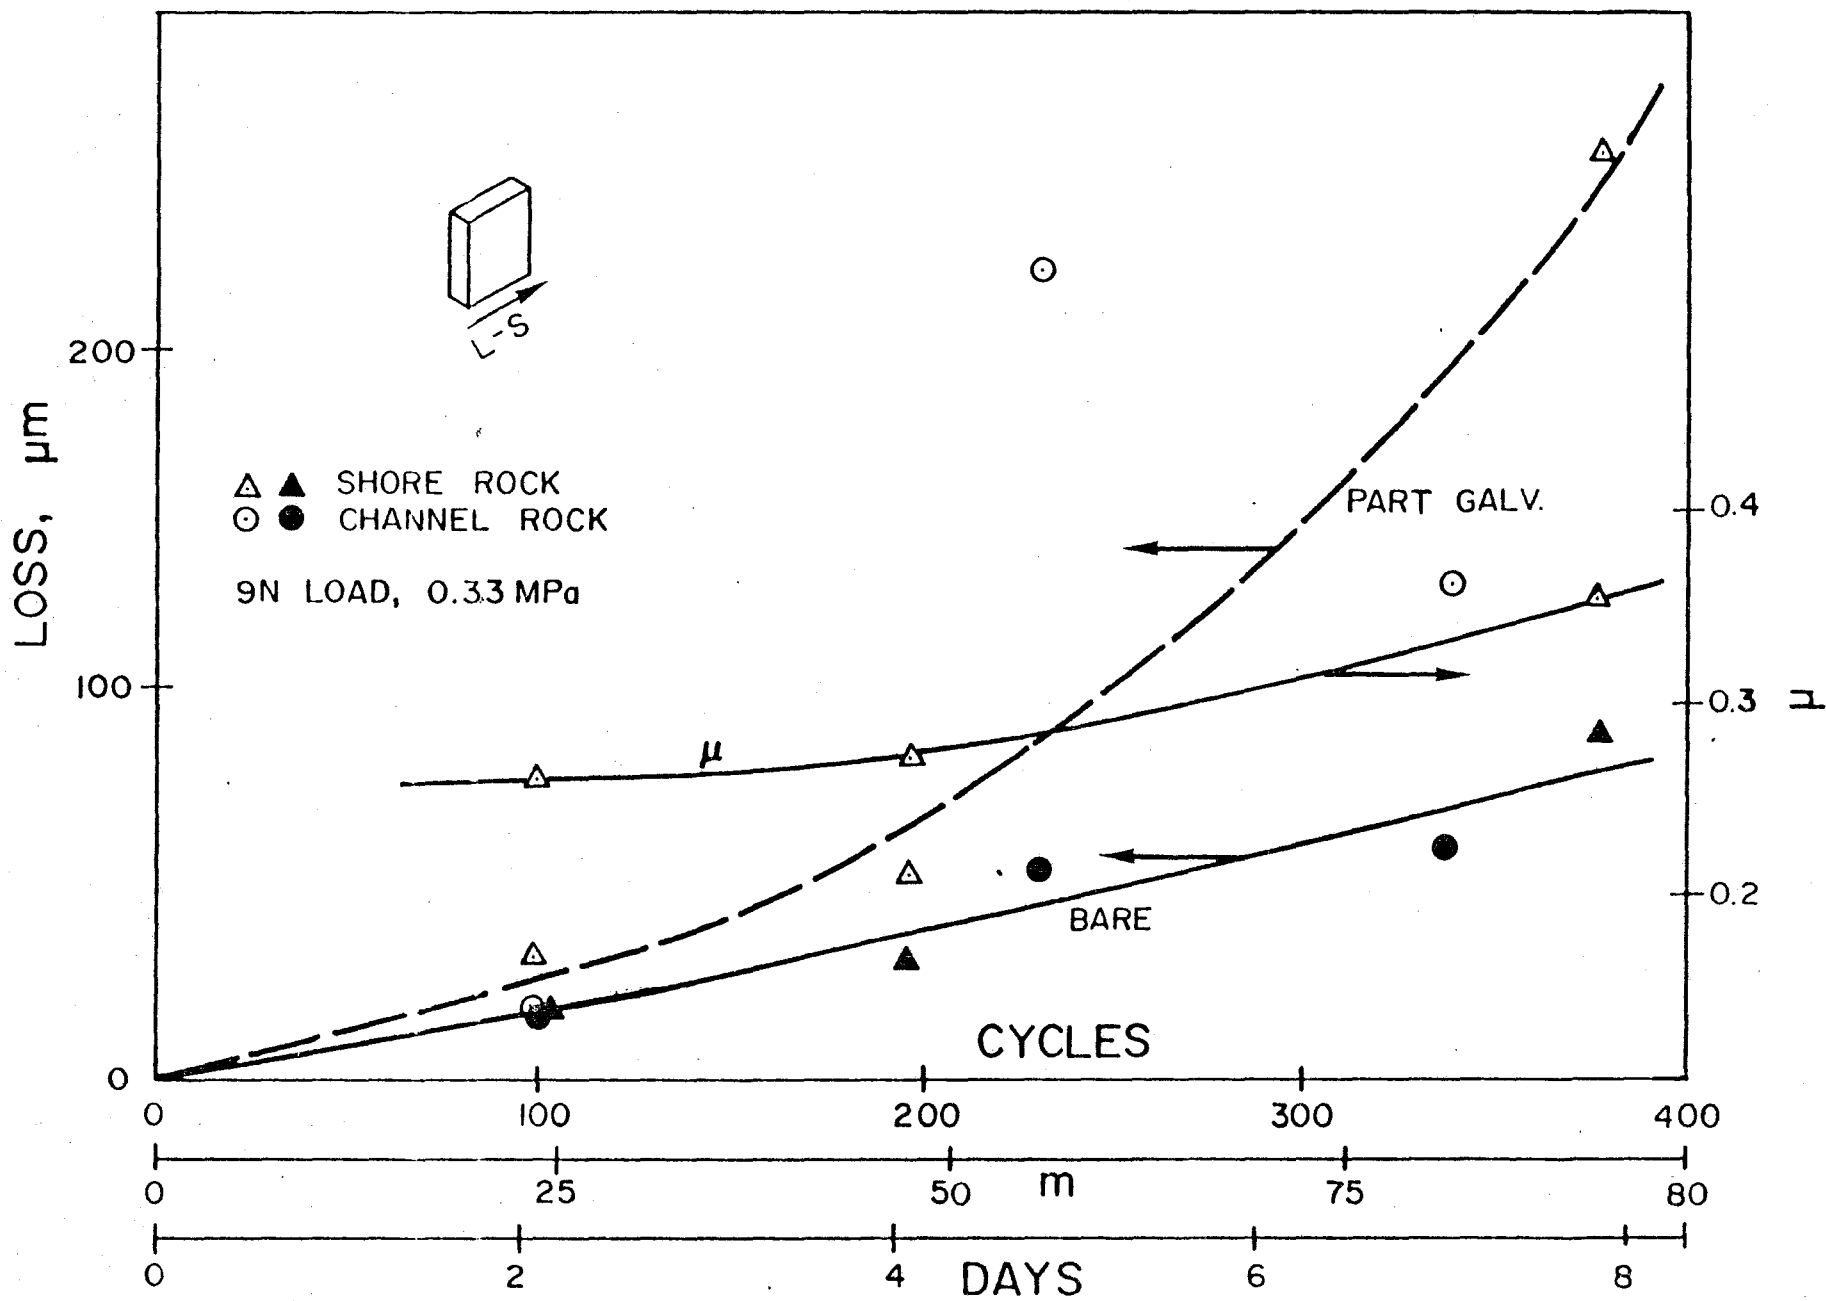
The abrasion tester used for the seawater and slurry tests was modified to be controlled by a program which switched on the motor each 15 minutes, just long enough to go through one-half abrasion cycle (0.12 m). Tests were run in stagnant seawater for up to one week. The results are shown in Fig. 23. The rocks were sandblasted before the test. The partly galvanized sample had the zinc coating removed on the bottom (contacting) 50% of the 29 mm long sample.

The results show that the nature of the rock has little effect in this case. The greater wear shown by the part galvanized sample is probably due to the direct corrosion of the zinc in the seawater. For the bare wire the wear in a week is about 75 μm . Corrosion of the non-wearing surface is responsible for about 35 μm of that number (using a weekly rate of 1 μm), which leaves 45 μm due to abrasion and corrosion of the contacting surface. Results shown in Figs. 17 and 18 for the same number of cycles and the same contact pressure (but a much shorter period of testing) gave a loss of 3-5 μm . Thus, the corrosion of renewed fresh surface during the week has contributed most of the loss, in the order of 35-40 μm , or 0.1 $\mu\text{m}/\text{cycle}$.

Fig. 23 Corrosion-erosion in stagnant seawater at room temperature.
