PRELIMINARY SURVEY OF A PORTION OF PARKER RANCH

W.M. Adams, F. Peterson, C. Lao

Memorandum 12

March 1968

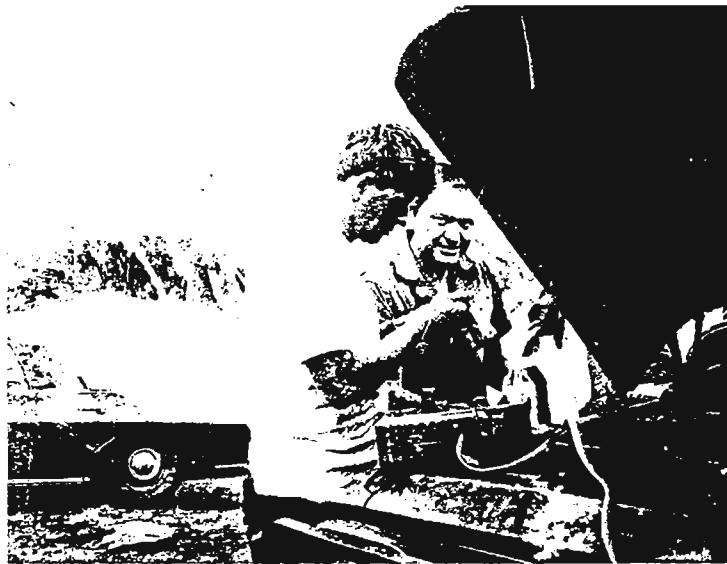
FIGURE 6. TESTING WATER SAMPLES FOR CONDUCTIVITY.  
NEAR PAVILLION AT HAPUNA BEACH PARK.  
2 MARCH 1968.  
F. PETERSON & W. ADAMS.

The conductivities were run using the procedure shown in Figure 6. The inverter was connected to the battery of the three-wheel drive vehicle, an International Harvester extended cab pick-up, with the bridge plugged into the inverter, and the sensor dipped into the water bottle sample. This was an extremely inconvenient field procedure. If future field trips are to be conducted, a portable system should be procured. In particular, a measurement system which does not use a nulling procedure is recommended. Nulling is a simple way of achieving high precision. For a reconnaissance effort, such precision is unnecessary. A non-nulling system, possibly with an optional portable recording attachment, would be especially suitable for reconnaissance along coastlines using small craft.
