OUTDOOR & LABORATORY CORROSION STUDIES OF ALUMINUM METAL – MATRIX COMPOSITES

A THESIS SUBMITTED TO THE GRADUATE DIVISION OF THE UNIVERSITY OF HAWAI'I IN PARTIAL FULFILLMENT OF THE REQUIREMENTS FOR THE DEGREE OF

MECHANICAL ENGINEERING

AUGUST 2004

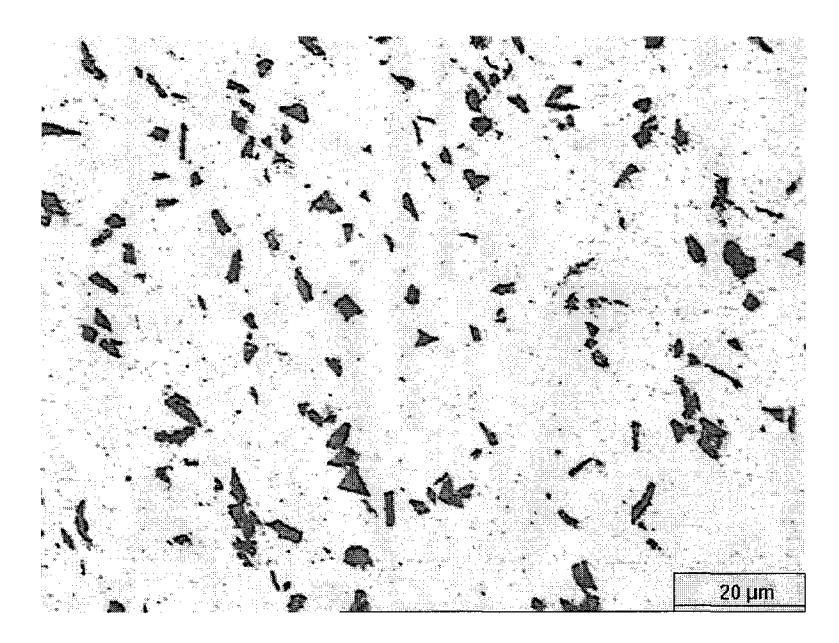
Figure 1.1: Microstructure of Al6092-T6/SiC/5p

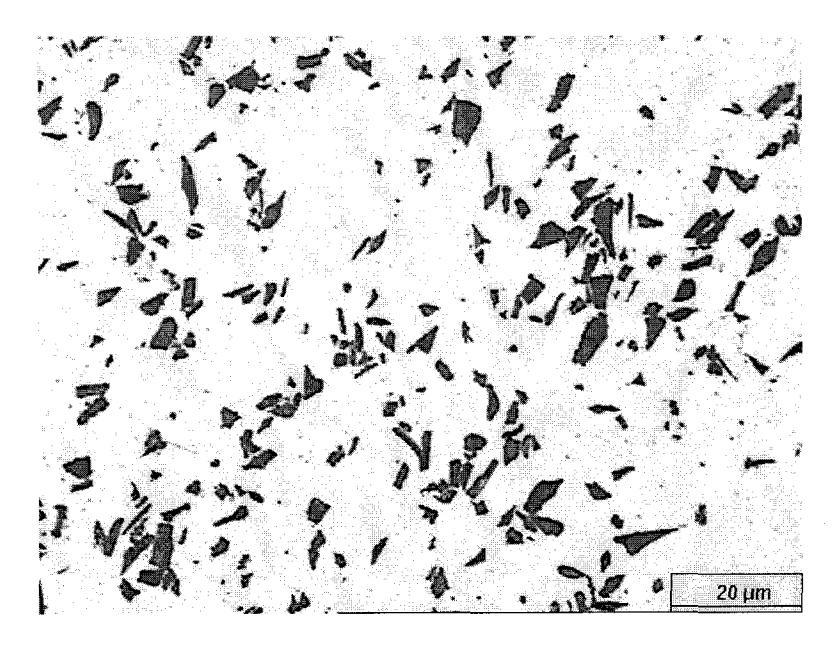
Figure 1.2: Microstructure of Al6092-T6/SiC/10p

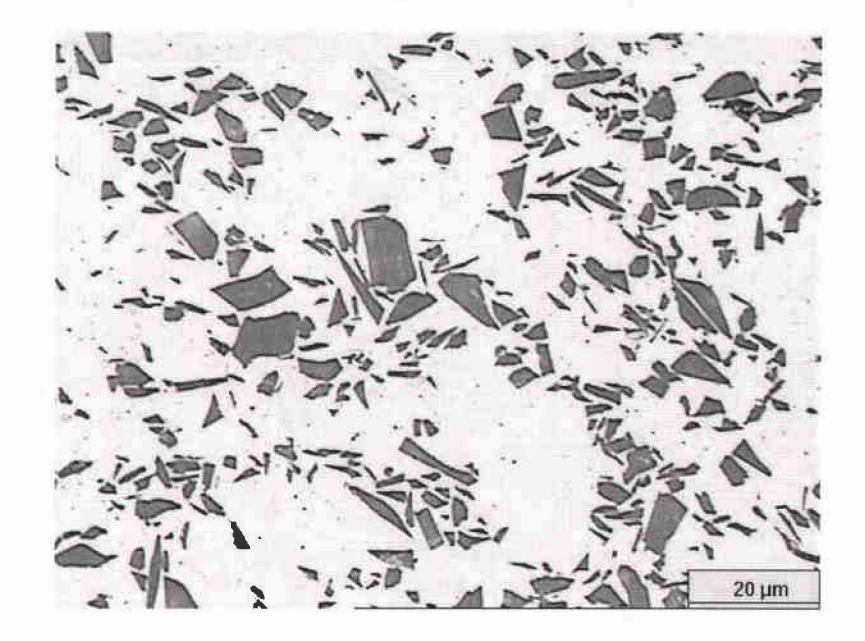
Figure 1.3: Microstructure of Al6092-T6/SiC/20p

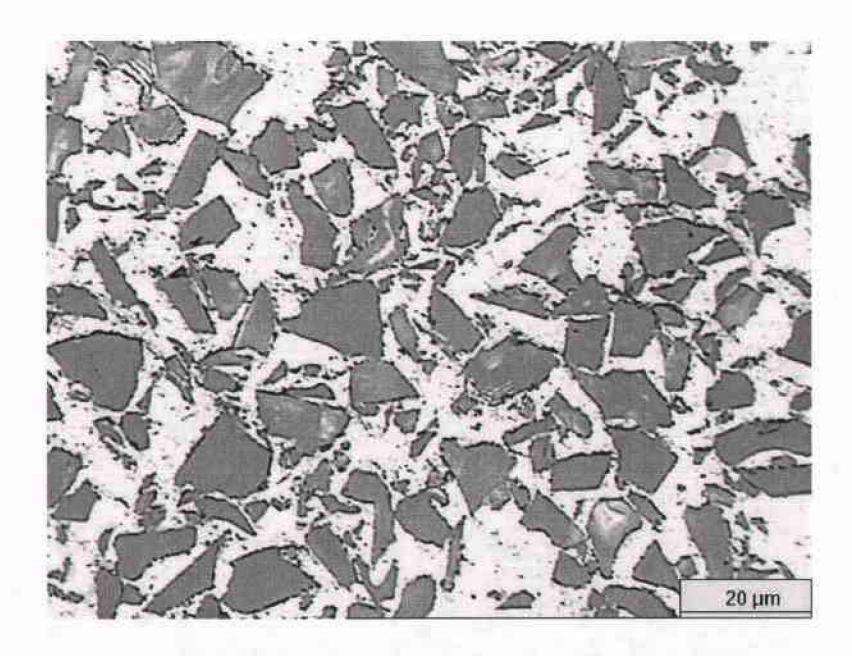
Figure 1.4: Microstructure of Al6092-T6/SiC/40p

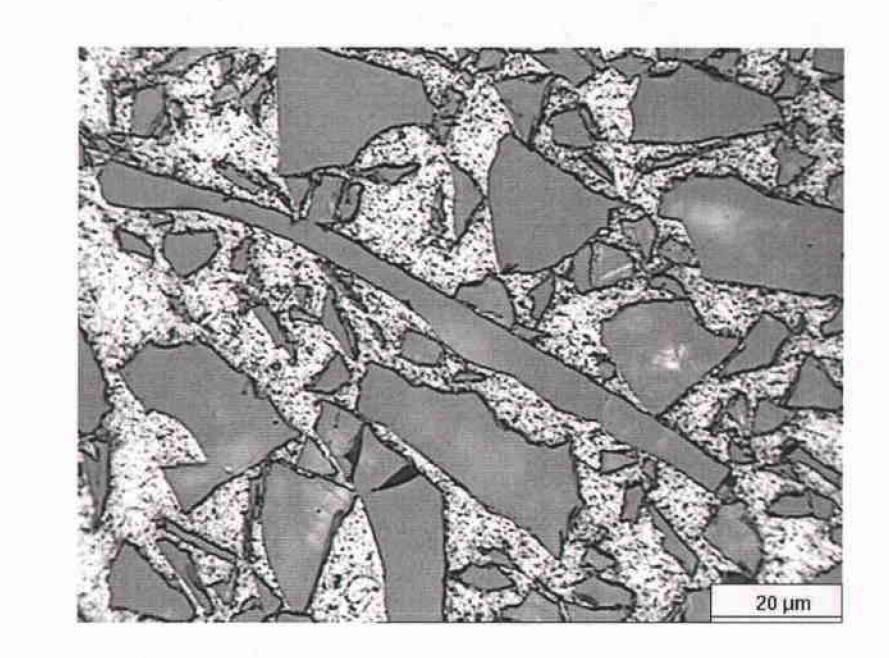
Figure 1.5: Microstructure of Al6092-T6/SiC/50p

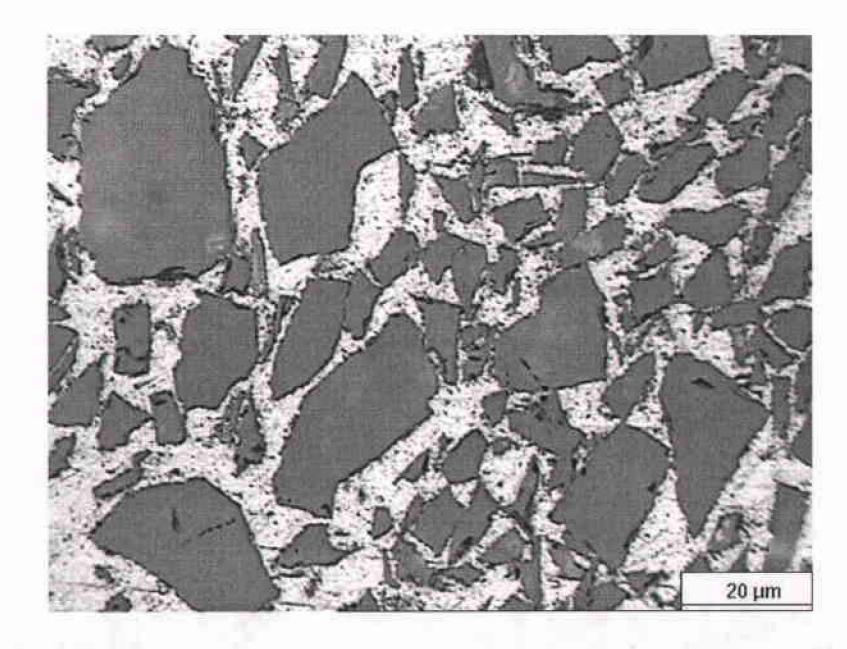
Figure 1.6: Microstructure of Al6092-T6/SiC/50p (Gr.)

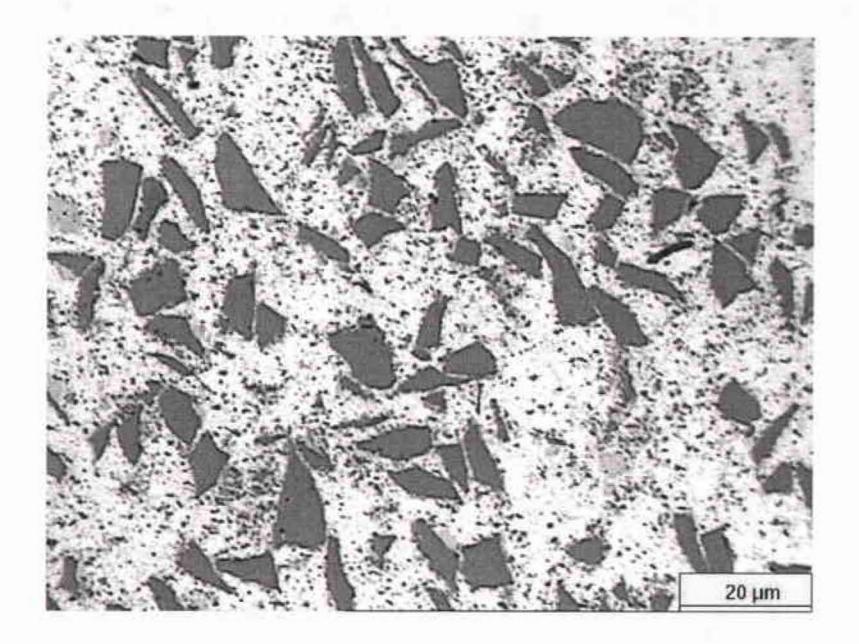
Figure 1.7: Microstructure of Al6092-T6/B₄C/20p

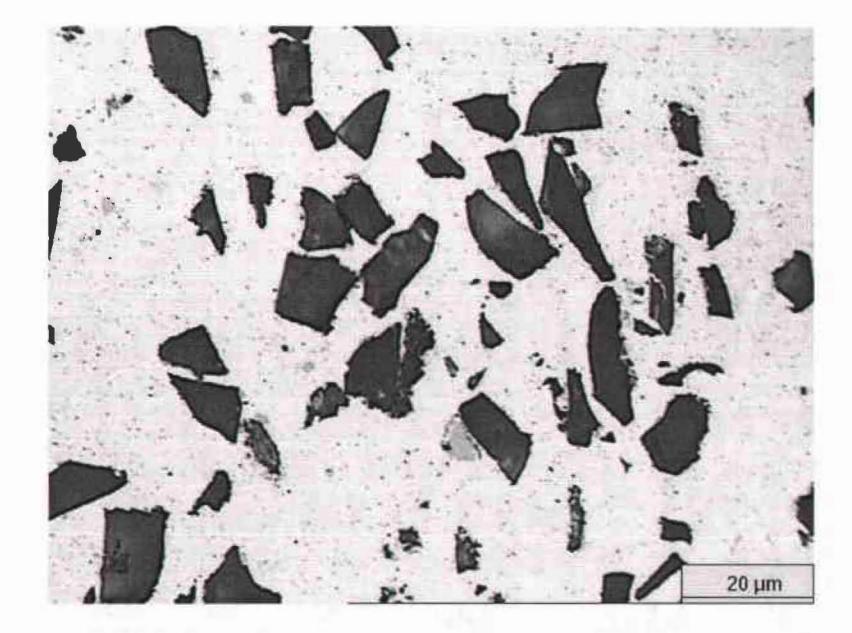
Figure 1.8: Microstructure of Al6092-T6/Al₂O₃/20p

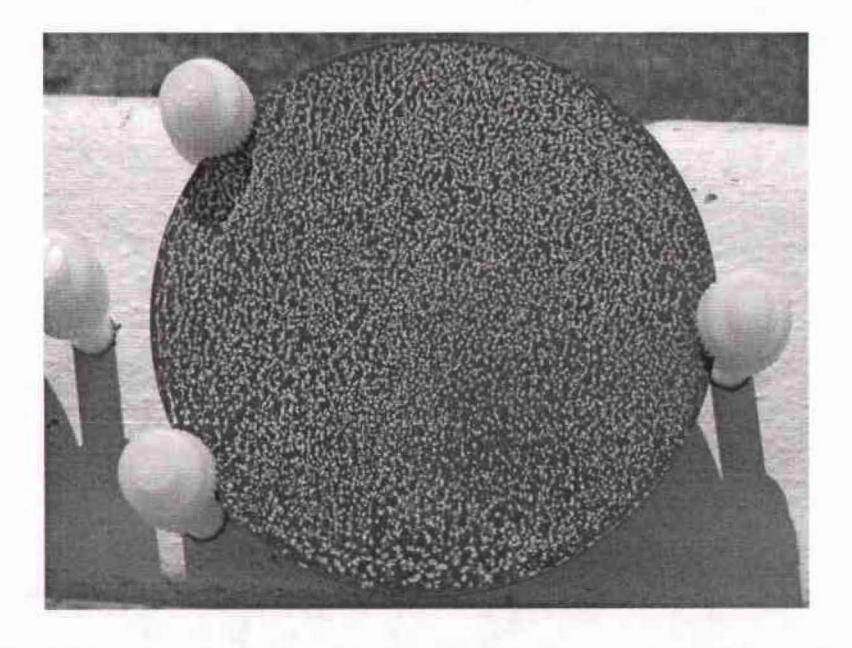
Figure 3.2: Nylon 6/6 (Polyamide) insulators securing MMC specimen

all test racks, with the exception of the Lyon Arboretum racks due to test site limitations, were oriented such that they face North East in an attempt to expose the specimens to the predominantly North Easterly trade winds. Dimensioned drawings of those racks are provided in Figures B.1 through B.4 in Appendix B. Test racks, equipment, specimens and test site locations are shown in Figures B.5 through B.12 in Appendix B. Standard exposure angles are either 30 or 45 degrees from the horizontal (the higher angle usually recommended for paints and other organic systems), and the lower edge of individual specimens should be not less than 0.8m (30 in.) from the ground [24]. For this corrosion study, the specimens were exposed at 30 degrees to the horizontal and each specimen was secured with three NYLON 6/6 (Polyamide) insulators as shown in Figure 3.2.

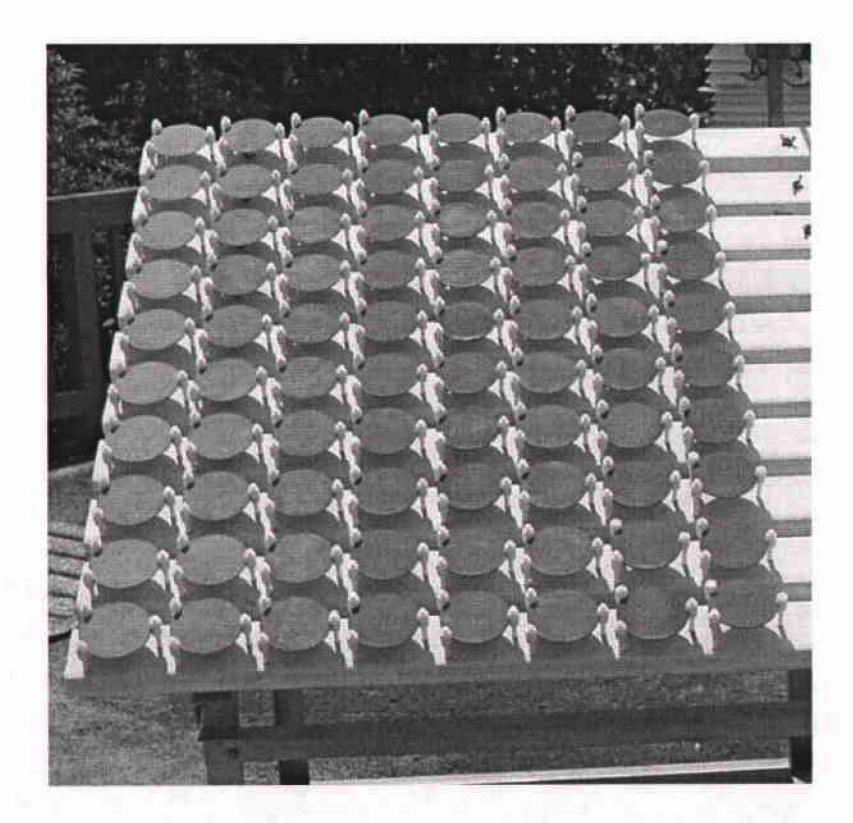
Figure 3.3: Typical arrangement of MMCs at test sites

The eight MMCs are arranged in eight columns of ten rows where each column contains the same type of MMC. Specimens were placed on the rack with the alphanumeric code on the underside (facing down). Table 3.1 shows the exposure schedule at each test site. At the time of writing, rows 1 through 6 at all six test sites had been retrieved and rows 7 through 9 had been retrieved from the Lyon Arboretum and Coconut Island sites. Rows 7 through 9 at the remaining four sites are scheduled to be retrieved at the end of June, 2004. Once the MMC specimens were recovered from the field, they were scanned or photographed in the uncleaned state. The majority of the disks were then cleaned in a solution of phosphoric acid (H₃PO₄), chromium trioxide (CrO₃) and ultrapure (18.1 MΩcm) water as described in ISO 8407:1991(E).

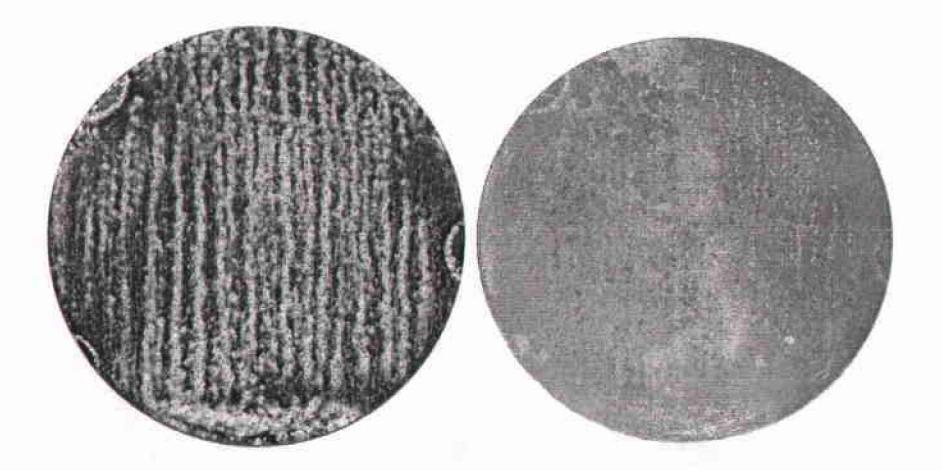
Figure 3.4: Al6092-T6/SiC/40p MMC exposed for 90 days - before and after cleaning

Figure 3.4 shows an Al6092-T6/SiC/40p specimen that was exposed at the Lyon Arboretum test site for 90 days. The specimen is shown before and after cleaning.

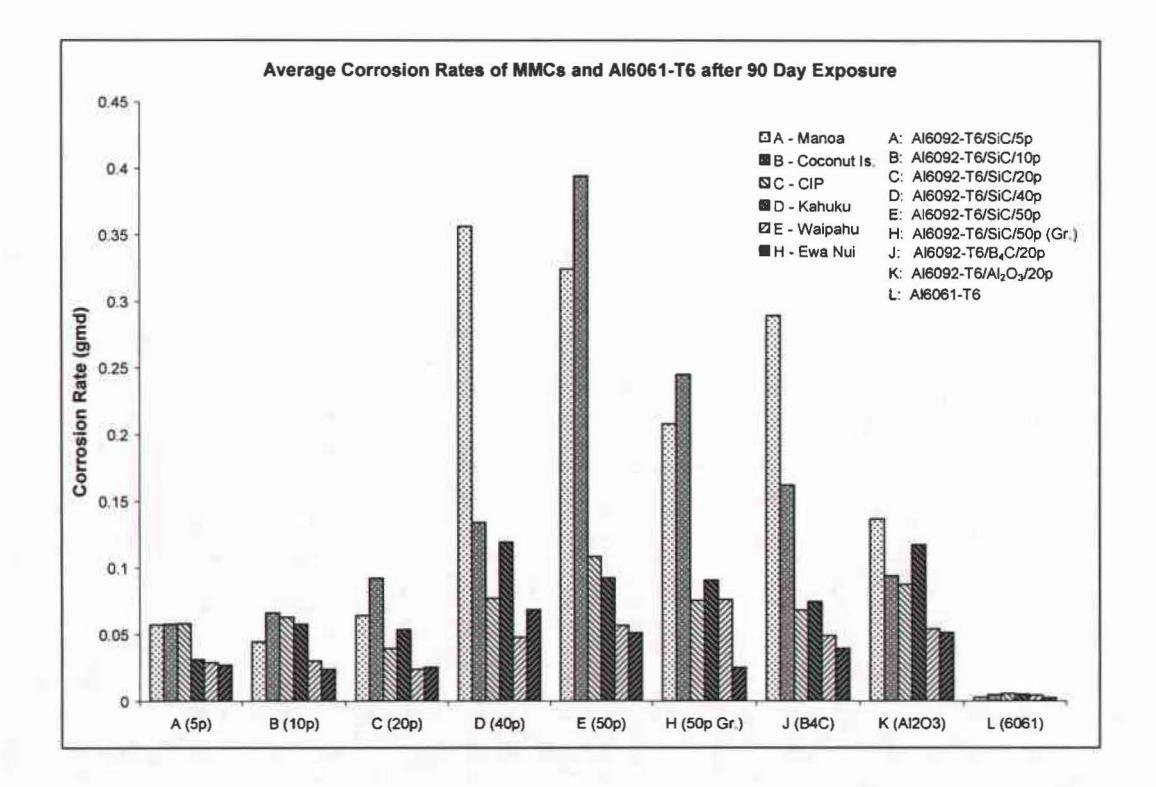
Figure 3.5: Average corrosion rates of MMCs and Al6061-T6 after 90 day exposure

Average corrosion rates for the 90 day, 180 day and 360 day exposures are provided in Figures 3.5, 3.6, and 3.7. Data for 360 day exposure corrosion rates has been collected for two of the test sites, namely Manoa and Coconut Island. Figure 3.7 compares average corrosion rates over 90, 180 and 360 day exposures for those sites.

Some trends are clearly visible from the corrosion data obtained. Corrosion rate of an MMC generally increases with an increase in volume fraction of the reinforcement. At the end of the 90 day exposure, Al6092-T6/SiC/50p at Coconut Island was the worst performing MMC having a corrosion rate more than 80 times that of Al6061-T6 at the same site exposed for the same duration. Even the best performing MMC, Al6092-T6/SiC/10p at the Ewa Nui test site had a corrosion rate almost 10 times greater than Al6061-T6 at the same site. Three of the eight MMCs have the same twenty percent volume fraction of reinforcement but Al6092/B₄C/20p generally appears to corrode at a higher rate than either SiC or Al₂O₃ reinforced aluminum. This is likely due to the resistivity of the reinforcements since boron carbide is generally considered to be a conductor, silicon carbide a semi-conductor and aluminum oxide an insulator. Corrosion rates for all of the MMCs at the Manoa (Lyon Arboretum) and Coconut Island test sites were comparable for the 90, 180 and 360 day exposures despite significant differences in atmospheric and weather conditions at the two sites. The data collected for the 360 day exposure only included two test sites, namely Manoa and Coconut Island, but Figure 3.7 shows some convergence of the corrosion rates of the MMCs at those sites. Not only are the corrosion rates of each MMC diminishing throughout the year, but the differences between the MMCs are becoming less obvious to the extent that one MMC has no clear corrosion advantage over another. After one year, the difference between the worst performing MMC at the Manoa site compared to Al6061-T6 at the same site had decreased by almost seventy five percent i.e. from 138 times to less than 39 times the

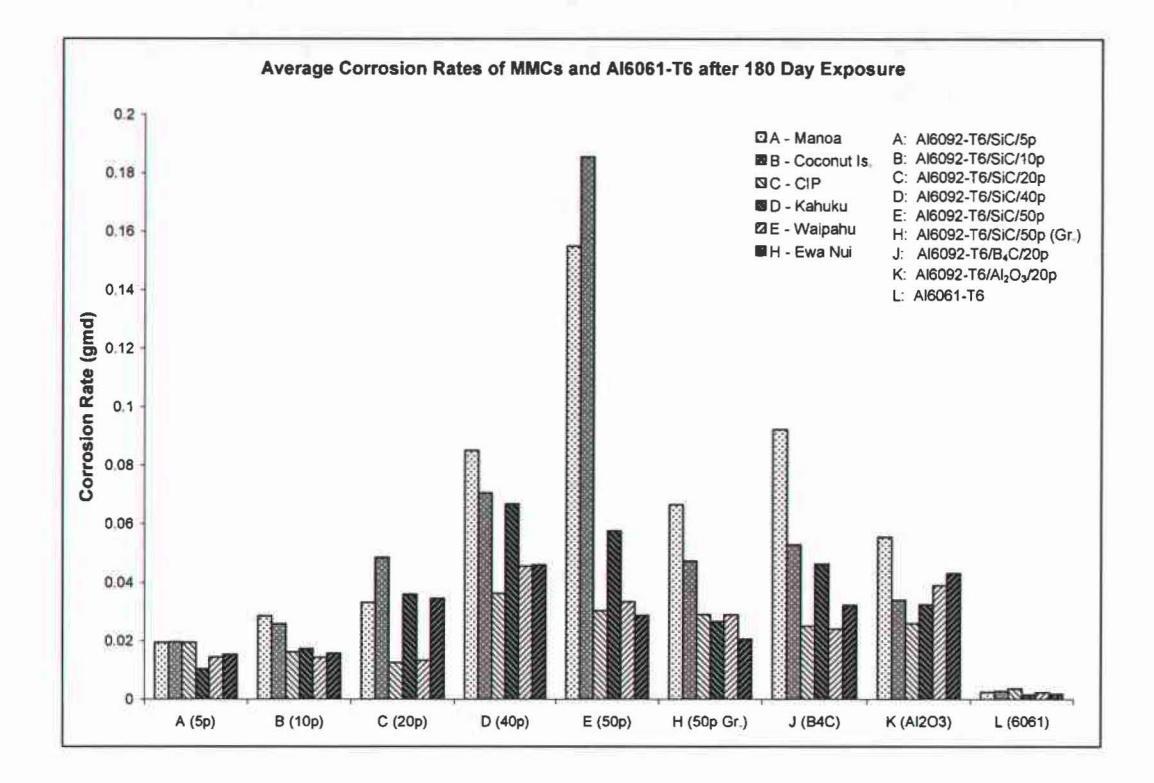
Figure 3.6: Average corrosion rates of MMCs and Al6061-T6 after 180 day exposure

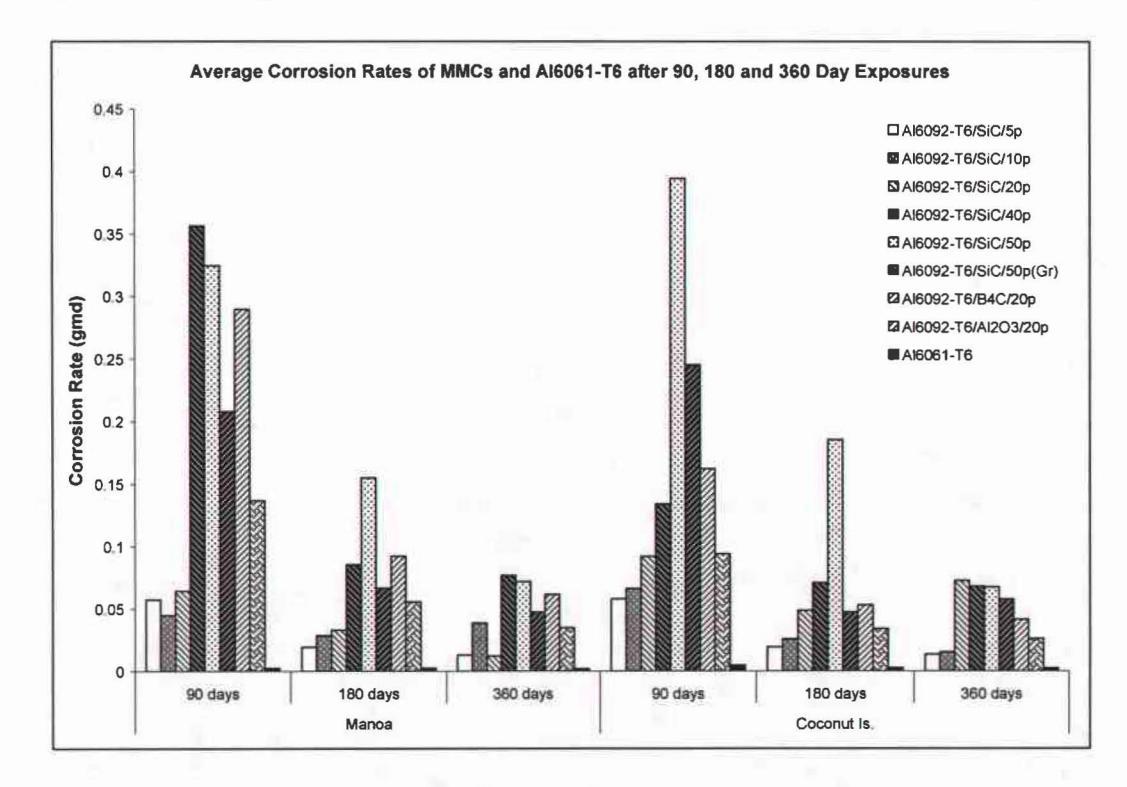
Figure 3.7: Average corrosion rates of MMCs and Al6061-T6 after 360 day exposure

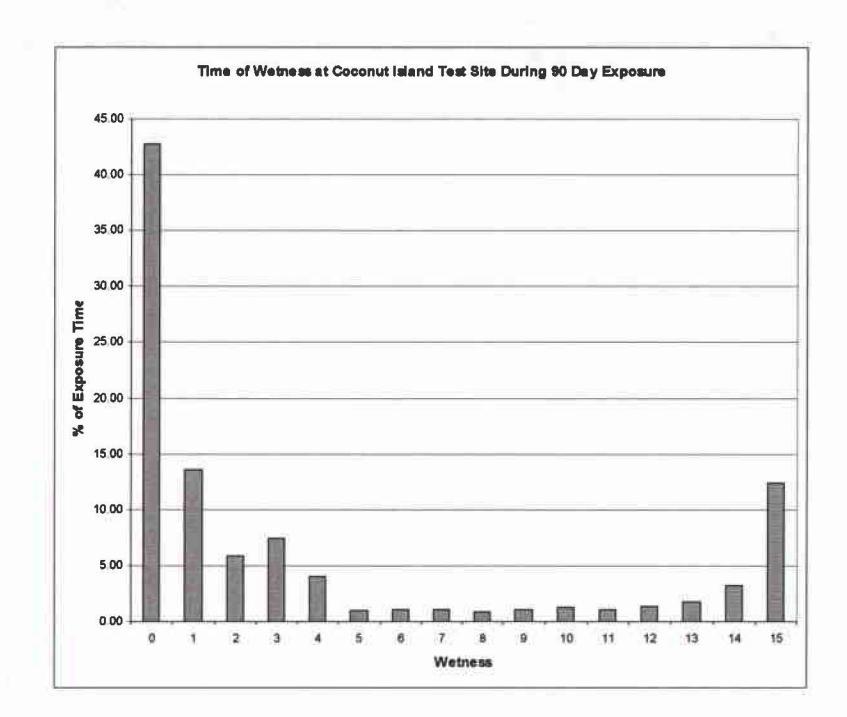
Figure 4.2: Time of wetness (TOW) of leaf wetness sensor at Coconut Island test site

Leaf wetness sensors, in addition to providing data indicating the percentage of the total exposure time at each test site when specimens are completely wet, may also provide an insight into how the specimens transition for the wet to the dry state. Figure 4.1 shows the time of wetness (TOW) of the leaf wetness sensor at the Lyon Arboretum during the 90 day exposure period. In contrast, Figure 4.2 shows the time of wetness (TOW) of the leaf wetness the time of wetness (TOW) of the leaf wetness the time of wetness (TOW) of the leaf wetness sensor at the Lyon Arboretum during the leaf wetness sensor at the Coconut Island test site during the same 90 day exposure.

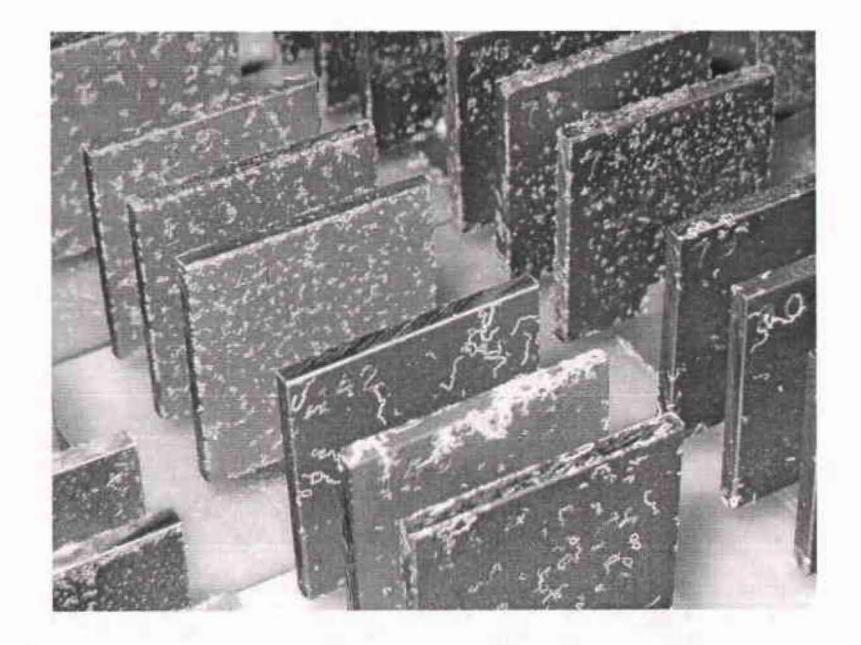
Figure 5.1: MMC specimens after 90 day exposure in humidity chamber

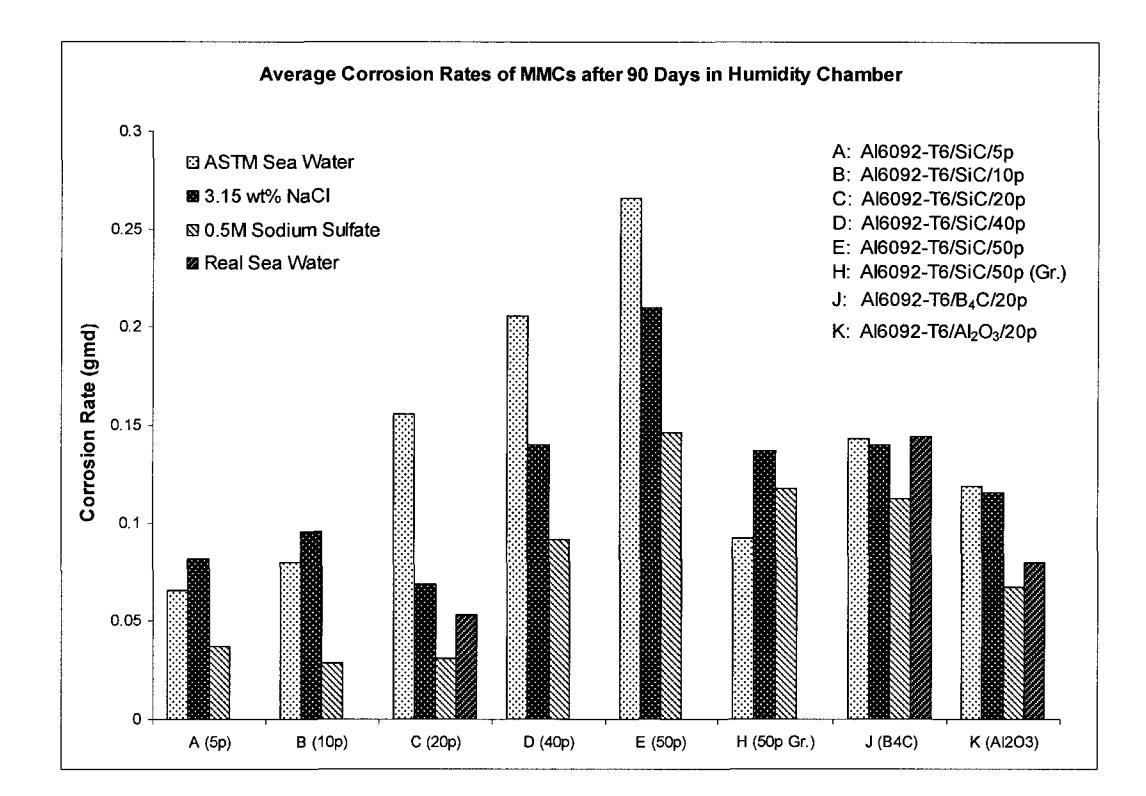
Figure 5.2: Corrosion rates of MMCs exposed in humidity chamber for 90 days

As in the field study, the corrosion rates were generally found to increase with an increase in the volume fraction of the particulate reinforcement. The corrosion rates of the specimens dipped in ASTM sea water, 3.15 wt.% NaCl and real sea water were similar. Of the three MMCs having a volume fraction of 20 percent, Al6092-T6/Al₂O₃/20p had a consistently lower corrosion rate than the B₄C reinforced aluminum. This may be due to the much greater resistivity of Al₂O₃ compared to B₄C. This explanation is further reinforced by the corrosion rate soft the three MMCs dipped in ASTM sea water. Of the three, the highest corrosion rate was the SiC MMC followed by

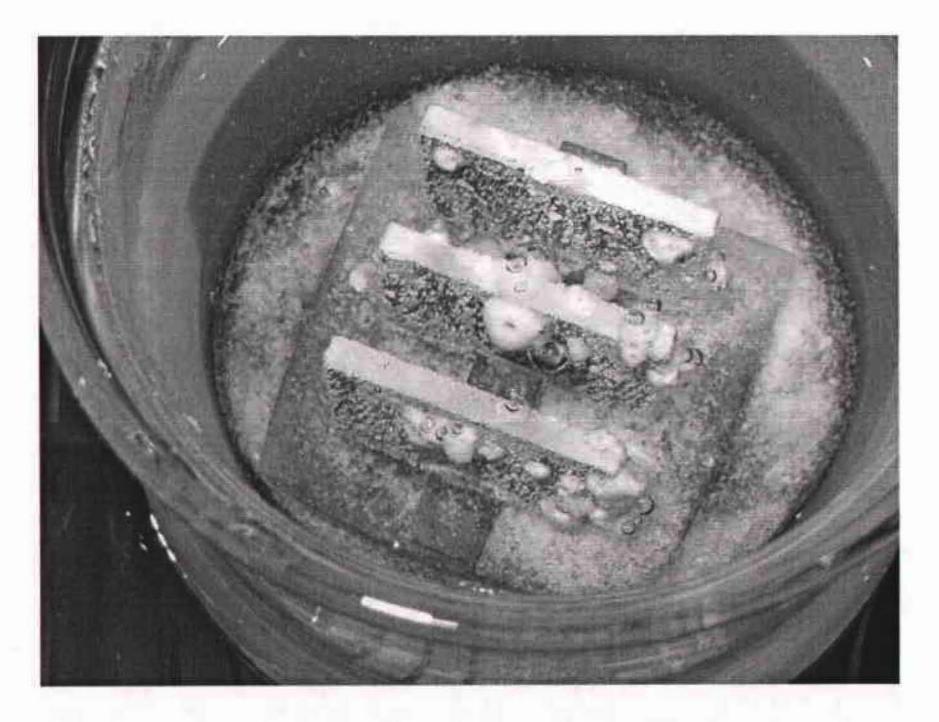
Figure 6.1: MMC in electrolyte after 90 day immersion

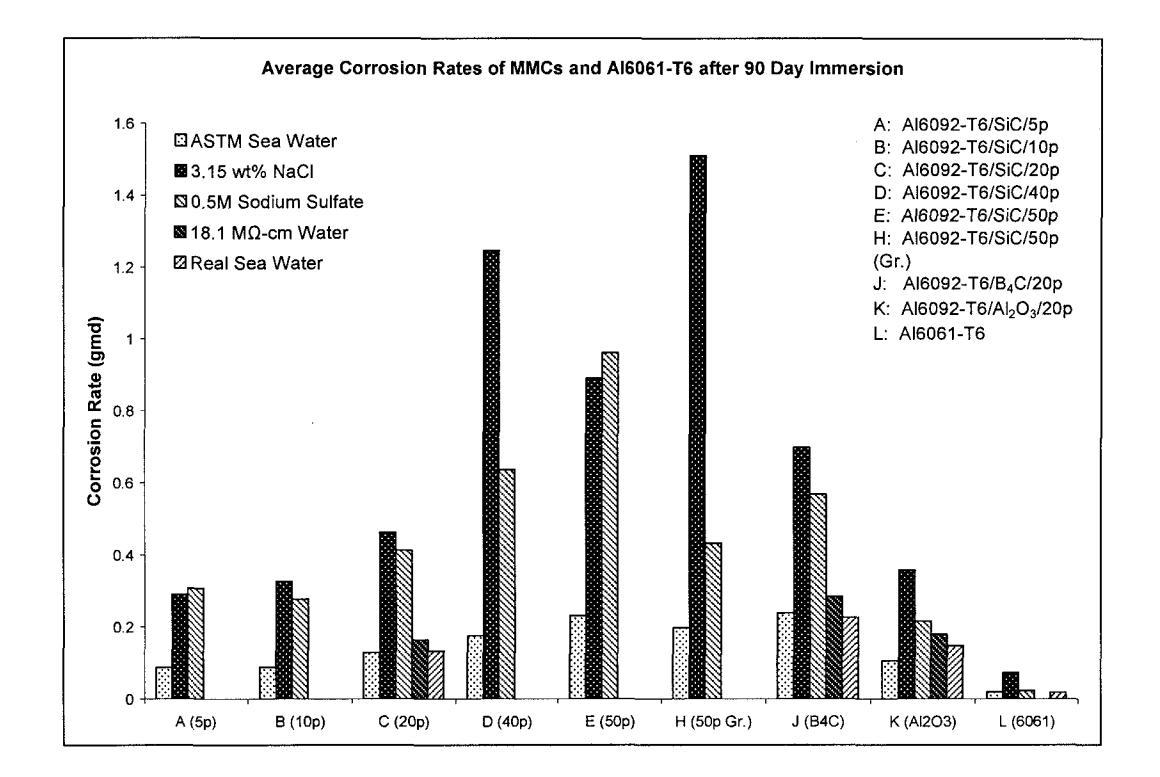
Figure 6.2: Corrosion rates of MMCs and Al6061-T6 after 90 day immersion

The data in Figure 6.2 shows an increase in corrosion rate with a corresponding increase in the volume fraction of the particulate reinforcement. As in the humidity chamber experiment, the corrosion rates of the three MMCs having reinforcement volume fractions of 20 percent exhibit corrosion behavior that may be partly explained by the relative resistivities of the reinforcement material. Of the three 20p MMCs in most of the solutions, the highest corrosion rates were observed in the B₄C MMC followed by SiC and Al_2O_3 MMCs. This trend maintains Al_2O_3 as the best performer and follows the respective resistivities of 10^{1} , 10^{0} and 10^{14} as shown in Table 1.2. The corrosion rates of all of the MMCs in 3.15 wt.% NaCl are markedly higher than corresponding rates in ASTM sea water or real sea water. In each case where the specimen was immersed in either ASTM sea water or real sea water, EDXA analysis indicated the presence of magnesium hydroxide $(Mg(OH)_2)$ and not calcium carbonate $(CaCO_3)$ as expected. It is suggested that the $Mg(OH)_2$ covered the cathodic sites on the composite thereby reducing the rate of corrosion in both ASTM and real sea water. Figures C.1 and C.2 in Appendix C show EDXA results of Al6092-T6/B₄C/20p and Al6092-T6/Al₂O₃/20p after immersion in 3.15 wt.% NaCl. In both cases there are no peaks to suggest the presence of either magnesium or calcium. This is expected since 3.15 wt.% NaCl solution shouldn't contain either element. However, the result may help to confirm that sea water is the source of the magnesium rather than the 6092 matrix material which does contain small amounts of magnesium as shown in Table 1.1. Real sea water and ASTM sea water have natural corrosion inhibitors in addition to providing some form of solution buffering. Both ASTM sea water and real sea water became more neutral over the 90 day immersion experiment. ASTM sea water had an initial pH of 8.2 and the real sea water had an initial pH close to 7.8 but after the experiment was completed the pH of both solutions was close to 7.5. The other three solutions became more alkaline ending with pH ranges of 7.4 to 8.7. Since all of the solutions were aerated in the sense that oxygen was allowed, both proton reduction (hydrogen evolution) and oxygen reduction could take place on cathodic sites. For MMCs in 0.5M Na₂SO₄, 3.15 wt.% NaCl or ultrapure water, the higher corrosion rates and hence increase in hydrogen evolution and/or oxygen

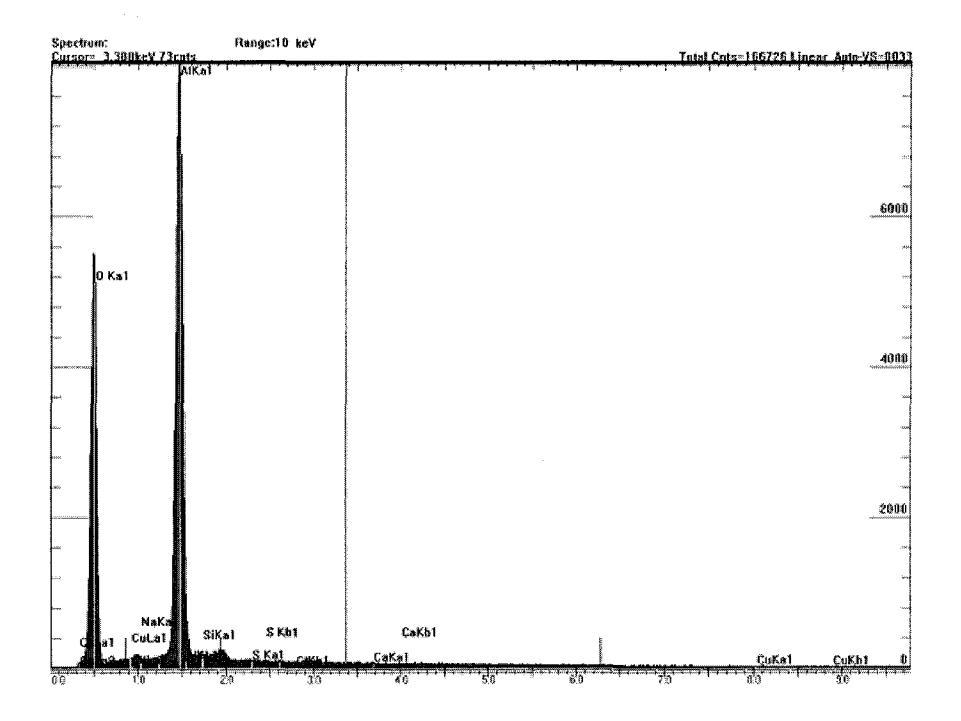
Figure 6.3: EDXA of Al6092-T6/SiC/20p immersed in 3.15 wt.% NaCl

Five MMC specimens were selected for Energy Dispersive X-ray Analysis (EDXA) after the 90 day immersion experiment to determine the composition of the corrosion products on the surface of each coupon. The five MMCs selected included Al6092/SiC/20p immersed in 3.15 wt% NaCl, ASTM sea water and real sea water. Also, Al6092-T6/B4C/20p and Al6092-T6/Al2O3/20p immersed in ASTM sea water. Figures 6.3 , 6.4 and 6.5 show the data collected from a 600 micron by 400 micron area from the three Al6092/SiC/20p MMC specimens.

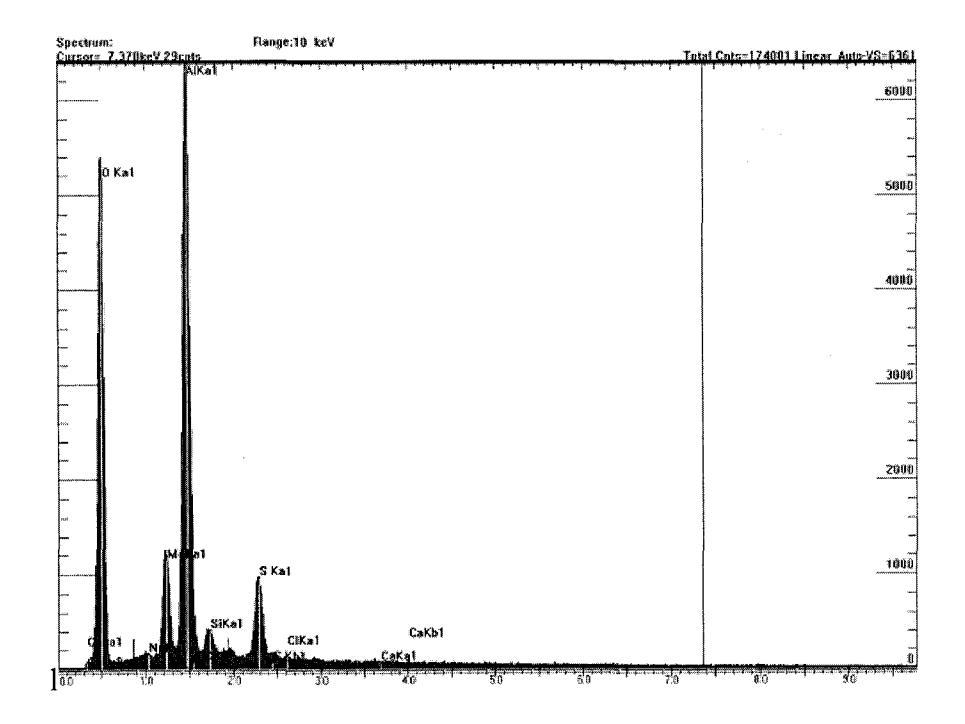
Figure 6.4: EDXA of Al6092-T6/SiC/20p immersed in ASTM sea water

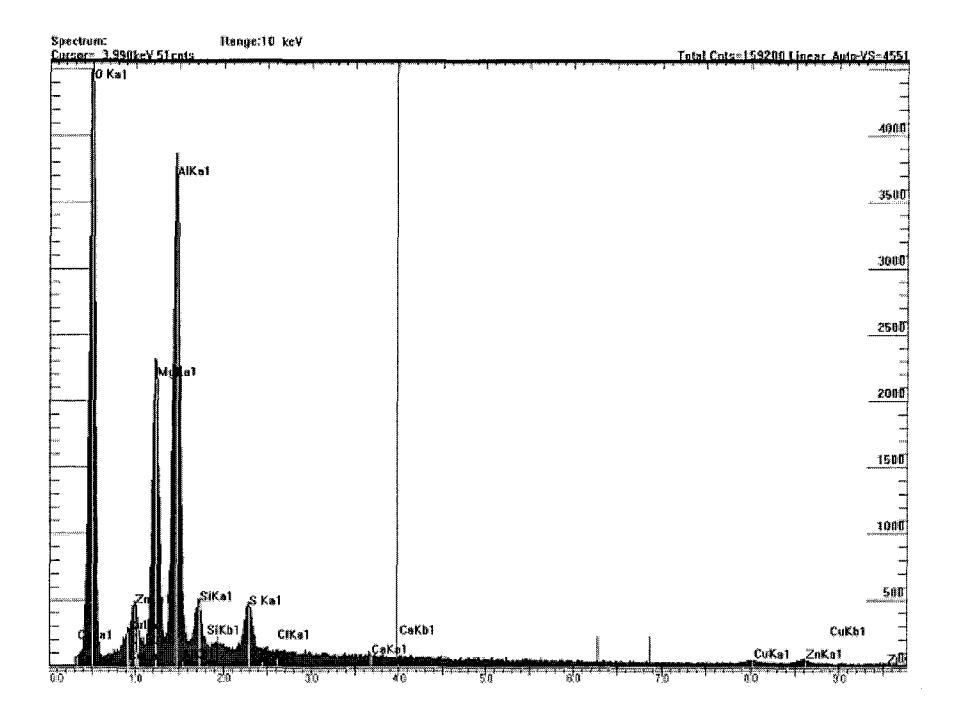
Figure 6.5: EDXA of Al6092-T6/SiC/20p immersed in real sea water

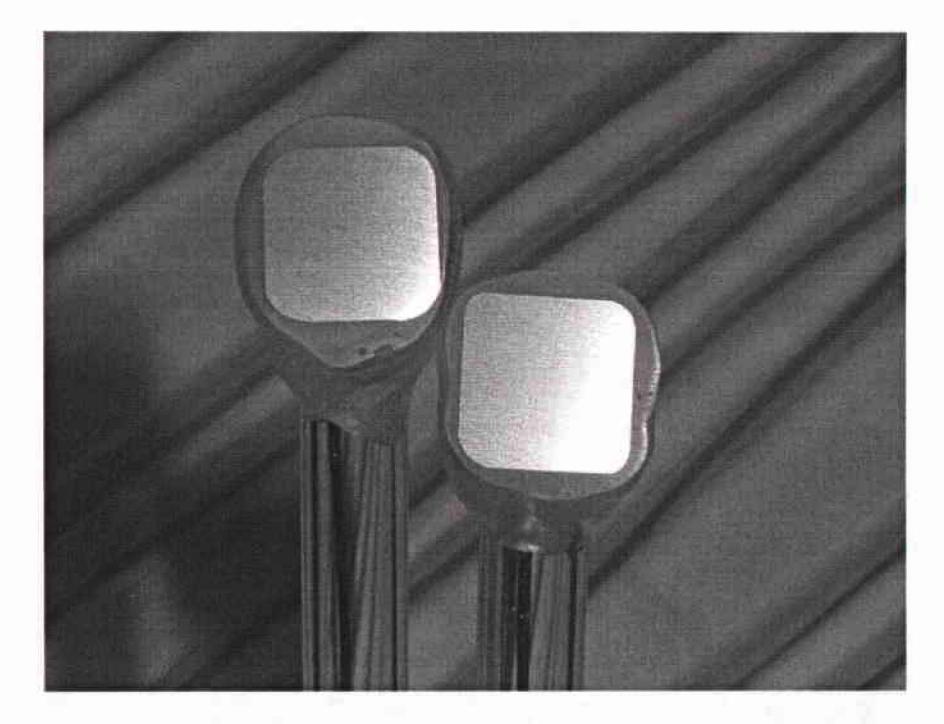
Figure 7.1: MMC polarization electrodes ready for final polishing

grit silicon carbide paper followed by 600 grit silicon carbide paper. After grinding with 600 grit silicon carbide paper, each electrode was viewed under an optical microscope to check for crevices between the edges of the electrode face and the surrounding epoxy. In addition, the resistance between the face of the electrode and the end of the copper wire was measured to ensure good conductivity. Resistances ranging from 0.5Ω to 1.0Ω were found to be ideal.

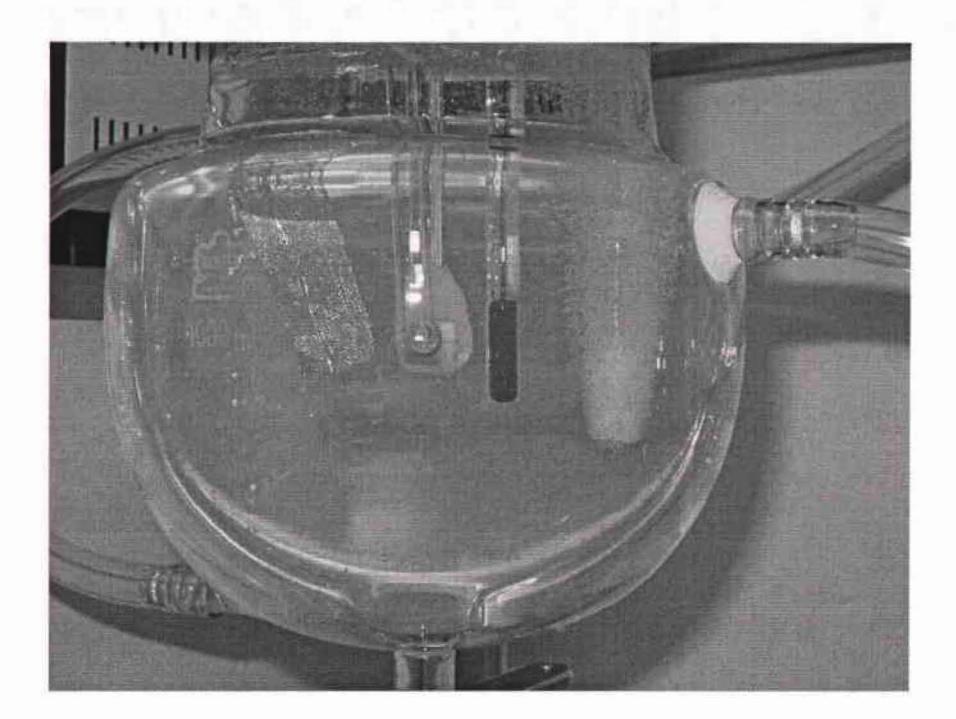
Figure 7.2: Typical polarization cell arrangement

Polarization experiments for the MMCs were conducted using a Princeton Applied Research Potentiostat/Galvanostat Model 273A controlled with DOS based software. Polarization experiments for the Al6061-T6 were conducted using a Princeton Applied Research Potentiostat/Galvanostat Model 283 controlled with Windows® based software. All of the anodic polarization experiments were run in either deaerated 3.15 wt.% sodium chloride (NaCl) solution or deaerated 0.5M sodium sulfate (NaSO₄) solution. In both cases the cell was deaerated with nitrogen (N_2) gas that was 99.999% pure. A typical polarization cell set up is shown in Figure 7.2. The cell contained a working electrode, a platinum counter electrode, a glass luggin probe that provided connectivity to a calomel reference electrode, a gas dispersion tube and a thermometer. The jacketed cell was connected to a Fisher Scientific model 9100 Isotemp refrigerated circulator that maintained the electrolyte inside the cell at 30°C. For each of the polarization experiments, the cell was filled with electrolyte and allowed to reach operating temperature while the working electrode was repolished with 0.05 micron alumina polish. The electrode was rinsed in ultrapure water and placed in a beaker of ultrapure water to prevent the oxide layer from drying out. The electrode was then placed in the cell and electrolyte was drawn through the luggin probe to the reference electrode.

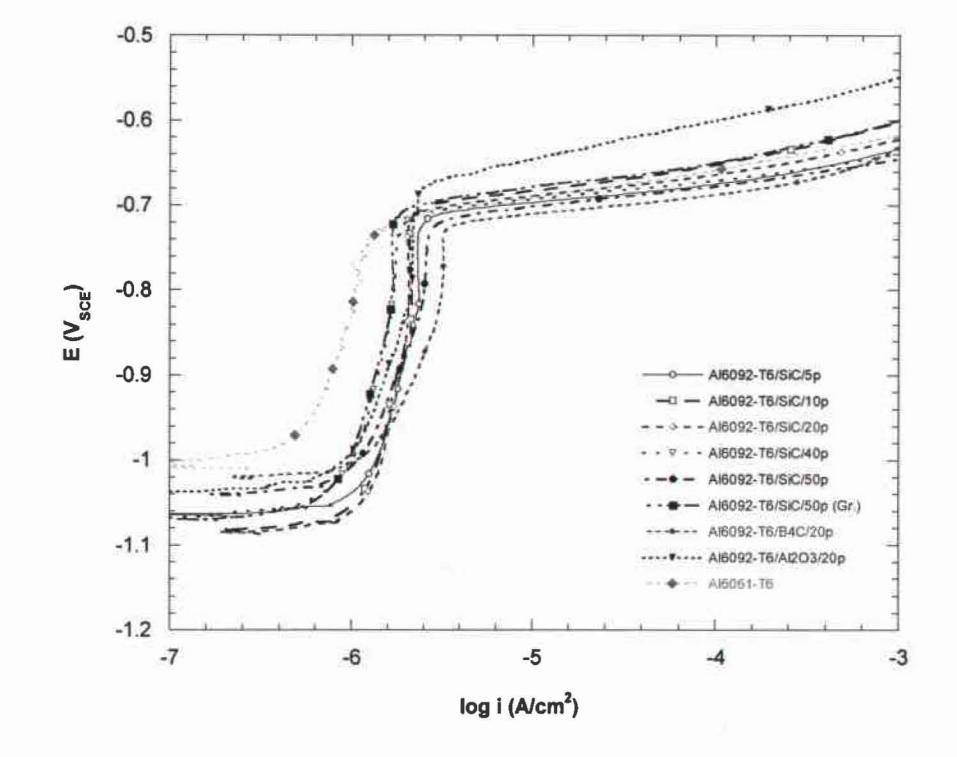
Figure 7.3: Anodic polarization in deaerated 3.15 wt.% sodium chloride solution

It should be noted that each curve in the above figures is an average curve obtained from three experiments conducted with two electrodes per MMC or Al6061-T6 per solution. The first electrode was polarized once whereas the second electrode was polarized twice. The electrode to be polarized a second time was removed from the cell and reground on 600 grit silicon carbide paper before being reused for the third experiment. It was repolished using 1, 0.3 and 0.05 micron deagglomerated alpha alumina polish until a "mirror-like" finish was achieved.

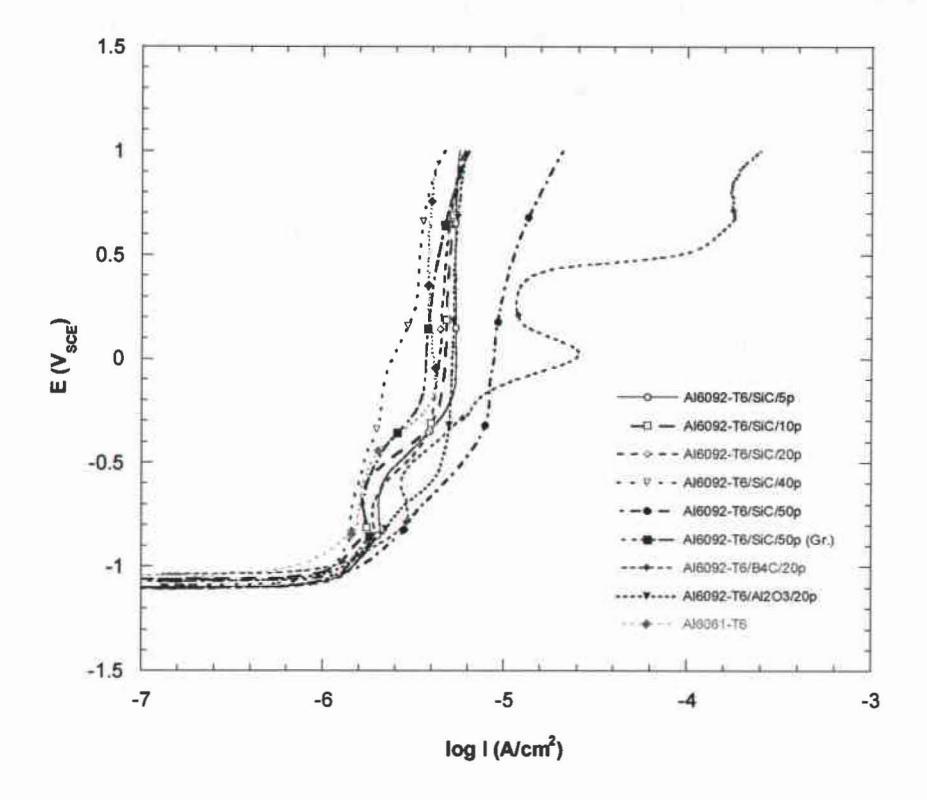
Figure 7.4: Anodic polarization in deaerated 0.5M sodium sulfate solution

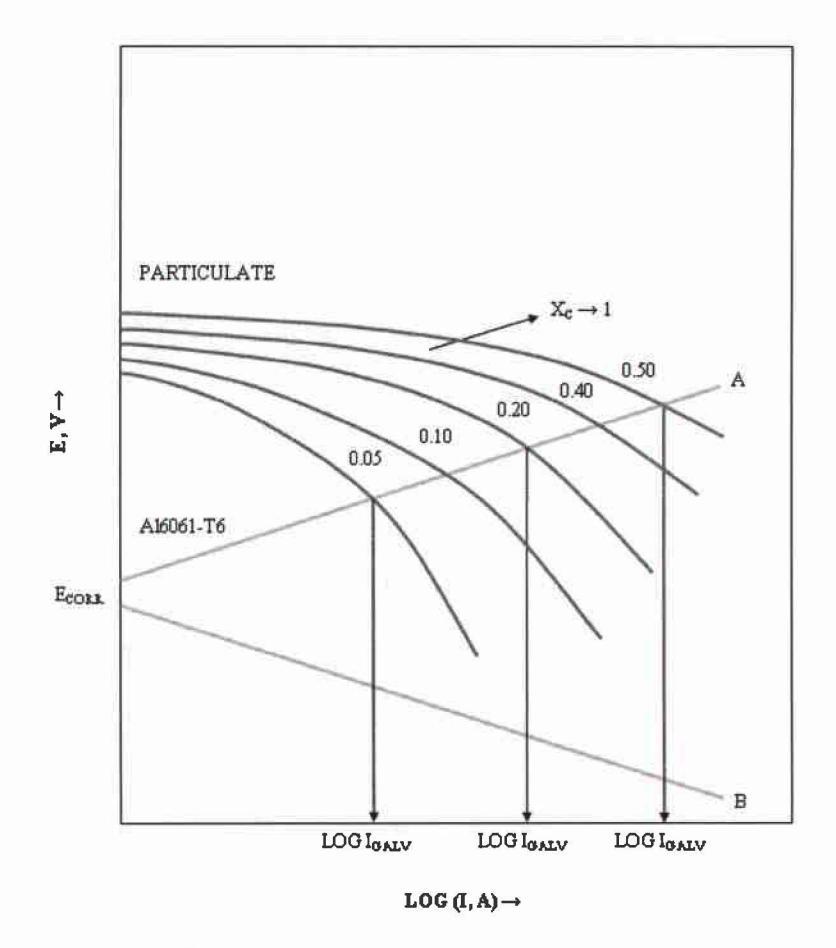
Figure 8.1: Generic polarization plot for Al6061-T6 and a noble particulate with increasing volume fraction

In equation (2), i_{GALV} is the dissolution current density of the matrix; i_C is the current density of the cathode; X_C is the area fraction of the cathode; and 1- X_C is the area fraction of the anode.

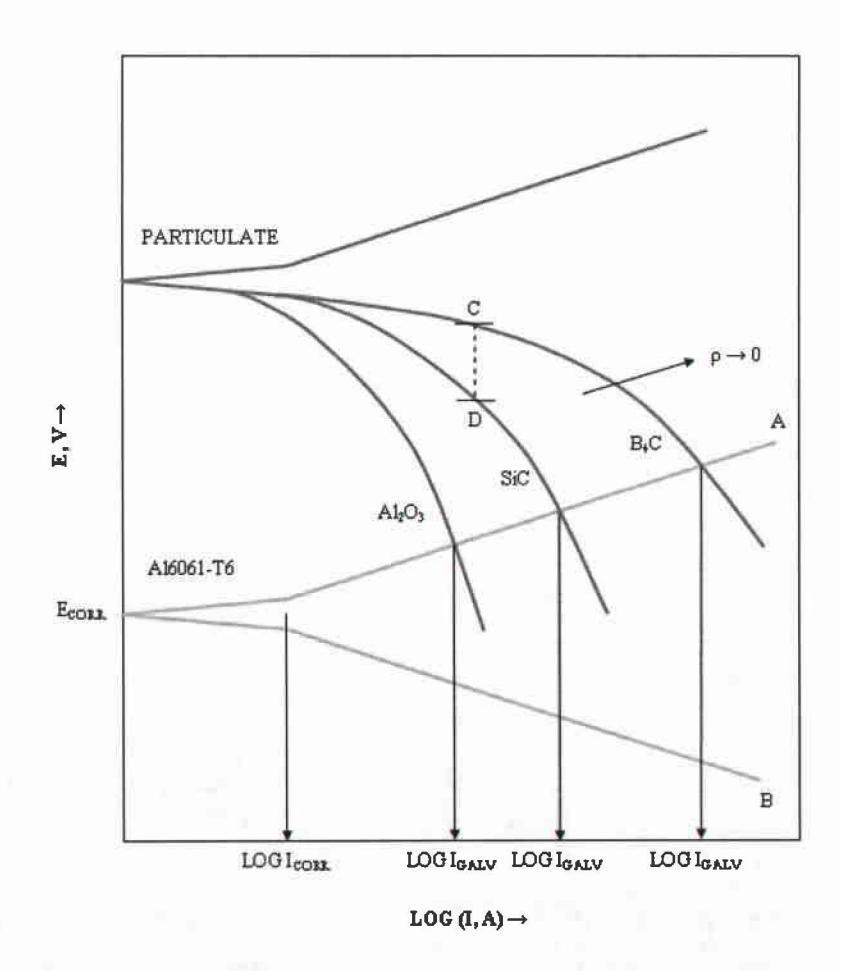
Figure 8.2 shows theoretical cathodic curves for Al_2O_3 , SiC and B_4C intersecting the anodic curve for Al6061-T6. As the resistivity (ρ) of the noble particulate decreases, the galvanic current increases.Line C-D in Figure 8.2 represents the ohmic loss between B_4C and SiC at a fixed current value. In addition to the influence that volume fraction and particle resistivity have on corrosion, the microstructure of each MMC may also have a significant effect. One of the MMCs manufactured for this study showed inconsistencies in processing. Large voids can clearly be seen in the matrix of the Al6092-T6/SiC/50p (Gr.) MMC shown in Figure 8.3. It is unclear at this time if the presence of such voids had a major effect on corrosion rates. Specimens with manufacturing voids retrieved from test sites showed an increase in weight after cleaning. The increase in weight could be due to corrosion products remaining in the voids.
