OUTDOOR & LABORATORY CORROSION STUDIES OF ALUMINUM METAL – MATRIX COMPOSITES

A THESIS SUBMITTED TO THE GRADUATE DIVISION OF THE UNIVERSITY OF HAWAI'I IN PARTIAL FULFILLMENT OF THE REQUIREMENTS FOR THE DEGREE OF

MECHANICAL ENGINEERING

AUGUST 2004

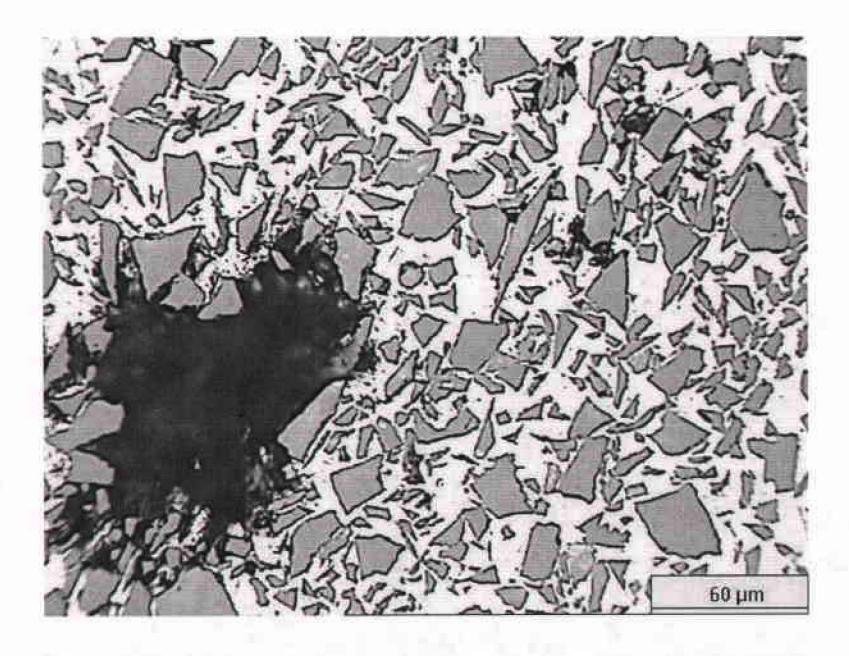
Figure 8.3: Large voids in Al6092-T6/SiC/50p (Gr.) MMC

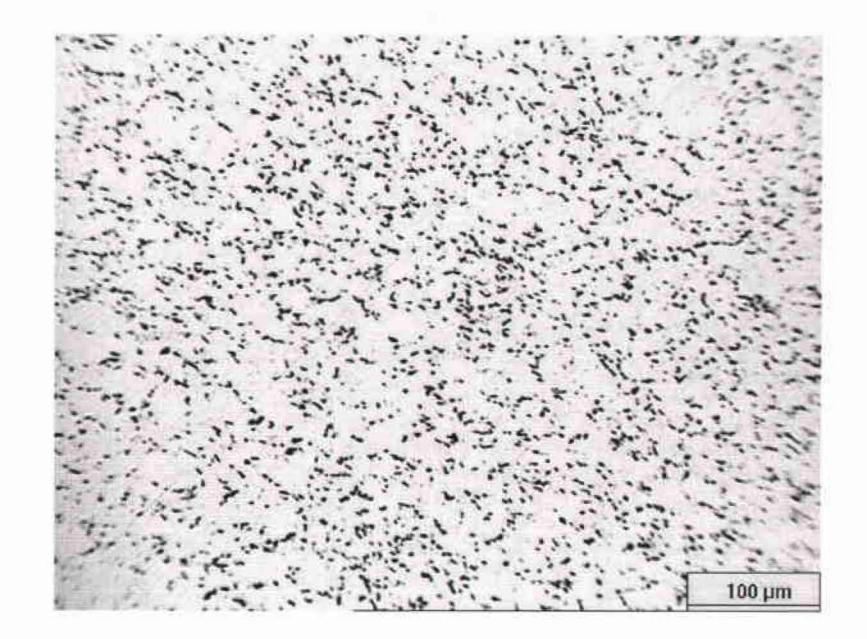
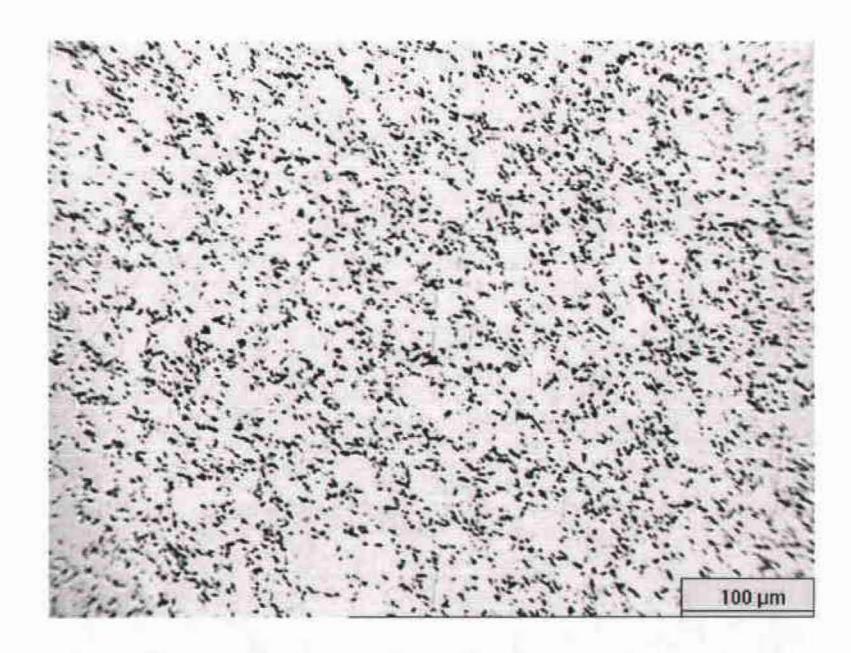
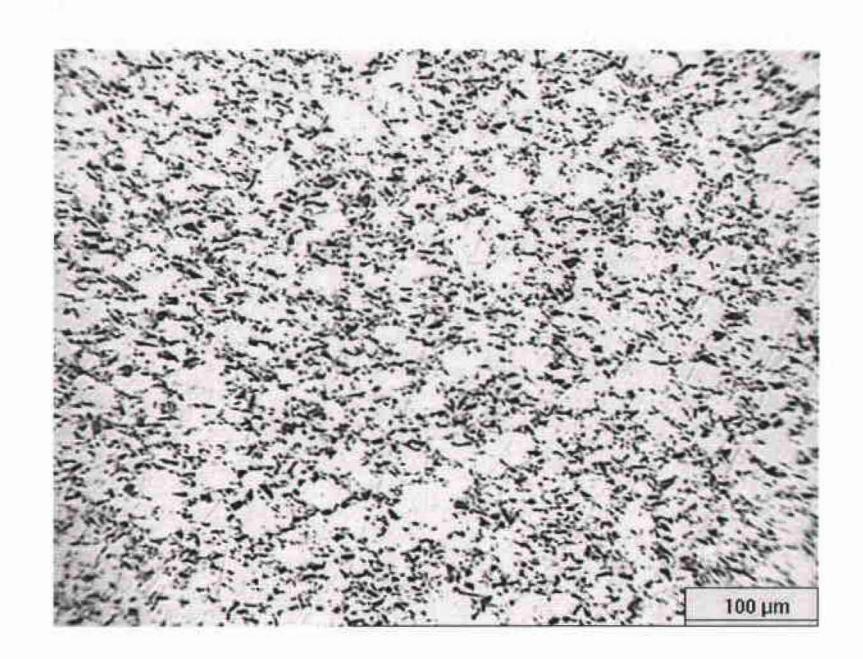
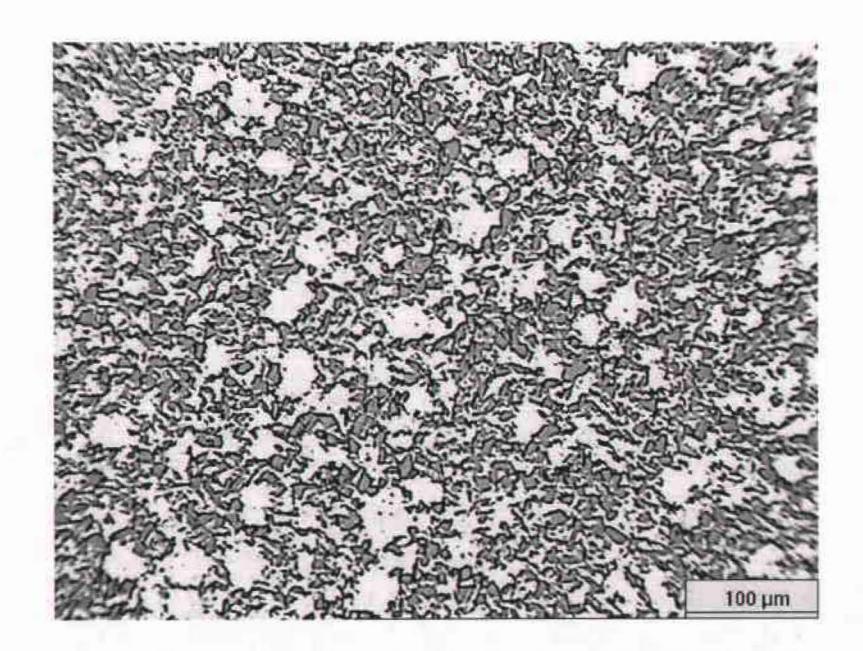
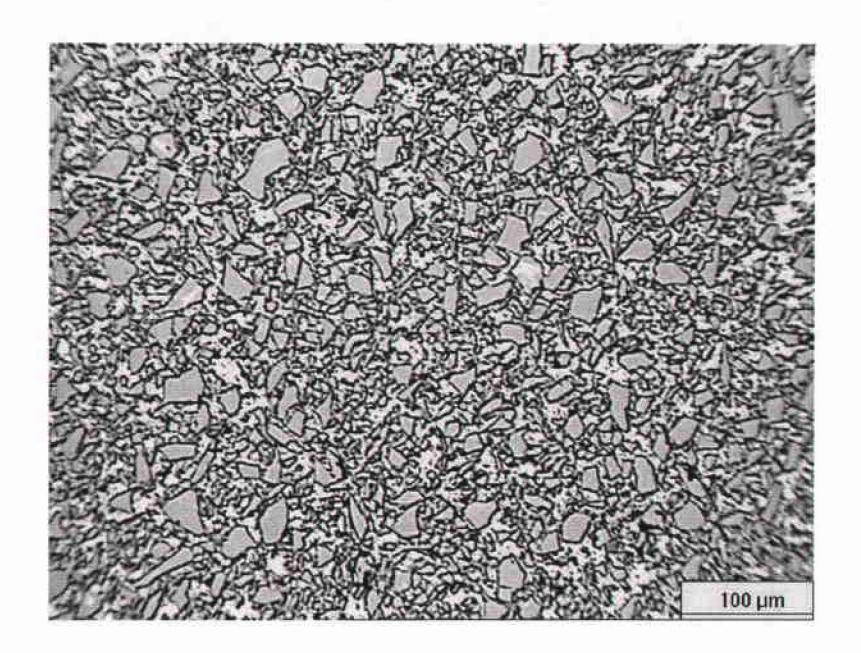
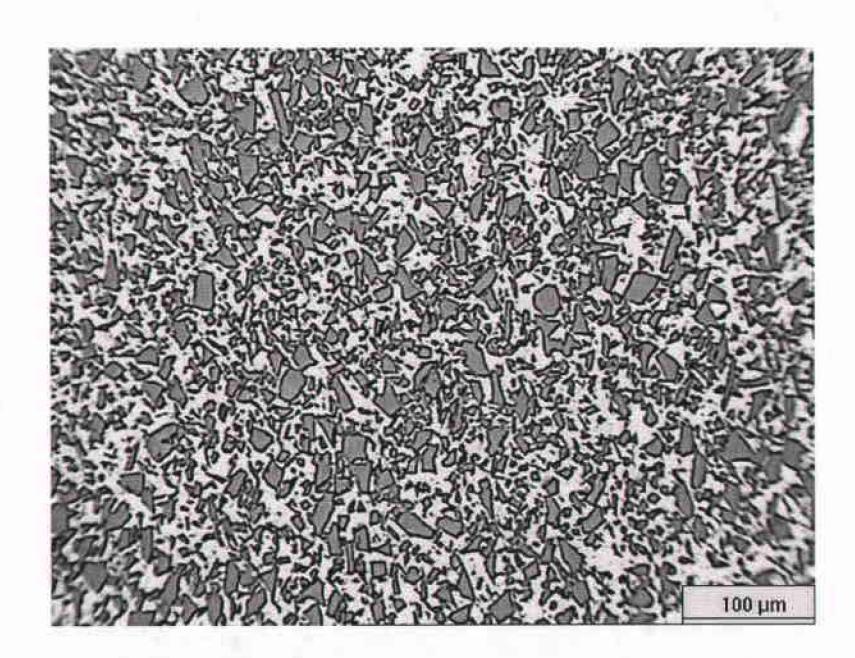
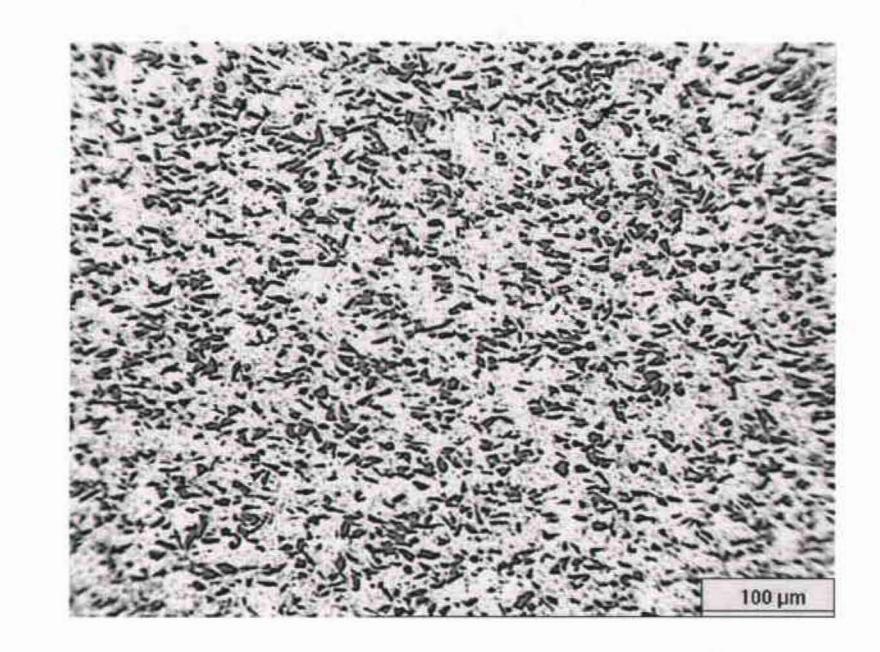
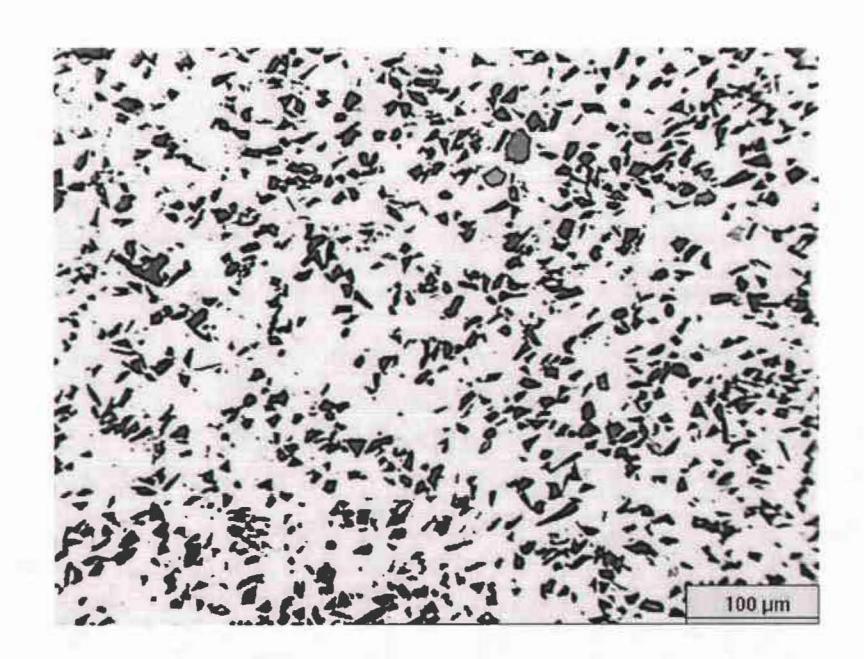
Figures A.1 through A.8 in Appendix A show the eight MMCs at a lower magnification thereby revealing the macroscopic uniformity of the microstructure.

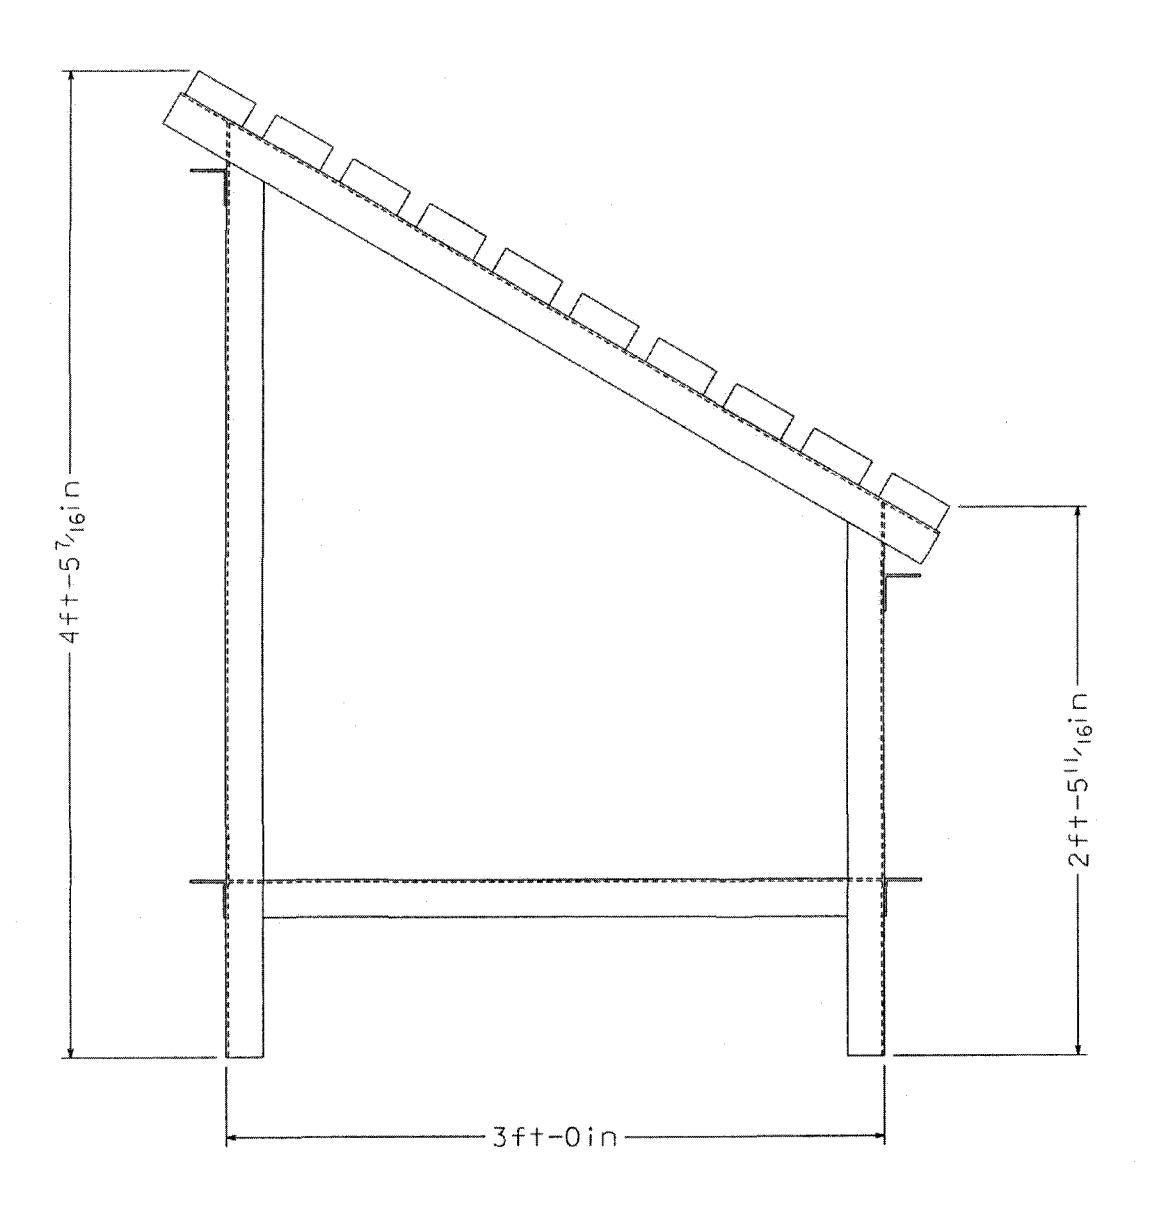
Figure B.1: Typical dimensions of 316 stainless steel test rack used at Manoa (Lyon Arboretum) and Coconut Island test sites

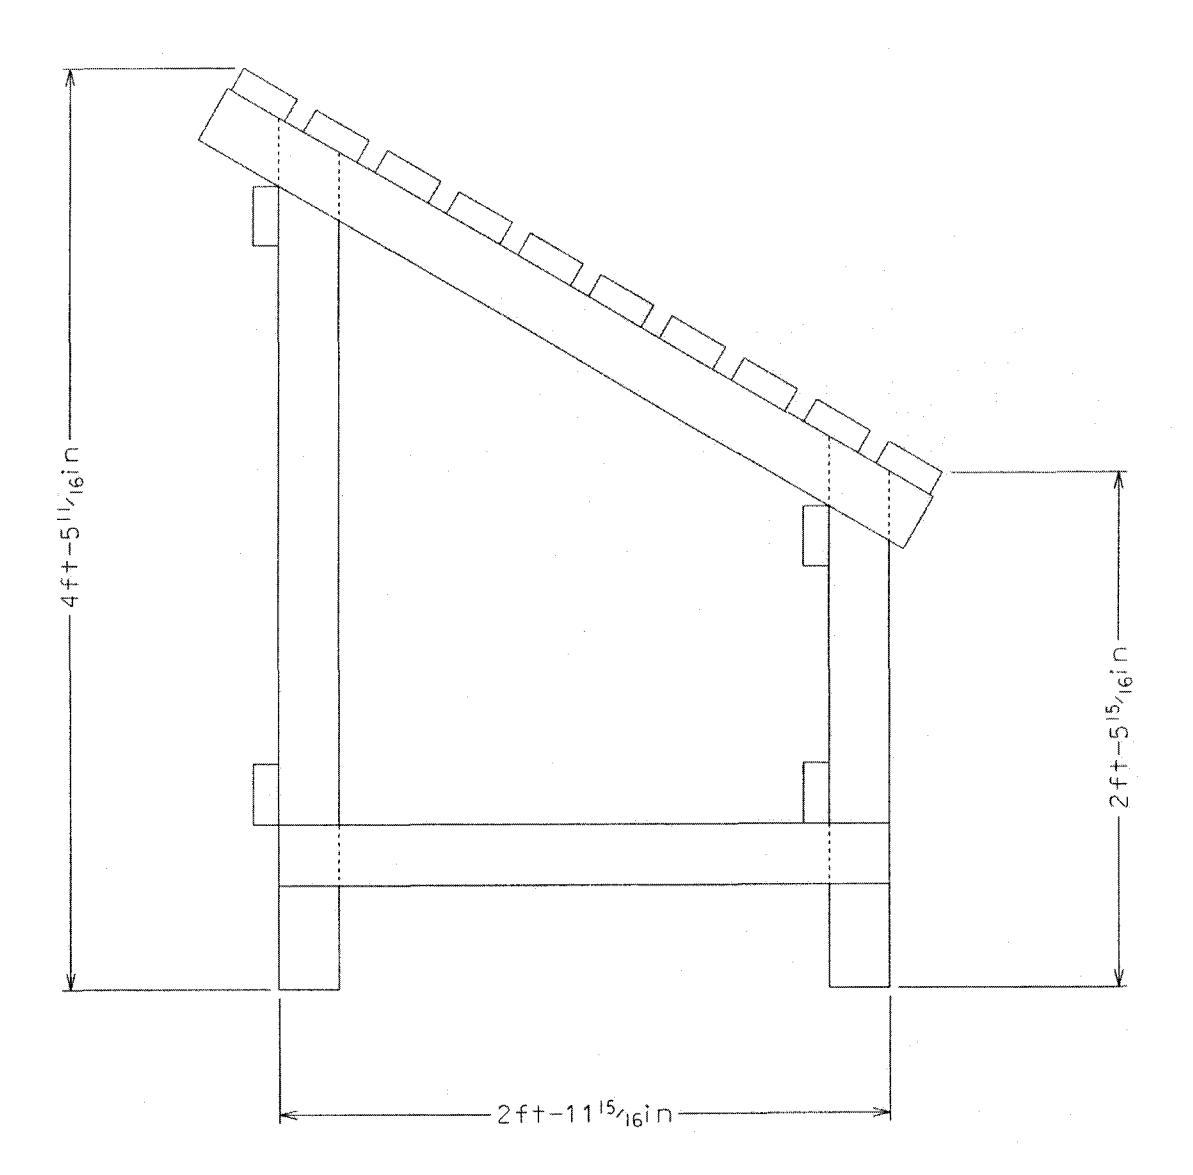
Figure B.2: Typical dimensions of TREX® test rack used at Hawaiian Electric Company (HECO) test sites

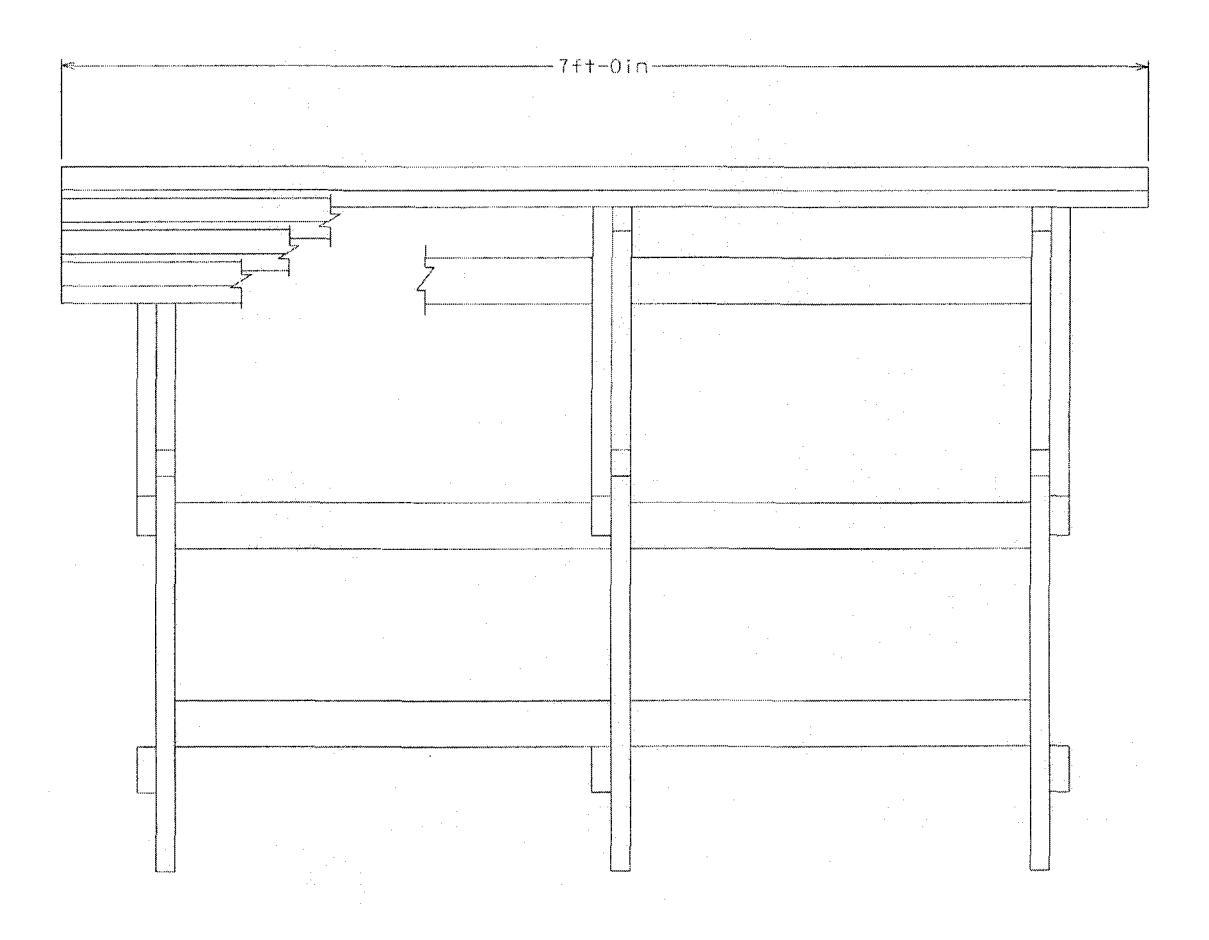
Figure B.3: Typical dimensions and front view of TREX® test rack used at Hawaiian Electric Company (HECO) test sites. Arrangement and dimensions are similar for stainless steel racks

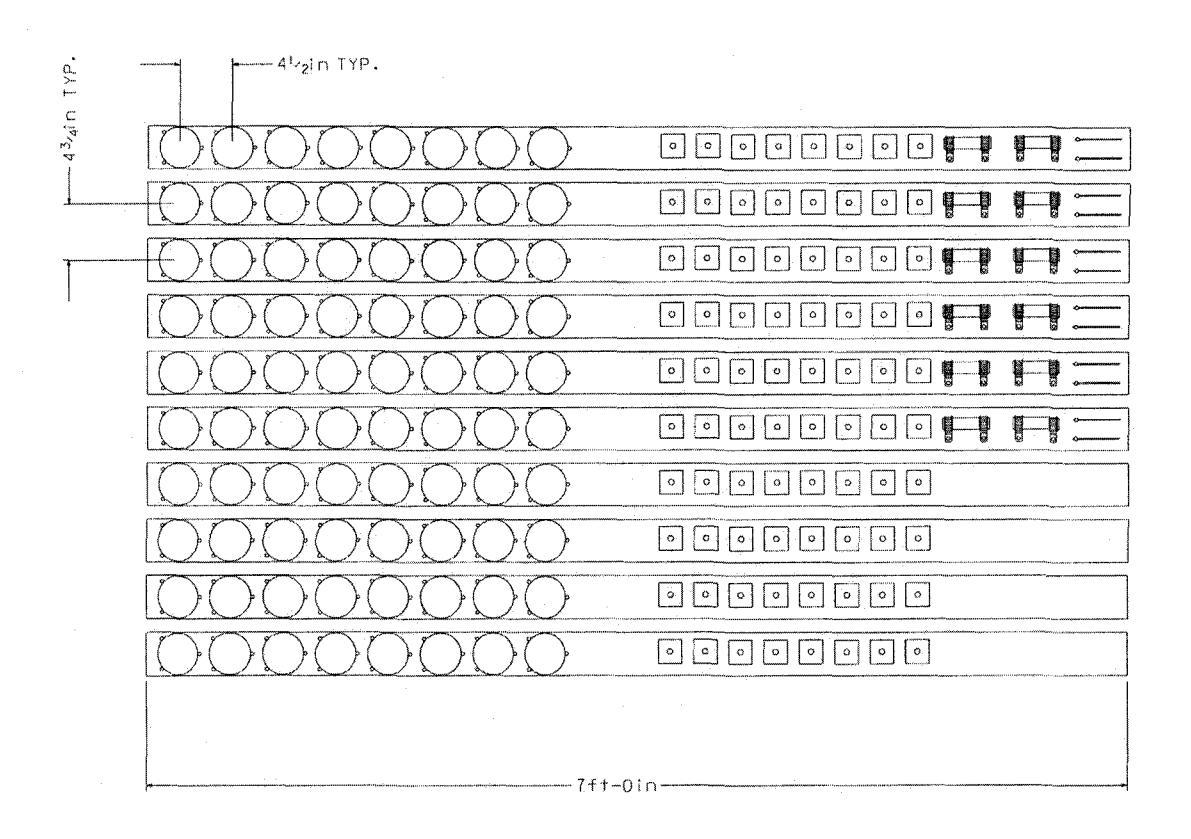
Figure B.4: Arrangement of metal-matrix composite disks (at left) on test racks at all six

atmospheric corrosion test sites

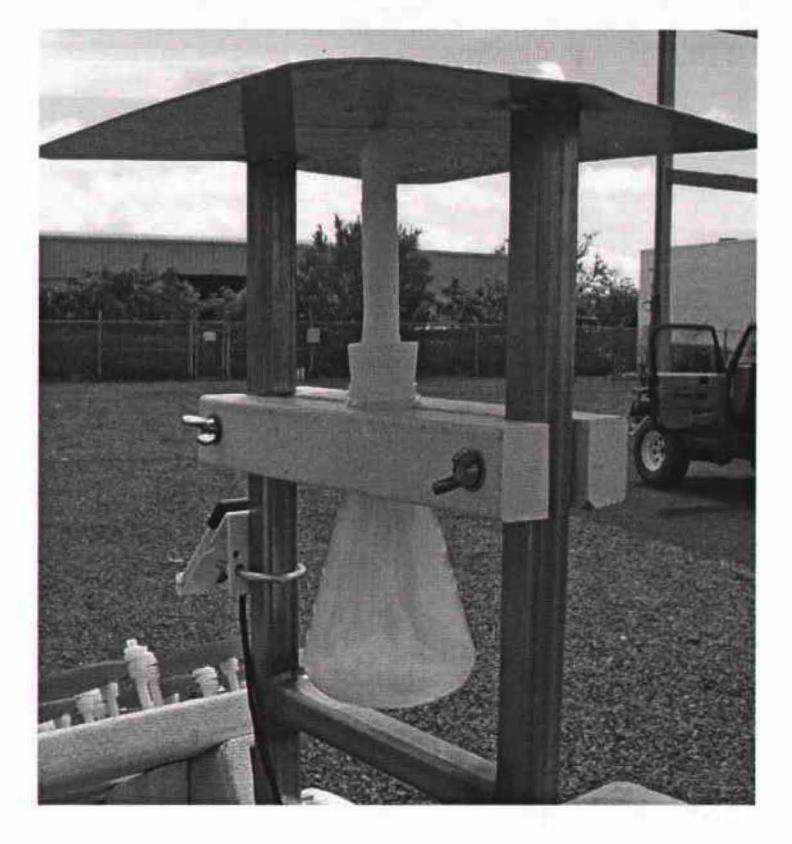
Figure B.11: Chloride candle and leaf wetness sensor

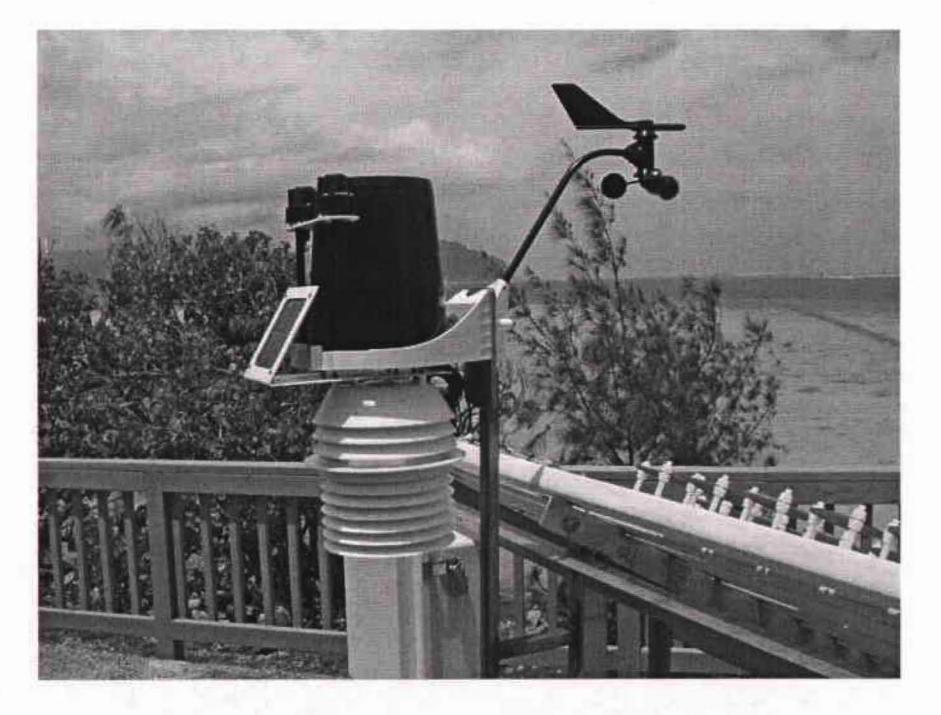
Figure B.12: Davis Vantage Pro weather station

A Davis Vantage Pro weather station at each test site measures and records independent weather variables such as temperature, humidity, atmospheric pressure, rainfall, wind speed, wind direction, leaf wetness and UV. Other dependent variables such as dew point, evapotranspiration and heat index are calculated in real time. Some of the parameters such as temperature are averaged for each 30 minute period, whereas others, such as rainfall, are totaled. In all, more than thirty data points are written to an internal data logger every half an hour. The data stored at each site is downloaded once a month. Chloride candles are exposed in the field for approximately thirty days and then brought back to the lab for analysis. The gauze wick is soaked in the remaining ultrapure water and 100mL of that solution is poured into a beaker. 2mL of 5M sodium nitrate (NaNO₃) is added to the beaker which serves as an ionic strength adjustor (ISA). Chloride candle

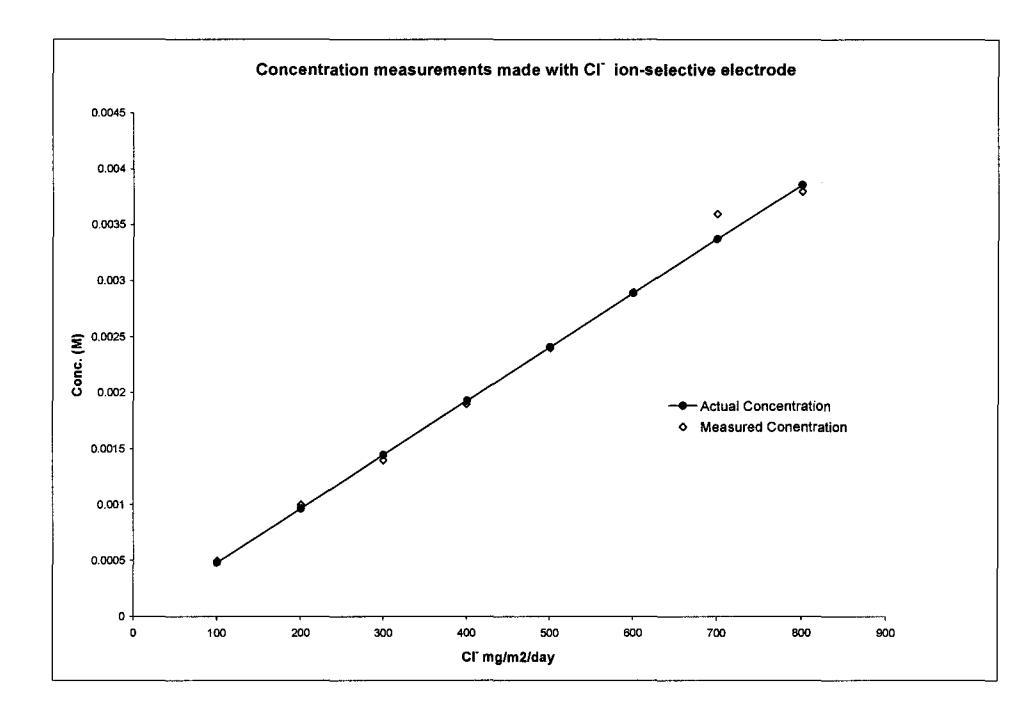
Figure B.13: Calibration curve for chloride candle measurements using an Orion 290A

ISE/pH meter and an ion (Cl-) selective electrode (9617BN)

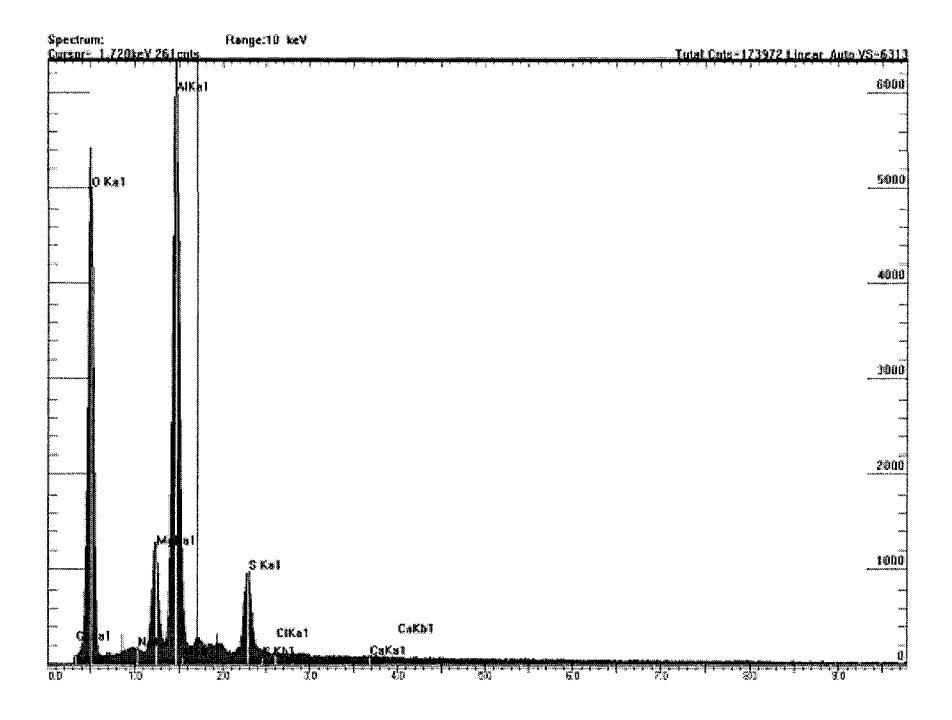
Figure C.1: EDXA of Al6092-T6/B₄C/20p immersed in 3.15 wt.% NaCl

EDXA results for the B_4C and Al_2O_3 MMCs are shown in Figures C.1 and C.2 in Appendix C.

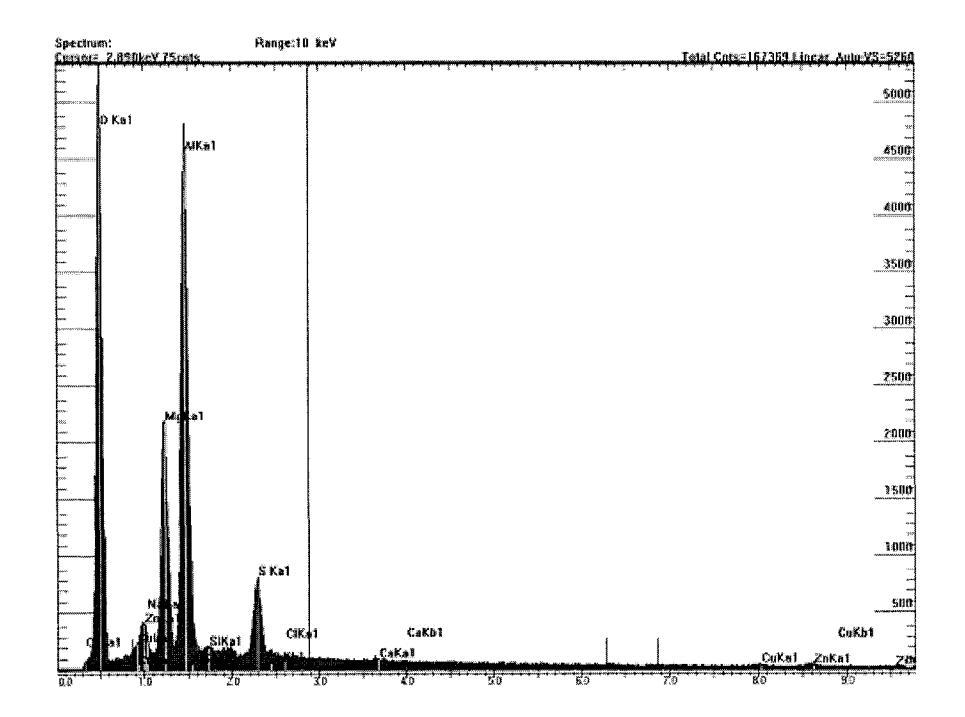
Figure C.2: EDXA of Al6092-T6/Al₂O₃/20p immersed in 3.15 wt.% NaCl

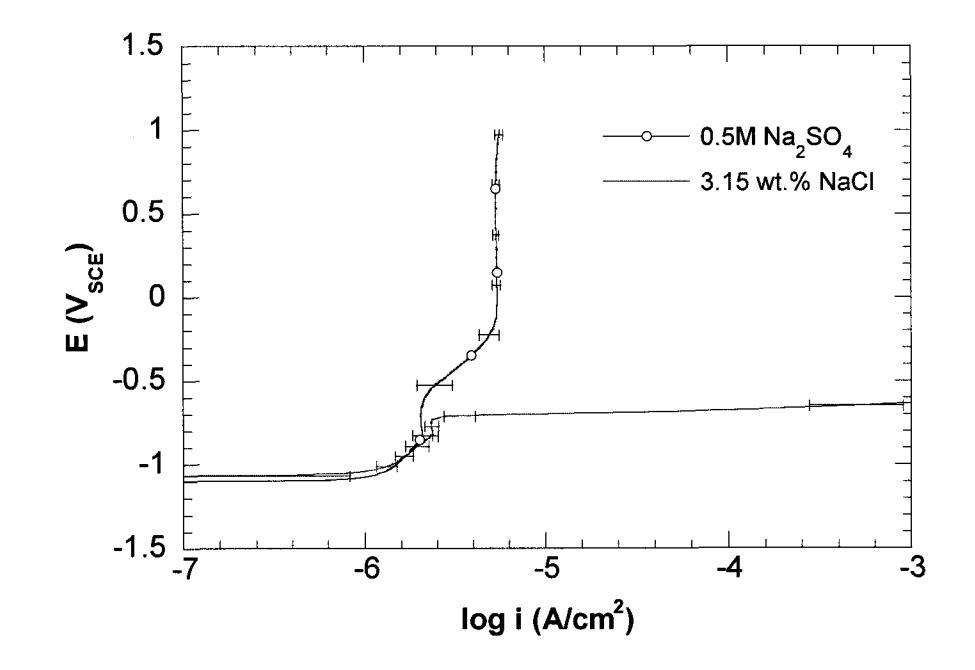
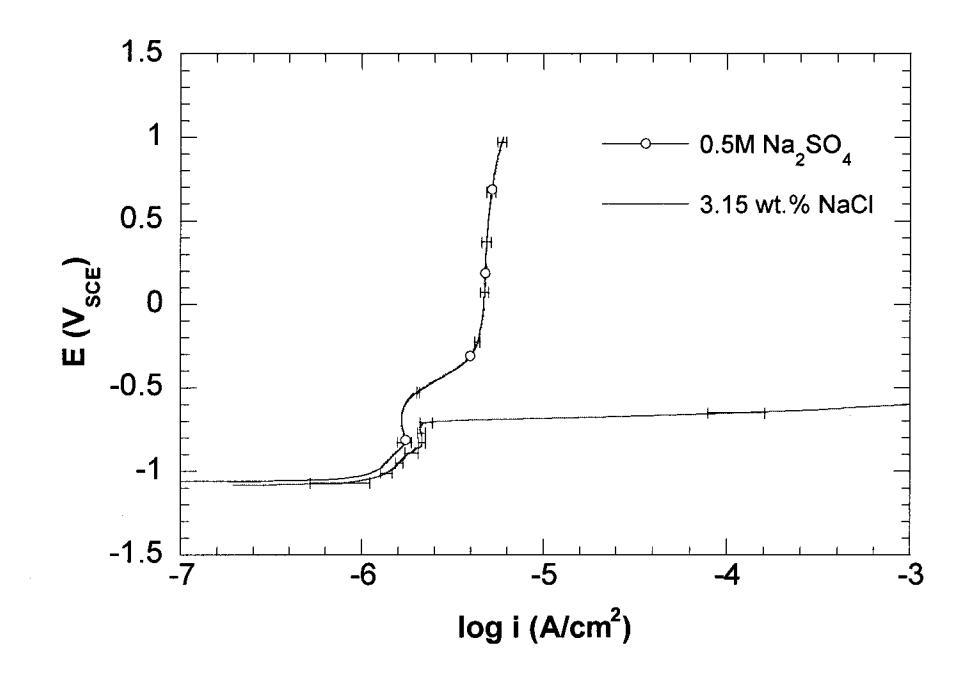
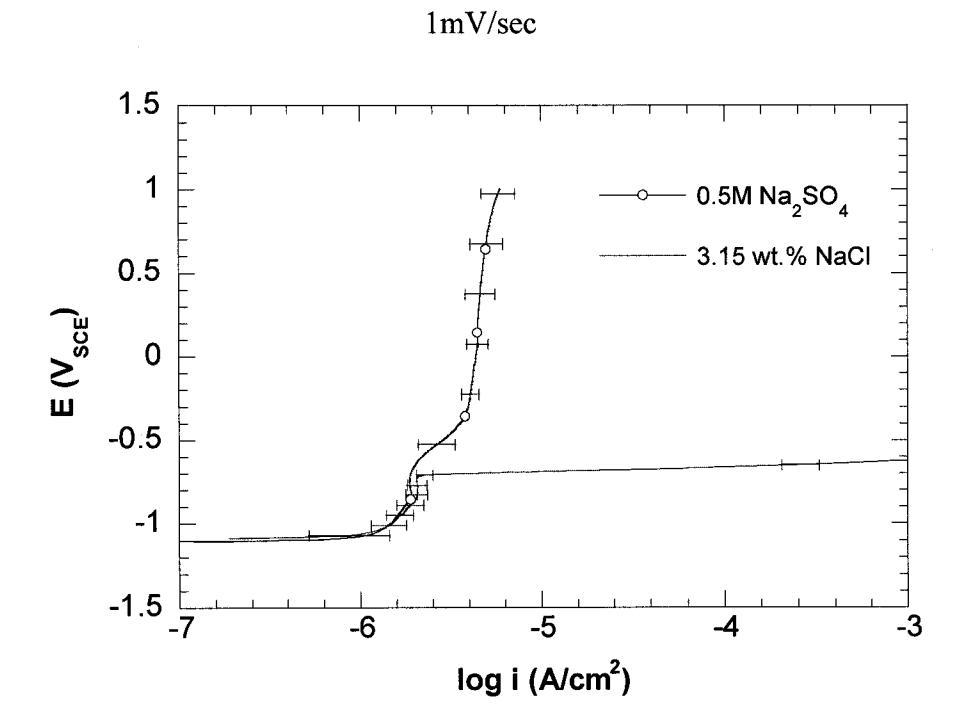
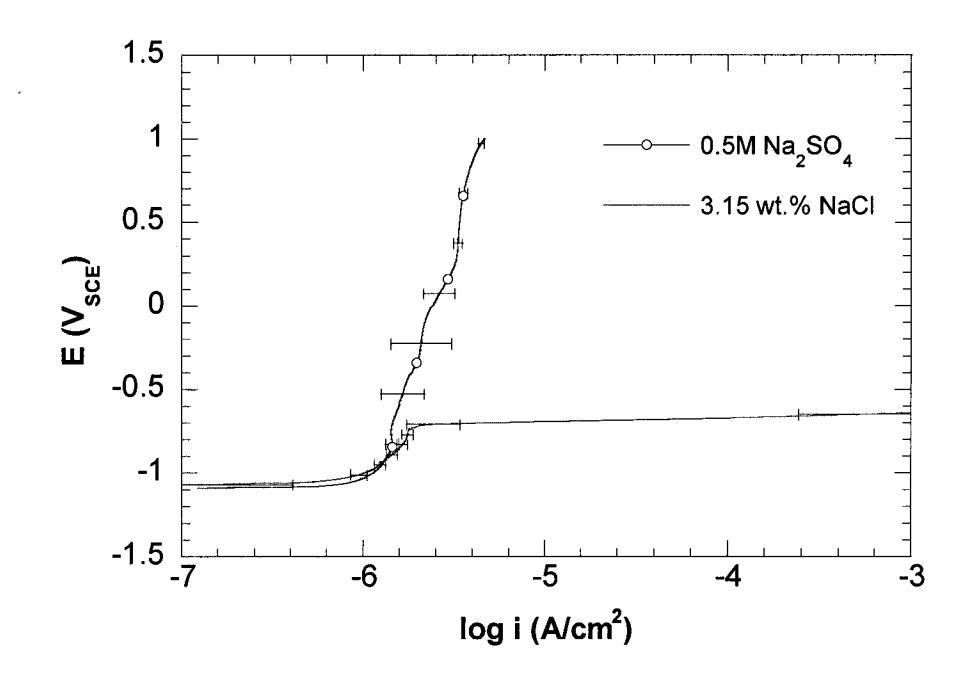
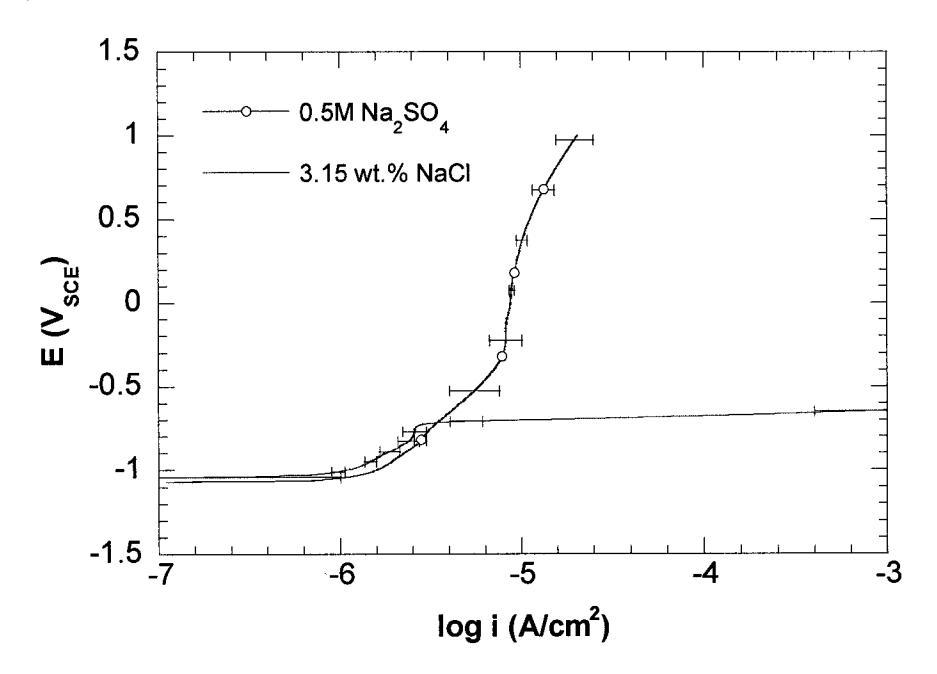
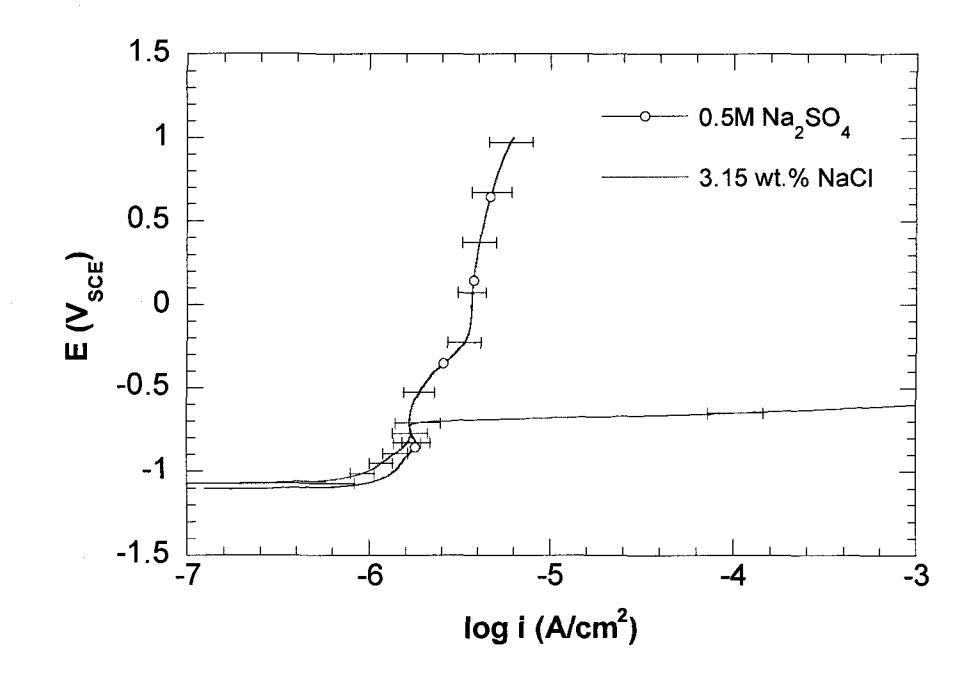
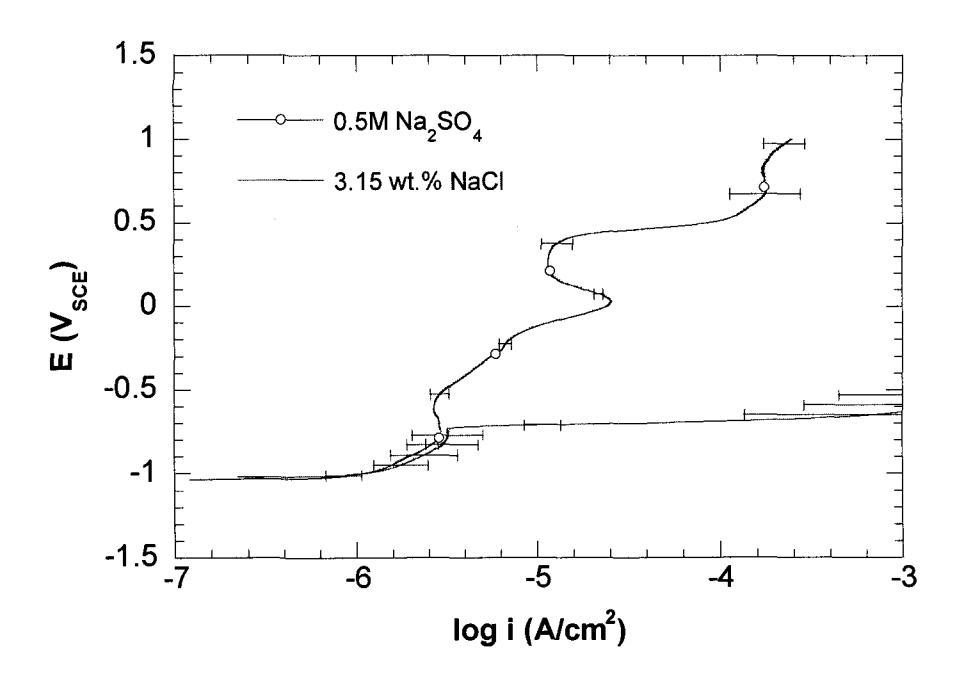
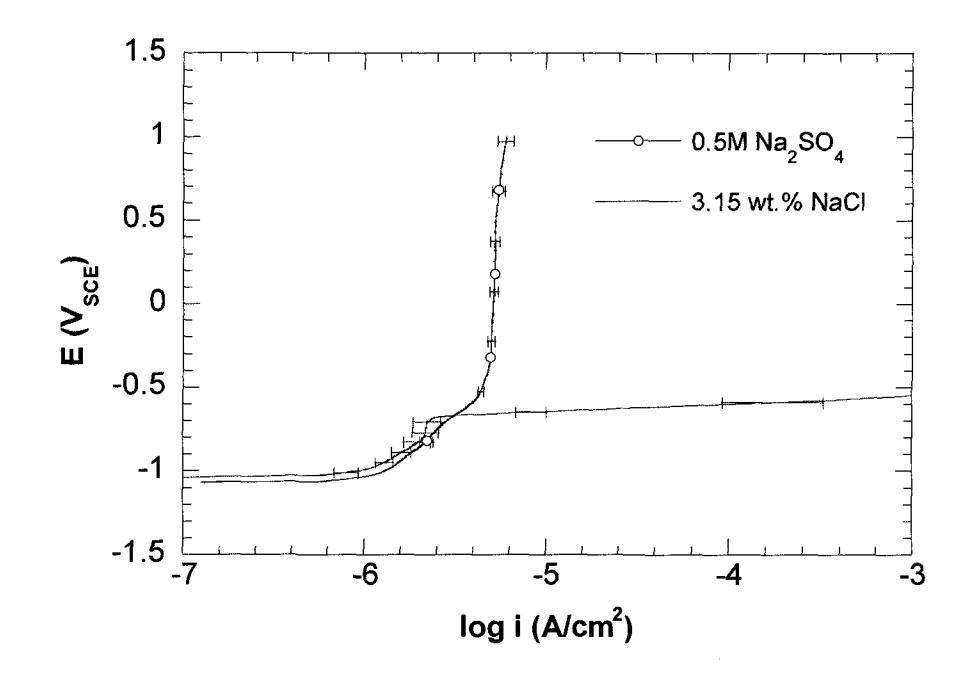
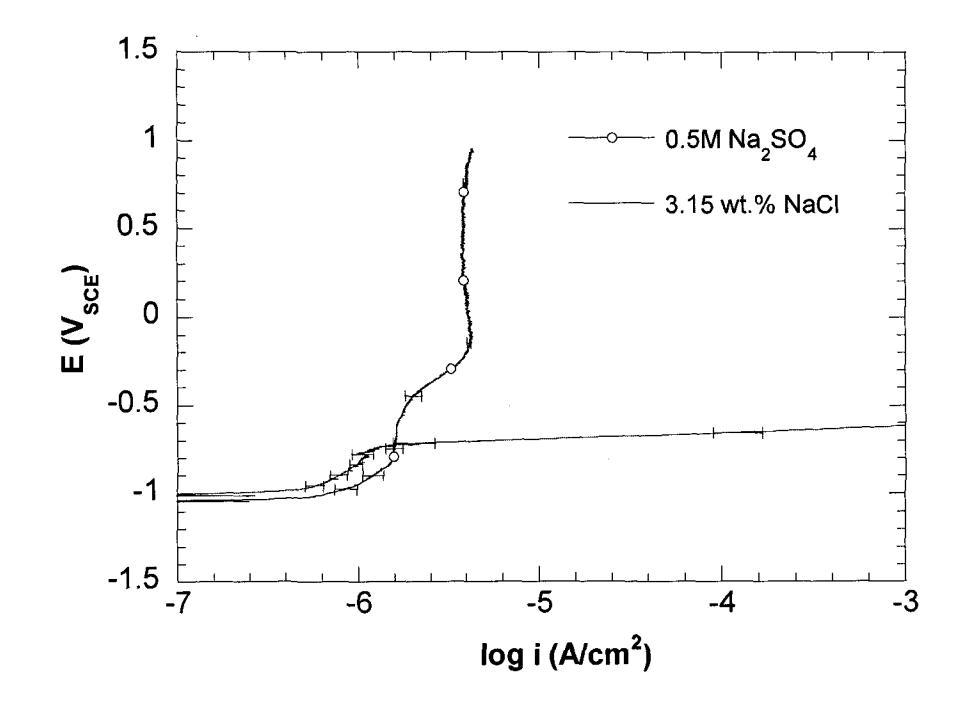
Figure D.1: Anodic polarization of Al6092-T6/SiC/5p at 30°C with scan rate of 1mV/sec

Figure D.9: Anodic polarization of Al6061-T6 at 30°C with scan rate of 1mV/sec

Table D.1 in Appendix D provides the pitting potentials and passive current densities for the eight MMCs and Al6061-T6 in both solutions. In addition, plots with data error bars for each of the MMCs and Al6061-T6 in both solutions are shown in Figures D.1 through D.9 in Appendix D.
